**CALSPAN ON-SITE ROLLOVER CRASH INVESTIGATION  
SCI CASE NO.: CA09077**

**VEHICLE: 2007 CHRYSLER ASPEN LIMITED**

**LOCATION: NORTH CAROLINA**

**CRASH DATE: OCTOBER 2009**

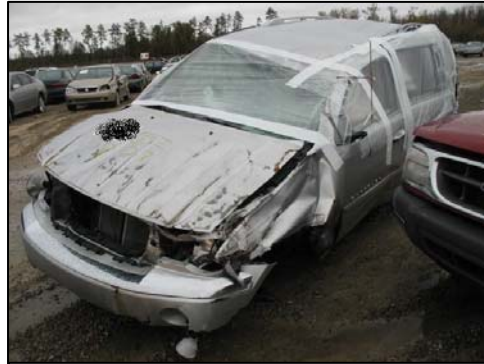
**Figure 1: Front left view of the 2007 Chrysler Aspen.**

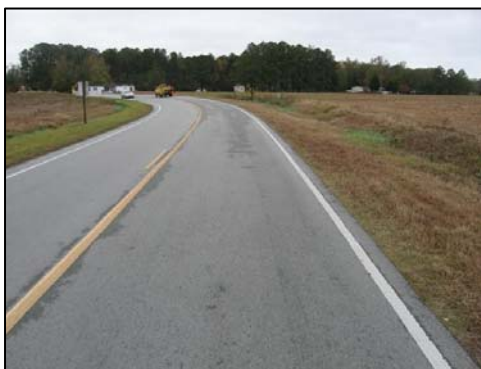
The restrained 26-year-old female driver of the Chrysler was operating the vehicle southbound in a curve to the left at a police estimated speed of 89 km/h (55 mph). **Figure 2** depicts the Chrysler's pre-crash trajectory. The Chrysler departed the roadway to the right and traveled off-road for approximately 105 m (345 ft) in a tracking attitude. As the west side of the embankment exiting the ditch on the west roadside began to gain height, the Chrysler initiated a counterclockwise (CCW) yaw. The vehicle yawed approximately 90 degrees CCW and traveled out of the ditch as the ditch turned right prior to an intersecting roadway. The right tires of the Chrysler furrowed into the soft dirt and grass of the roadside. Although equipped with ESC, the irregular off-road surfaces limited the effectiveness of the system.

**Figure 3: Pre-crash trajectory of the Chrysler.**

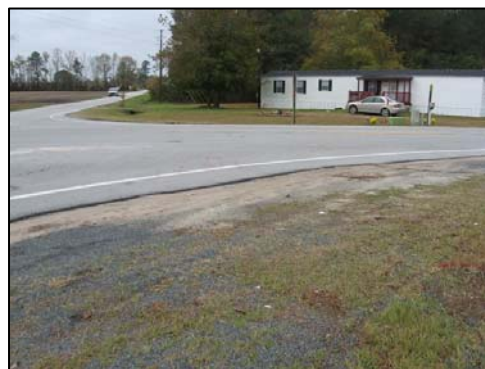
**Figure 2: Location of the start of the rollover.**

The tires furrowing into the soil on the roadside tripped the Chrysler into a right side leading rollover prior to the vehicle crossing the intersecting roadway. **Figure 3** depicts

the location of the rollover. Based on evidence at the scene and the damage to the vehicle, the Chrysler rolled four-quarter turns over a distance of 23 m (75 ft). The vehicle traveled across the asphalt roadway, creating a group of six gouge marks near the roadside and two individual gouge marks near the center of the roadway as it rolled. The undercarriage of the Chrysler impacted the stop sign on the wooden post, fracturing the post. The Chrysler came to rest on its wheels facing in an easterly direction on the grass roadside at the southwest corner of the intersection.

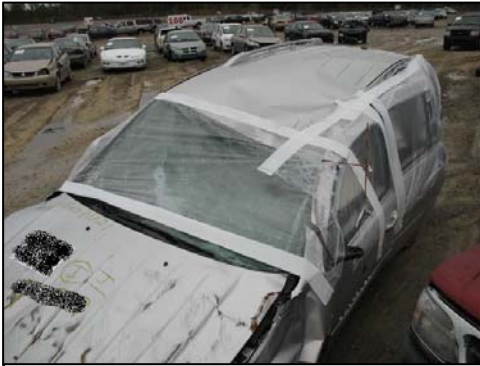
The exterior of the Chrysler sustained moderate damage to the left, top and right planes as a result of the rollover event. The windshield was 100 percent fractured; however, the laminate was intact. The left front, left rear door glazing and left and right rear glazing adjacent to the third row disintegrated as a result of the rollover. The right front, right rear door glazing and quarter glass, and the left rear door quarter glass were not damaged in the crash. The scratches on the roof were oriented laterally and in one direction only, indicating the vehicle had rolled over the roof only one time during the event. The direct contact to the roof extended 117 cm (46.0 in) laterally from roof side rail to roof side rail and longitudinally 457 cm (180 in) from the leading edge of the hood rearward to the backlight header. The maximum vertical and lateral crush was located at the junction of the left A-pillar and the windshield header. The maximum vertical crush measured 11 cm (4.3 in). The maximum lateral crush measured 4 cm (1.6 in).

All four door hinges were intact and remained attached to their respective pillars. The four latches remained engaged post-crash, and the front left, front right, rear right and back hatch were operational post-crash. The rear left door remained closed during the crash and was opened post-crash. Body deformation prevented it from closing post-crash. The damage sustained by the Chrysler in the rollover is depicted in **Figures 4 and 5**. The Collision Deformation Classification (CDC) assigned for the rollover event was 00TDDO3.

**Figure 4: Overhead view of the rollover damage.**

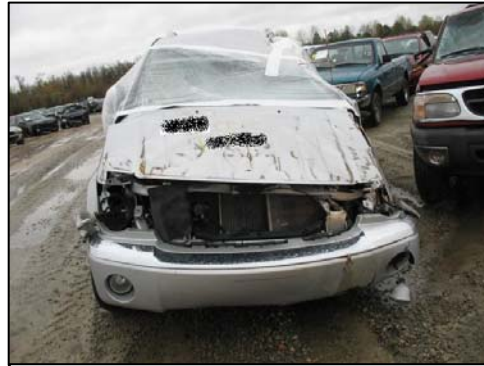
**Figure 5: Frontal view of the rollover damage.**

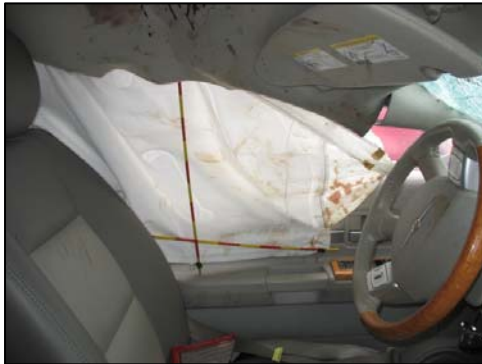
There was smeared blood transfer on the inboard side of the left IC, covering the sail panel and the IC from the upper to the lower aspect and from the front of the IC extending rear 44 cm (17.3 in). There were droplets of blood on the inboard side of the right IC, in the front row. Neither IC was damaged in the crash. The right IC was labeled with the nomenclature: 28038450

Figure 6: Left IC adjacent to driver's seat.

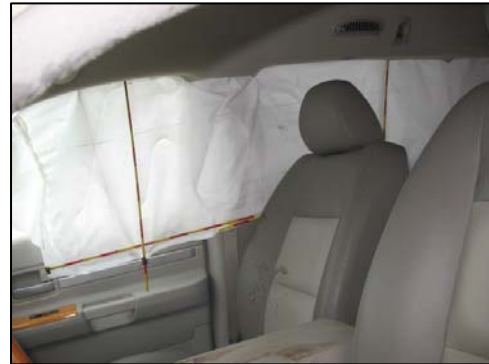
Figure 7: Right IC.

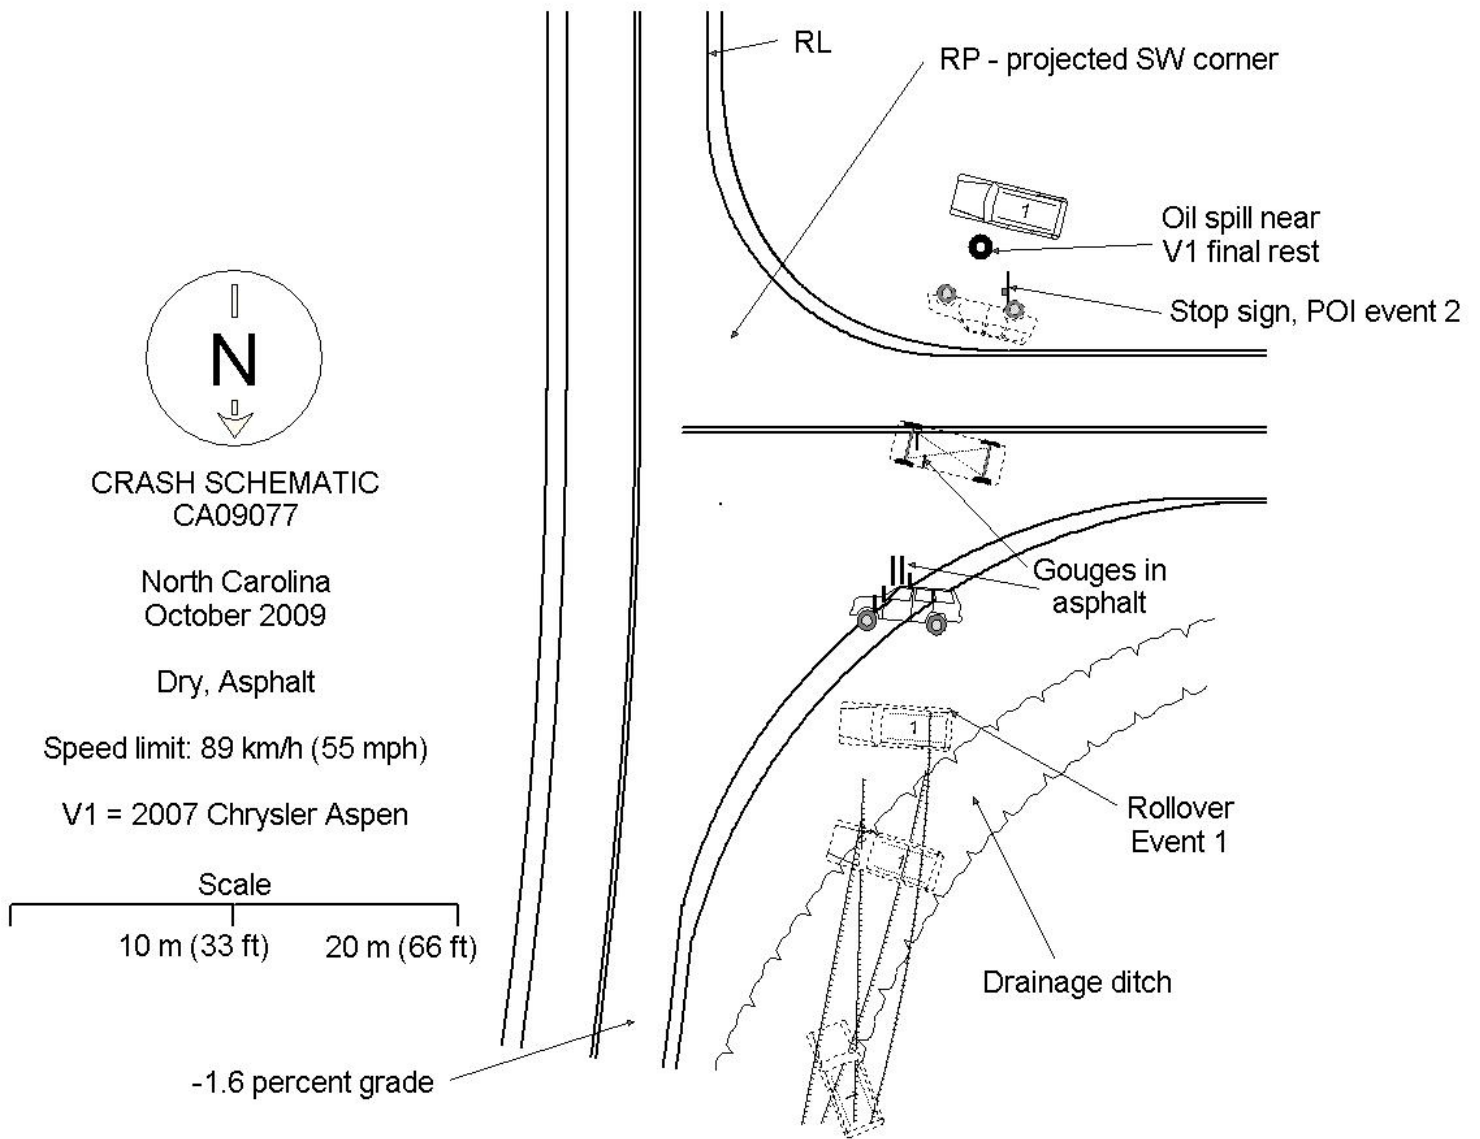
**Figure 9: Enlarged area near rollover location.**
