**CALSPAN ON-SITE AMBULANCE CRASH INVESTIGATION**  
**SCI CASE NO: CA09080**

**VEHICLE: 2000 FORD E-350 TYPE III AMBULANCE**  
**LOCATION: TENNESSEE**

**CRASH DATE: SEPTEMBER, 2009**

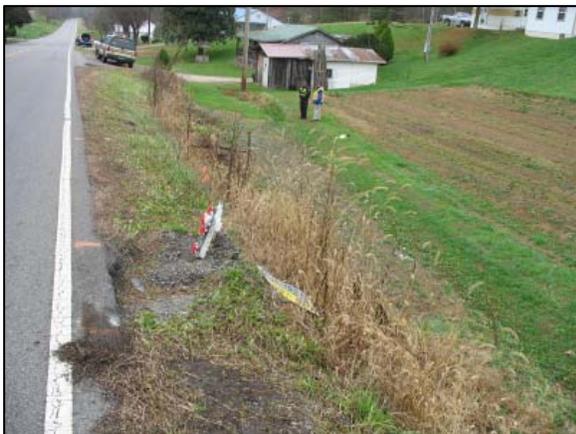
The west-northwest trajectory of the ambulance was evidenced by a series of gouge marks distributed over a 21.4 m (70.2 ft) length west of the impact. These marks were located 0.9 m (3.0 ft) inboard of the fog line and angled toward the pavement edge. The gouge marks were attributed to components of the left front suspension. A tire impression from the aired out left rear tire of the ambulance was also observed. Immediately inboard of the north fog line, the pavement was heavily abraded over an 18.3 m (60.0 ft) length from the undercarriage of the ambulance as the vehicle slid along the roadside. Along this trajectory, the rear aspect of the ambulance encountered the steep roadside embankment and the vehicle initiated a CCW rotation. The ambulance rotated approximately 50 degrees and fell-over (Event 2) due to the slope of the roadside embankment. A 20 cm (8 in) deep gouge was located in the soft roadside terrain 40.6 m (133.2 ft) west of the impact. This gouge measured 25 cm x 25 cm (10 in x 10 in) and was attributed to contact with the upper right corner of the ambulance's patient compartment. Asphalt debris was noted in the fractured corner of the compartment. **Figure 3** is a view from the gouge toward the final rest of the ambulance. **Figure 4** is a lookback from final rest to the road departure. The ambulance continued down the steep embankment into the open field to final rest position on its right plane. The distance from the estimated fall over to final rest measured 22 m (72 ft). The ambulance came to rest 64 m (210 ft) from the initial impact.

**Figure 3: View along the fall-over trajectory of the ambulance to final rest.**

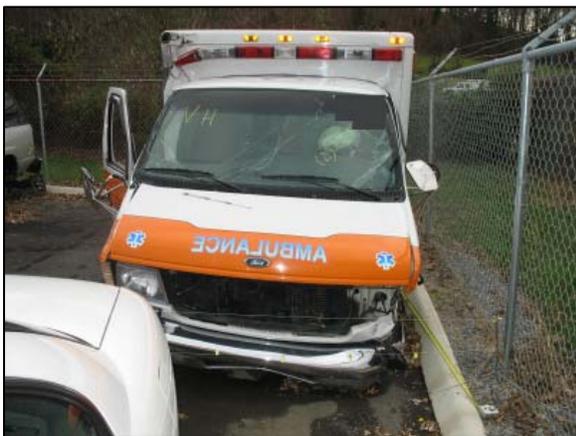
The Ford ambulance sustained direct contact damage to the front and left side planes as a result of the offset frontal crash (Event 1). **Figures 5 and 6** are the front and left side views depicting the damage. The direct contact damage on the frontal plane began 64 cm (25.0 in) left of center and extended 24 cm (9.5 in) to left front bumper corner. The residual crush profile along the front bumper was as follows: C1 = 11 cm (4.3 in), C2 = 0, C3 = 0, C4 = 0, C5 = 0, C6 = 0. The direct contact with the Chevrolet extended along the left plane of the ambulance to the forward left corner area of the patient compartment. The direct contact ended 74 cm (29.0 in) rearward of the forward wall of the ambulance body. This contact jammed closed the 55 cm x 152 cm (21.5 in x 60 in) exterior door of the forward storage compartment. The impact with the Chevrolet fractured the left front suspension and separated the wheel assembly. The left aspect of the windshield was fractured from the exterior crash force. The left door was jammed closed. The left front window glazing was closed at the time of the crash and disintegrated. The Collision Deformation Classification (CDC) was 12-FLEE9.

**Figure 5: Front view of the Ford ambulance.**

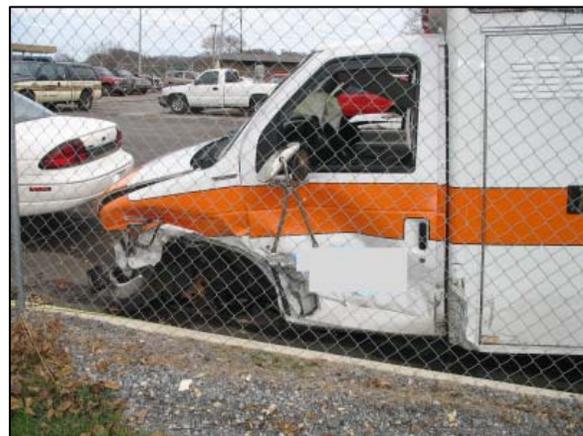
**Figure 6: Left view of the ambulance depicting the extent of damage.**

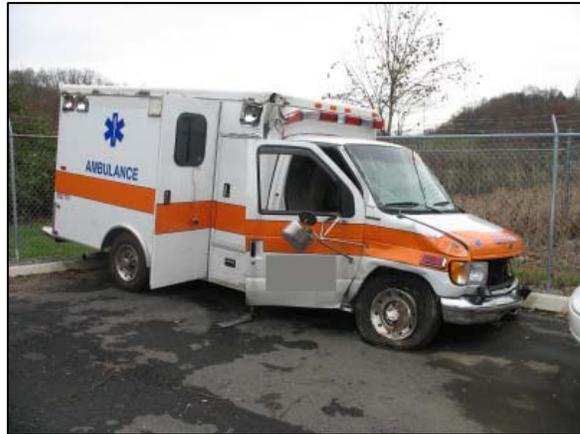
The right plane of the ambulance exhibited evidence of the one-quarter turn rollover (Event 2). **Figure 7** is a right side view of the ambulance. The right fender and A-pillar were abraded by contact with the road pavement with minor deformation. The front right corner of the patient compartment was abraded at its upper aspect and holed by ground impact. The hole measured 8 cm x 10 cm (3 in x 4 in). Asphalt debris was embedded in the contact area. The top longitudinal aspect of patient compartment was abraded along its entire length. All the right side storage compartment doors and the right entry door were operational. There was no change in the right wheelbase dimension. The right door remained closed during the crash, but was open at the time of the SCI inspection. It would not close due to body deformation. The window glazing was disintegrated. The CDC for Event 2 was 00-RDAO2.

**Figure 7: Right side view of the ambulance.**

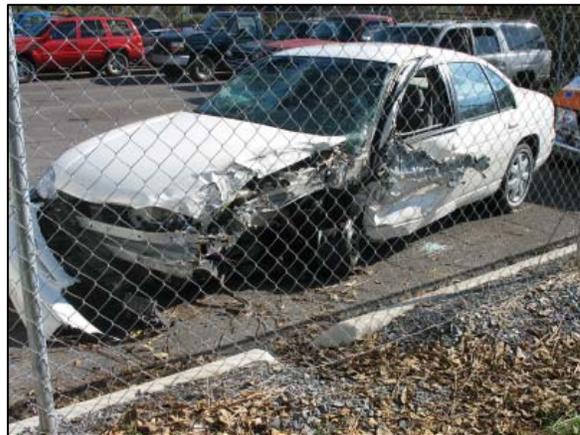
The Chevrolet Lumina sustained moderate severity impact damage to the left front corner that extended along the left side plane onto the driver's door panel, **Figure 8**. The direct contact damage to the frontal plane measured 30 cm (12.0 in) and began 38 cm (15.0 in) left of center extended in the left front corner. The impact fractured and separated the bumper fascia exposing the bumper reinforcement bar. The residual crush profile measured along the reinforcement bar was as follows: C1 = 31 cm (12.2 in), C2 = 16 cm (6.3 in), C3 = 11 cm (4.3 in), C4 = 8 cm (3.1 in), C5 = 8 cm (3.1 in), C6 = 4 cm (1.6 in). The maximum crush was located at the left front corner, the C1 crush measurement. The direct contact then extended along the left side plane ending 118 cm (46.5 in) forward of the left rear axle. The left front wheel assembly of the Chevrolet contacted the left front wheel assembly of the ambulance resulting in a fracture of the suspension. The left front rim was displaced rearward 42 cm (16.5 in) and the tire deboned and separated. The left front door was jammed closed and its window glazing disintegrated. The CDC was 12-FLEE9.

**Figure 8: Left oblique view of the Chevrolet depicting the extent of damage.**

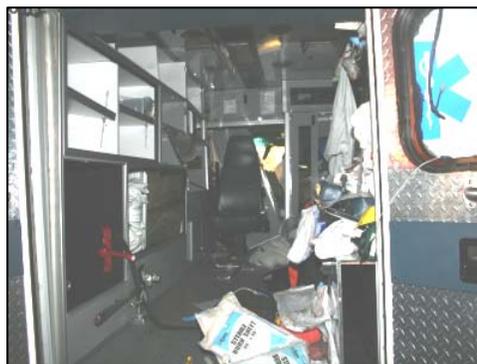
**Figure 9** is a police image of the patient compartment interior taken on the night of the crash after the vehicle was up-righted. There was no interior damage to the compartment from the exterior force of the crash. The interior damage to the compartment was associated to the displacement of the occupants and loose interior objects. The design of the compartment consisted of the typical layout with multiple cabinets, shelves and counter space along the left wall, a side-facing, three-passenger bench along the right wall and a storage unit at the forward right aspect.

**Figure 9: Police image of the patient compartment interior.**

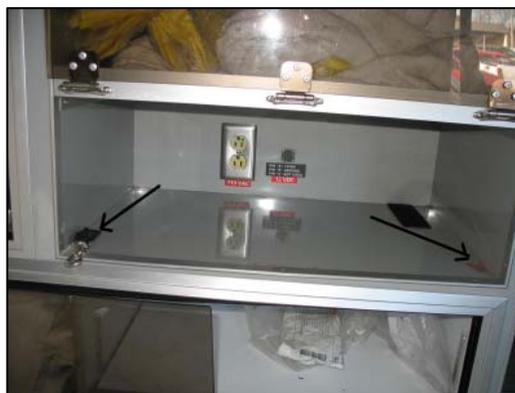
At the time of the crash, a cardiac monitor was located on the center shelf (**Figure 10**) of the compartment's left wall and was in use monitoring the patient. It was secured to the shelf by two 5 cm (2 in) long straps. A spring clip fastened to one end of the strap was attached to the monitor. The use of the spring clip allowed for the easy removal of the unit. The fixed end of each strap was secured to the shelf with a wood screw. During the crash, the monitor was displaced from the shelf by the impact force. The wood screw securing the forward strap pulled out of the particle board shelf. The paramedic reported that the cardiac monitor struck him in the chest.

**Figure 10: View of the shelf that housed the cardiac monitor at the time of the crash. Note, the missing wood screw and strap.**

In his interview, the paramedic recalled that the cardiac monitor was displaced from the shelf and that it struck him in the chest. This loose interior object was the source of his sternal fracture. He also recalled that the patient was being displaced from the cot, moving forward toward him. The patient contacted the paramedic in the area of his knees causing the contusion to that body region. The patient then continued forward into the paramedic's torso. Coincident with this interaction, the paramedic was rebounding from the jump seat and also responding to the rolling of the vehicle. As the vehicle rolled down the embankment, the paramedic was displaced toward the right side and roof of the patient compartment. Due to his size and weight, the paramedic's momentum also redirected the patient to the right side of the patient compartment. It was likely that the injuries to his left leg, ankle and foot resulted from contact with the cot frame during his displacement.

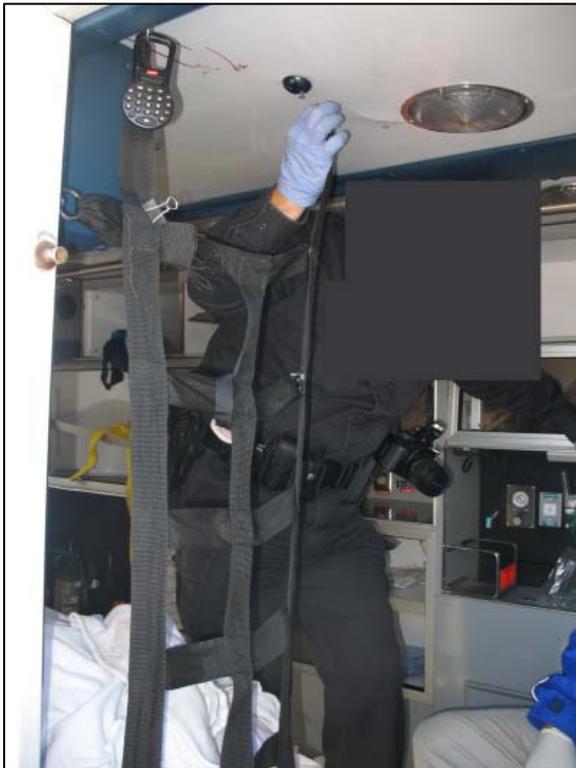
The right side of the patient compartment consisted of the side-facing bench seat. A vertically-oriented net restraint was located at the forward end of the bench. The net restraint covered an area that measured 30 cm x 122 cm (12 in x 48 in) and was comprised of six horizontal straps woven to three vertical straps. Each strap was 4 cm (1.5 in) wide. The end of each strap was threaded through a metal ring that was attached to spring loaded fastener and the strap was sewn onto itself forming a loop. The net was hung by attaching the spring loaded fastener at the end of the vertical straps to four retainers that were attached to the ceiling and the end of the bench cabinet. Each retainer was attached to the ceiling and the cabinet by two wood screws. During the rollover, the netting was loaded by the paramedic. The stitching at the upper aspect of the inboard vertical strap and at the center aspect of upper horizontal strap released. Additionally, the wood screws securing the ceiling retainers partially pulled free. **Figures 11 and 12** are views of the restraint net.

**Figure 11: Overall view of the restraint net.**

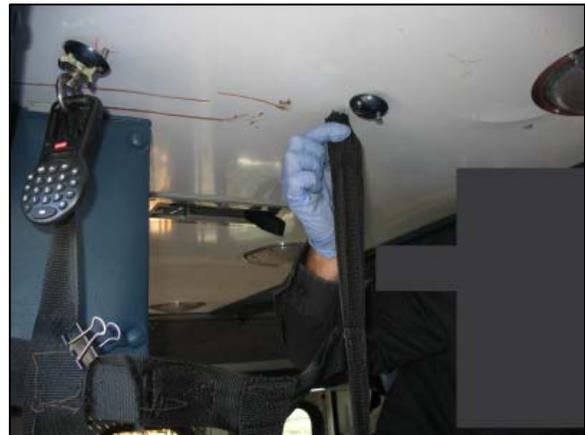
**Figure 12: Close-up view of the separated upper aspect of the net.**

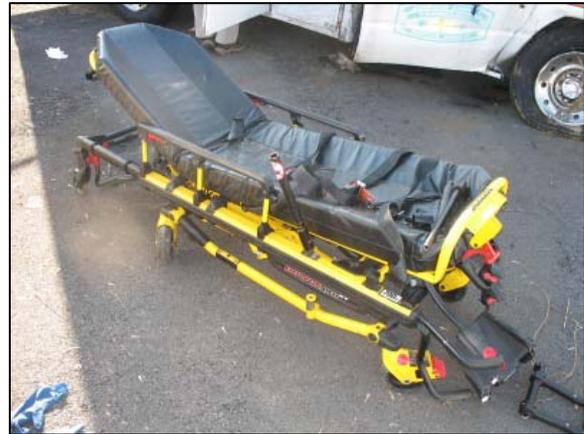
The cot used to transport the patient in this crash was a Stryker Pro-Pro XT 6500; Serial Number: 060939589. **Figure 13** is a view of the cot. This cot was constructed of steel tubing with a scissor design which allowed for height adjustment. This model was designed with a battery-powered hydraulic lift assist. The cot measured 183 cm (72 in) in length and 46 cm (18 in) in width. The empty weight of the cot was 57 kg (125 lb). The maximum patient weight capacity was 318 kg (700 lb). The angle of the back rest was set via a pneumatic adjustment. The specific angle of the back rest at the time of the crash was not known. The paramedic reported the back rest was slightly elevated in a semi-fowler's position. A 20 cm (8 in) length of the cot at the patient's feet was deformed vertically. The source/cause of the deformation could not be determined.

**Figure 13: Overall view of the Stryker cot.**
