CALSPAN ON-SITE CHILD RESTRAINT SYSTEM CRASH INVESTIGATION

SCI CASE NO.: CA09086

VEHICLE: 2009 TOYOTA HIGHLANDER

CRASH DATE: DECEMBER 2009

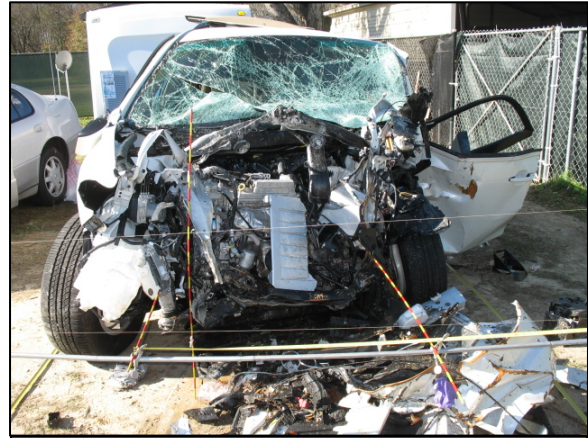
The Toyota Highlander sustained severe frontal damage as a result of the impact sequence with the Ford Mustang (**Figure 4**). The direct contact damage extended across the entire end-width of the vehicle. The bumper fascia, bumper beam, grille, hood and the left front fender separated during the crash event. The maximum crush was located at the left frame rail end and measured 101 cm (39.8 in). The right frame rail crush measured 29 cm (11.4 in). The center point of the right shock tower was displaced 22 cm (8.7 in) rearward. The left shock tower was displaced 61

cm (24 in) rearward. The front wheels were displaced rearward and the left wheelbase was shortened by 65 cm (25.6 in); the right wheelbase reduced 8 cm (3.1 in). The Collision Deformation Classification (CDC) assigned for this impact was 11FDEW5.

Figure 4: Frontal damage sustained by the Toyota.

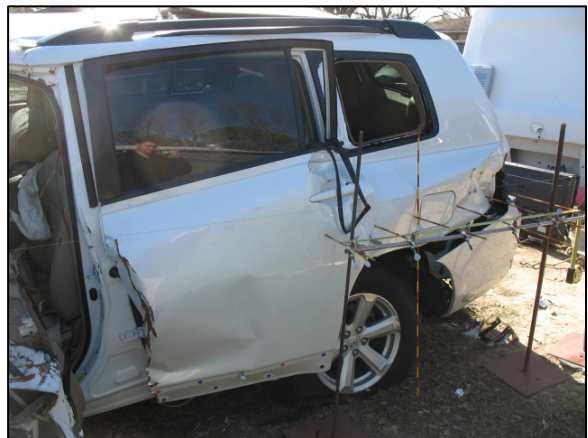
The rear aspect of the left side of the Toyota sustained minor severity damage from the impact with the Ford truck (Event 3). **Figure 5** is a view of the left side damage to the Toyota. The direct damage began at the left rear corner and extended 129 cm (50.8 in) forward. The damage at locations C3-C6 was overlapped by the deformation of the left rear door as a result of the initial event and the extrication efforts during the removal of the driver. A residual crush profile was obtained at the mid door level and was as follows: C1 = 10 cm (3.9 in), C2 = 5 cm (2 in), C3 = 0, C4 = 0, C5 = 0, C6 = 0. The maximum crush measured 10 cm (3.9 in) and was located at the left rear bumper corner. The damage height measured 50-89 cm (19.7-35 in), consistent with the 51 cm (20.1 in) front bumper height of the Ford truck. The CDC assigned for this impact was 08LZEW1. The left side doors were jammed closed post-crash. The right side doors were closed and operational post-crash.

Figure 5: Left rear damage sustained in Event 3 impact.

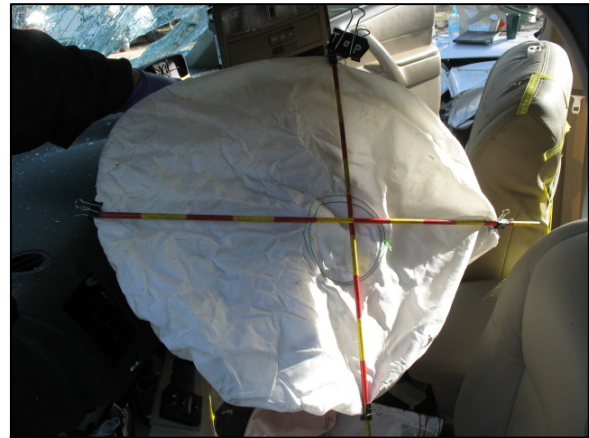
Figure 6: Driver's frontal air bag in the Toyota.

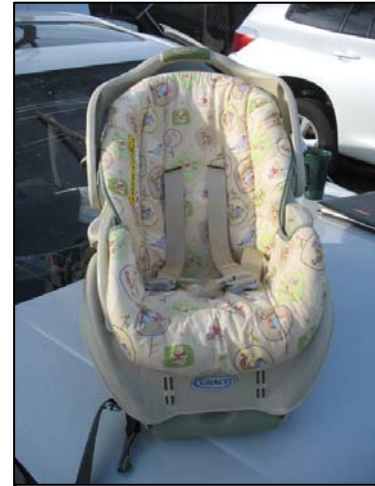
Figure 7: Rear center CRS.

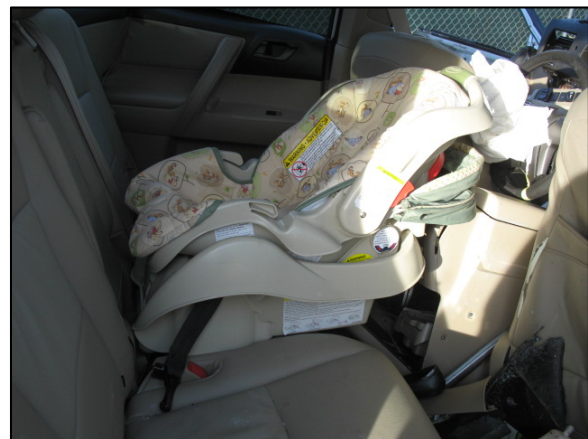
The CRS had been removed from the Toyota post-crash. There was an imprint on the LATCH webbing from the length adjustment buckle. The imprint was located 23 cm (9.1 in) above the end of the left LATCH hook. When the adjustment buckle was returned to this position, the LATCH webbing length measured 82 cm (32.3 in) from the tip of the left hook to the tip of the right. When the base and CRS were returned to the Toyota, this length of webbing would be of a length to tightly install the base in the vehicle. There was an angle adjustment foot on the lower rear of the base. This foot was in the upper position of three available settings. When the base and CRS were replaced in the vehicle, the angle of the CRS was shown to be within the required limits by the operational blue and yellow angle indicator. **Figure 8** depicts the CRS and base reinstalled in the second row

Figure 8: CRS and base on rear center seat of the Toyota.

The shell of the CRS was not damaged in the crash. The shell, fabric cover, and 5-point restraint were unremarkable for damage and/or contact evidence. Located under the fabric cover behind the occupant's back was a 3 cm (1 in) thick section of foam padding. A formed white Styrofoam backer was located behind the foam padding in the area of the head and back of the infant. There was no damage evident to the upholstery foam or Styrofoam backer.

The base sustained minor damage from the crash. A crack and color loss due to stress loading were present at the rear left of the base, between the second and third cutouts for securing the angle adjustment foot. There were frictional abrasions present on both ends of the belt path at the location where the belt webbing angled down to attach to the lower anchors. There was a 3 cm (1.2 in) by 8 cm (3.1 in) impression in the plastic of the belt path with a diamond/straight line pattern consistent with the pattern noted on the belt webbing, located at the right end of the belt path. The hooks at the ends of the webbing were not deformed; however, there was an area of black paint missing from the inside of each hook where the hook engaged the vehicle's anchor. There was no deformation to the inboard LATCH anchor bars in the seat bights of the Toyota's second row seat. There were scratches present on the lower anchor bars.

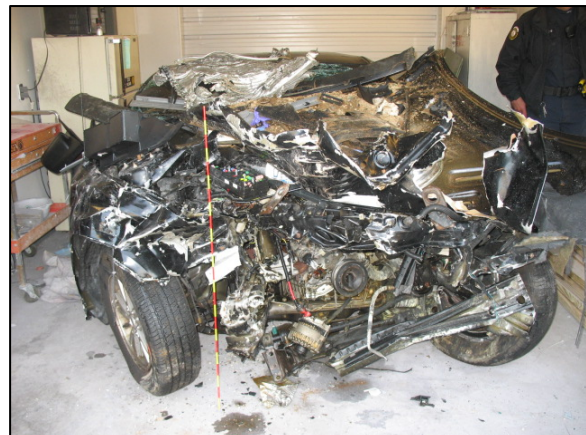
The front plane of the Ford sustained severe damage from the impact with the Toyota (**Figure 9**). The direct damage extended from the front left bumper corner to the front right bumper corner. The maximum crush was located 18 cm (7.1 in) inboard of the right frame rail end and measured 77 cm (30.3 in). The left frame rail end was displaced rearward 40 cm (15.7 in); the right frame rail end crushed 59 cm (23.2 in). Both front wheels were displaced rearward resulting in wheelbase reductions of 55 cm (21.7 in) on the left and 24 cm (9.4 in) on the right. The CDC assigned for this impact was 12FDEW3.

Figure 9: Frontal damage sustained by the Ford Mustang.

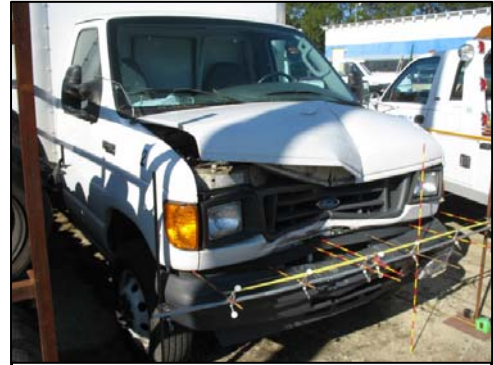
The frontal structure of the Ford truck sustained minor-severity damage in the impact event with the Toyota Highlander (Event 3). This damage is depicted in **Figure 10**. The direct contact damage began 40 cm (15.7 in) right of the vehicle's centerline and extended 179 cm (70.5 in) left. The maximum crush was located at a level above the bumper, 9 cm (3.5 in) left of the centerline. The damage to the bumper was limited to surface abrasions on the top aspect of the bumper. The bumper was displaced downward 3 cm (1.2 in). As a result, crush profiles were documented at the heights of the bumper and the lower radiator support. The residual crush at the bumper level was zero. The above bumper crush profile was: C1 = 0, C2 = 2 cm (0.8 in), C3 = 5 cm (2 in), C4 = 10 cm (3.9 in), C5 = 10 cm (3.9 in), C6 = 0 cm. Maximum crush measured 11 cm (4.3 in) and was located 9 cm (3.5 in) left of the vehicle centerline. The truck's wheelbase dimensions were unchanged. The CDC assigned for this impact was 12FDEW1.

Figure 10: Frontal damage to the Ford truck.

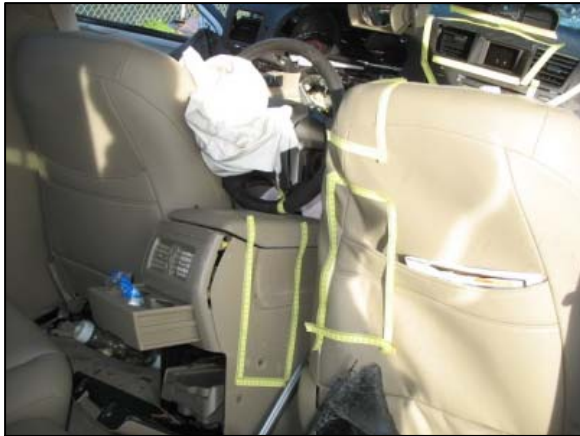
Figure 11: Right interior view of the passenger's contacts to the seat back and center console.

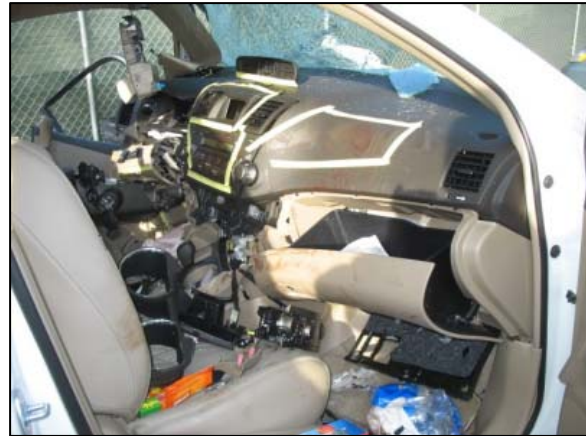
Figure 12: Right interior view depicting the passenger contacts to the center instrument panel.
