CALSPAN ON-SITE CHILD RESTRAINT SYSTEM CRASH INVESTIGATION
SCI CASE NO: CA10001

VEHICLE: 2008 TOYOTA YARIS

LOCATION: NEW YORK

CRASH DATE: JANUARY 2010

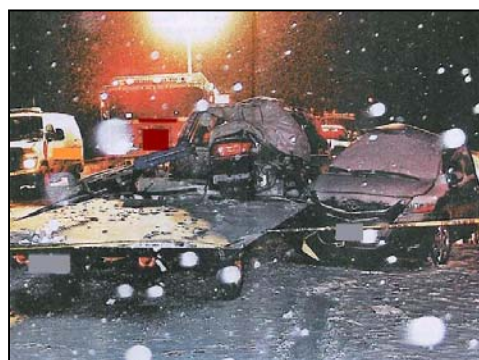
The force and direction of this impact, slightly rearward of the Toyota's center of gravity, caused the vehicle to rotate clockwise (CW) approximately 100 degrees from initial impact to its final rest position. On-scene media images depict the Toyota's final rest south of the initial point of impact within the west shoulder area facing a northerly direction. The Chevrolet rotated approximately 5 degrees CW from impact to its final rest position. The Chevrolet came to final rest within its original travel lane facing a southeasterly direction with the Toyota located at the rear aspect of its right plane as depicted in **Figure 3**.

Figure 3: On-scene image of the vehicles' final rest location.

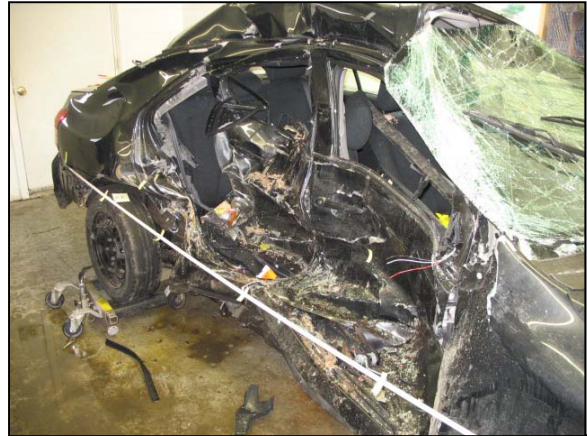
Figure 4 is a right oblique view of the damage to the Toyota's right plane. The direct contact damage began 25 cm (9.8 in) forward of the right rear axle and extended 189 cm (74.4 in) forward. The impact resulted in lateral deformation to the right fender, doors, sill, roof side rail and the A-, B-, C-pillars. Six equidistant crush measurements were documented longitudinally along the mid-door level which produced the following profile: C1 = 0 cm, C2 = 25 cm (9.8 in), C3 = 71 cm (28 in), C4 = 57 cm (2.4 in), C5 = 25 cm (9.8 in), C6 = 0 cm. The maximum crush was located at C3. The right doors were jammed in a closed position and the left doors remained

closed during the crash and were operational post-crash. The windshield was fractured with a partial bond separation in the upper right corner that extended vertically down the right A-pillar. The glazing located in the right side doors and backlight areas were disintegrated from impact forces; however, the glazing in the left side doors was intact and undamaged. The Collision Deformation Classification (CDC) for this damage pattern was 03RPAW5.

Figure 4: Close-up view of the Toyota's right side impact damage.

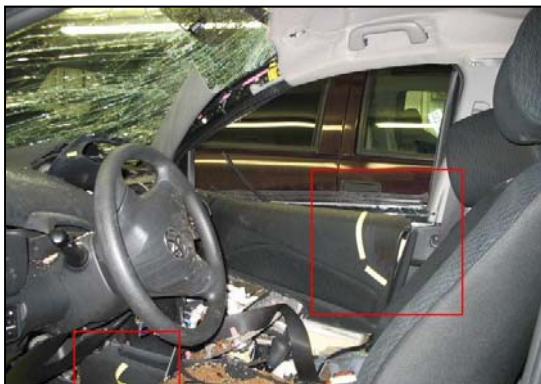
Figure 5: Left lateral view of Toyota's front row depicting the driver interior contacts.

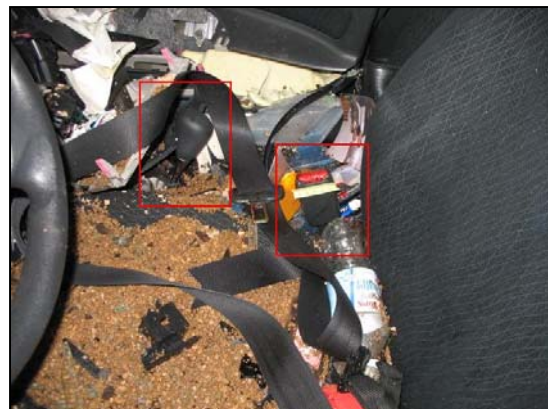
Figure 6: Left lateral view of Toyota's front row depicting the driver contacts to the buckle stalk and transmission selector.

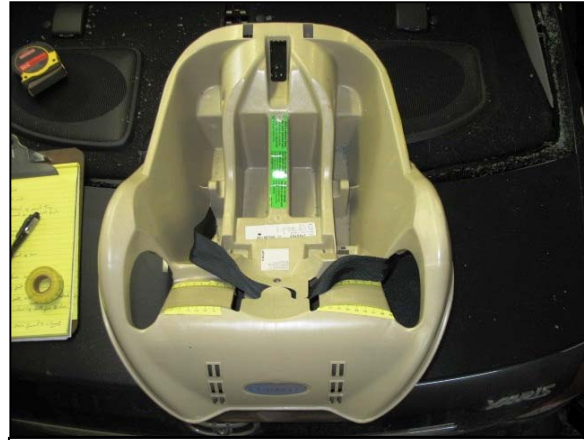
This CRS was installed in the second row center position and its base was held in place by the Toyota's corresponding 3-point safety belt system with the retractor in the ELR mode at the time of the crash. Police-reported first responder statements corroborate this assertion. An inspection of the base (**Figure 7**) revealed that the adjustable foot was in the lowest position of three available slots. With respect to the Toyota's orientation, loading evidence in the form of stress marks within the plastic was identified on the face of the foot, the right inboard edge of the belt path and the right side of the base from midpoint to the leading edge.

Figure 7: Top view of the CRS base.

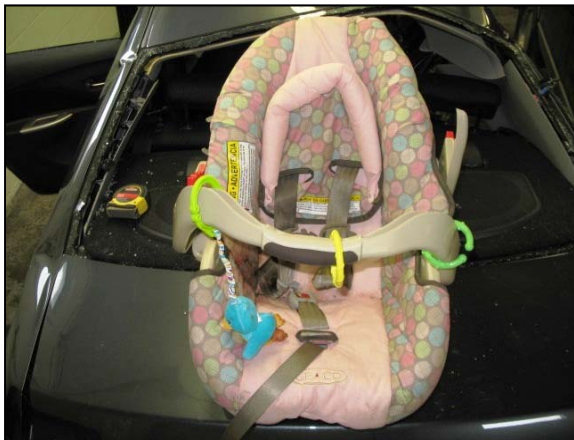
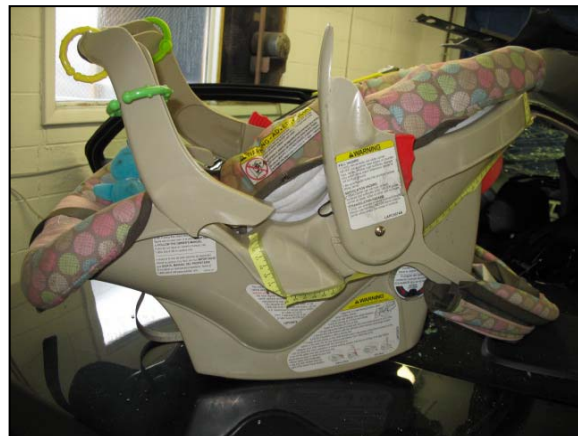
The infant carrier (**Figures 8 and 9**) was designed with a 5-point safety belt harness that was routed through the top shoulder slots. Relative to the occupant, the chest clip was found in place with a one-half twist in the left side harness webbing. The right side webbing was stained with multiple types of bodily fluid. The top carrier handle was fractured on the left side and located in a vertical (up) position. The right side of this handle was set in the full-down position. Bodily fluid had pooled in the right side of the carrier cushion. Stress marks were identified on the left side of the carrier shell and the handle's left side pivot hinge from contact with the vehicle's intruding right rear door panel. The left side of the carrier was visibly compressed and deformed laterally inward towards its center.

Figure 8: Top view of the CRS infant carrier.

Figure 9: Left side view of the CRS infant carrier.

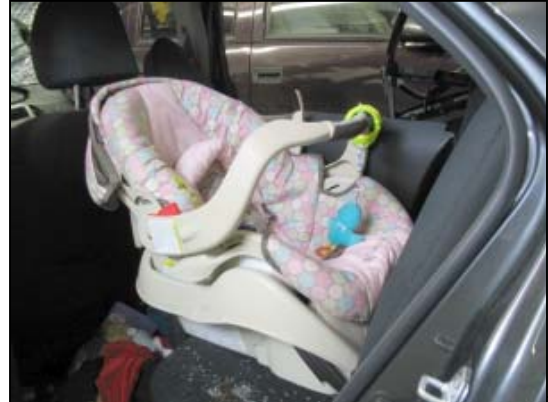
harness straps of the CRS resulting in the contusion and laceration of the spleen and the liver laceration. **Figure 10** depicts the residual intrusion of the right rear door into the center aspect of the second row and the reconstructed position of the CRS.

Figure 10: View of the post-crash location of the intruded right rear door within the Toyota's second row.

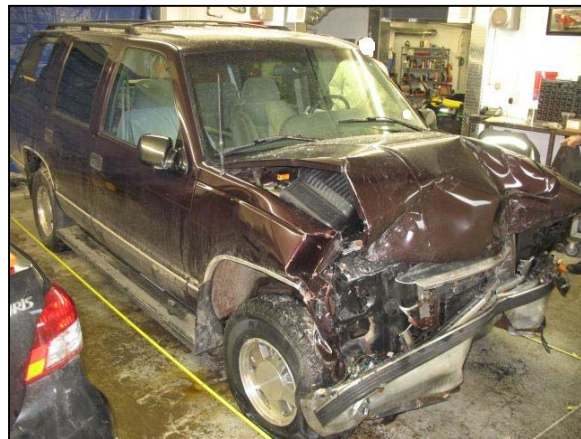
The 1996 Chevrolet Tahoe sustained moderate severity frontal damage (**Figure 11**) as a result of the impact with the Toyota. The direct contact damage began at the left bumper corner and extended laterally to the right bumper corner. The damage consisted of longitudinal crush of the frontal components, which included the front metal bumper, radiator, headlight assemblies, and the leading edge of the hood and front fenders. SCI observations of the Chevrolet's deformed hood identified an imprint of the Toyota's B-pillar within the damage pattern. Immediately to the right of the B-pillar imprint, a circular dent in the hood face was observed.

Figure 11: Right front oblique view of the frontal damage to the Chevrolet.

Immediately to the right of the B-pillar imprint, a circular dent in the hood face was observed. The circular dent was attributed to contact from the Toyota driver's head during the crash. Six equidistant crush measurements were documented along the Chevrolet's deformed metal bumper, which produced the following profile: C1 = 14 cm (5.5 in), C2 = 10 cm (3.9 in), C3 = 22 cm (8.7 in), C4 = 9 cm (3.5 in), C5 = 10 cm (3.9 in), C6 = 11 cm (4.3 in). The maximum crush was located at C3. The CDC for the Chevrolet's impact with the Toyota (Event 1) was 12FDEW1.
