ON-SITE OFFICE OF DEFECTS INVESTIGATION POTENTIAL UNINTENDED ACCELERATION INVESTIGATION

CASE NUMBER - IN10003
LOCATION - TEXAS
VEHICLE - 2006 LEXUS RX-330
CRASH DATE - January 2010

June 22, 2010

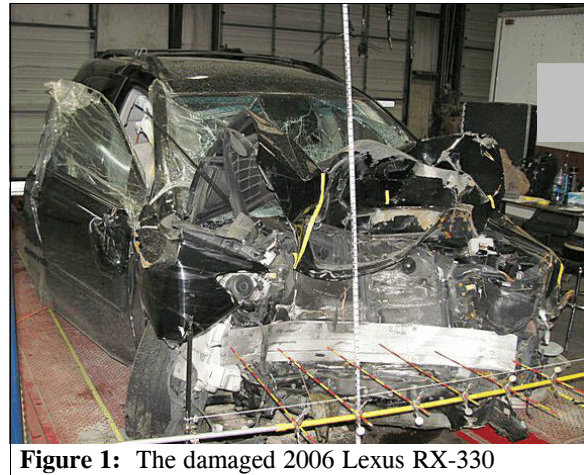
Figure 1: The damaged 2006 Lexus RX-330

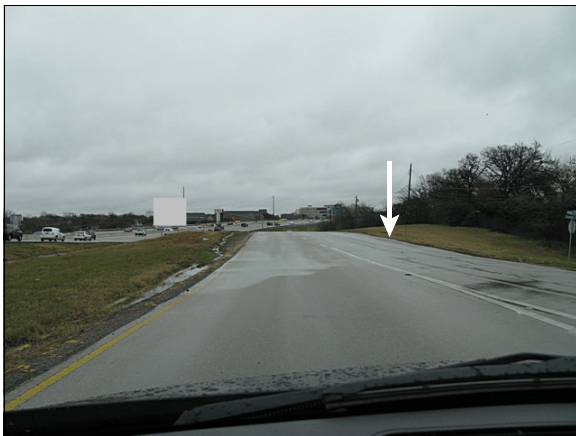
Pre-Crash: The driver of the Lexus was a restrained 64-year-old male driver. Just prior to the crash sequence, he was traveling east on the divided state highway, which traversed parallel to the frontage road where the crash took place. Based on the police crash report, the driver called his wife on a cellular telephone and told her that he was feeling ill and was on the way home. The time this call was placed is not known. At approximately 0940 hours witnesses observed the vehicle weaving in and out of traffic and passing vehicles at speeds of approximately 129 km/h (80 mph). The driver exited the divided highway onto the 1-lane exit ramp for the frontage road and passed two vehicles on the right. The crash sequence began when the Lexus entered the frontage road and immediately departed the right (south) side of the roadway (**Figure 2**).

Figure 2: Exit ramp from state highway entering the frontage road; arrow shows the area of initial roadway departure

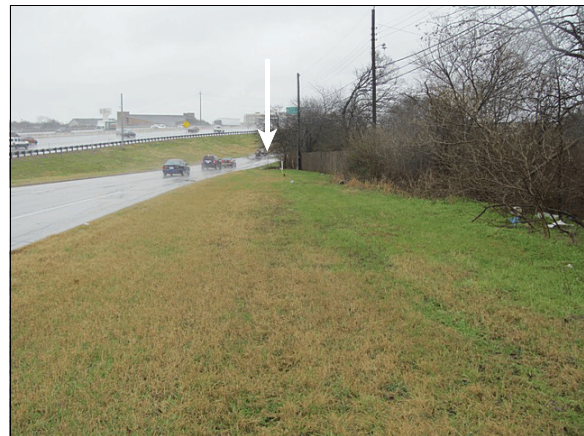
Figure 3: Path of travel of Lexus on south side of roadway; arrow shows small saplings and low hanging tree branches Lexus passed through prior to reentering roadway

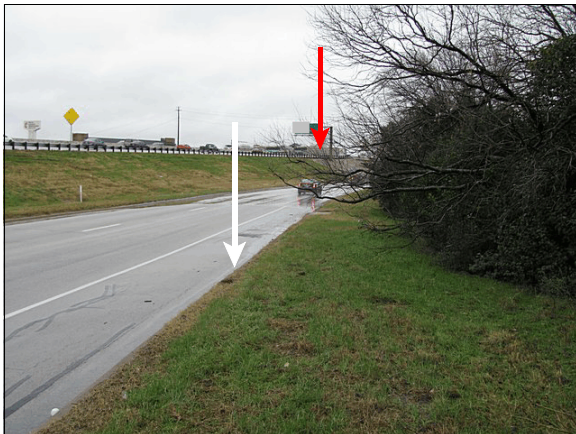
Figure 4: Arrow shows area Lexus reentered roadway, arrow in background shows location of impacts

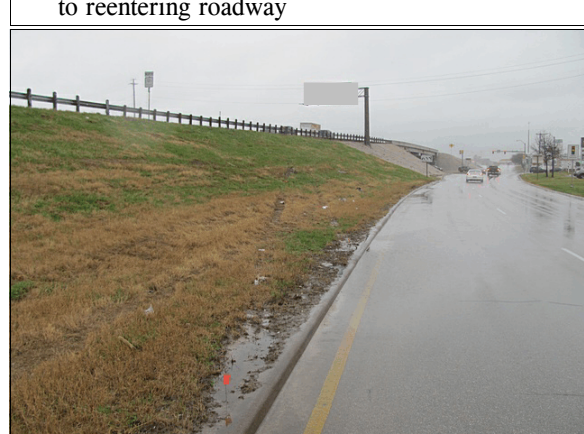
Figure 5: Lexus departs left (north) side of roadway and approaches impacts

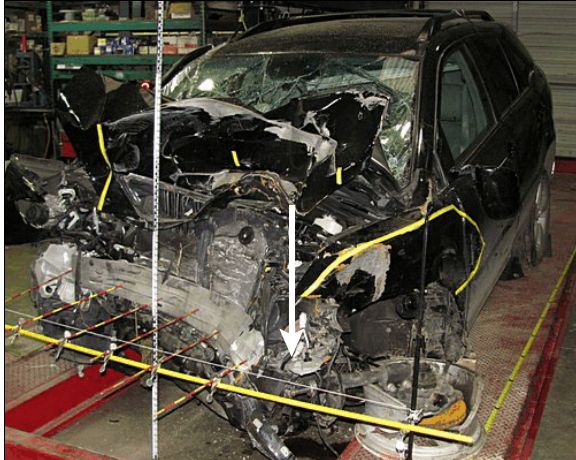
Figure 6: Arrow shows the area of impact with the guardrail posts on the front left corner; yellow tape shows extent of contact down left fender

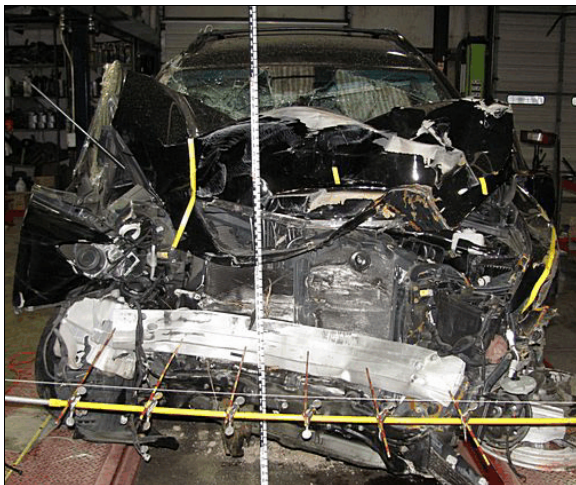
Figure 8: Damage on the front plane of the Lexus from the impact with the metal support pole of a large traffic sign

The Lexus also sustained front plane damage from the impact with the metal support pole. The front bumper, grille, and hood were directly damaged. The direct damage began 52 cm (20.5 in) left of the vehicle's centerline and extended 95 cm (37.4 in) across the front plane. The crush measurements were taken on the bumper bar and the maximum residual crush was 89 cm (35 in) occurring at C₄ (**Figure 12**). The crush profile was reasonable since the guardrail post impacts did not involve the bumper bar. The vehicle's right side wheelbase was reduced 27 cm (10.6 in).

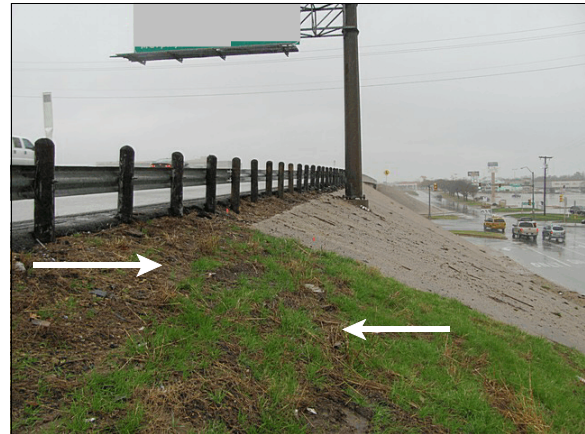
Figure 7: Approach to impact with guardrail posts, arrow on left shows left side tire track; arrow on right shows right side tire track

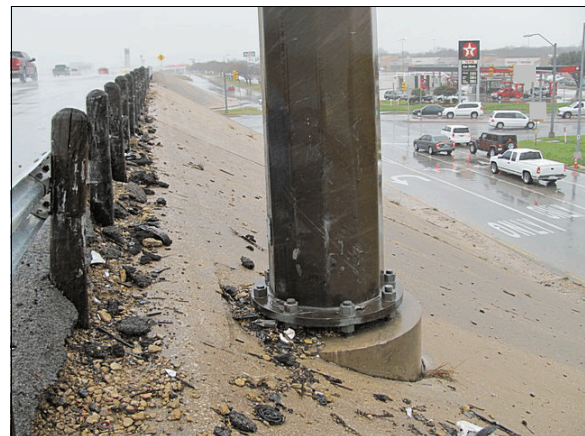
Figure 9: Impact scratches on the metal support pole

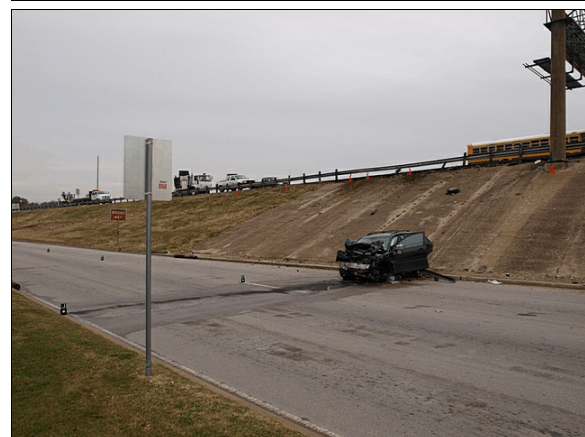
Figure 10: Police photo showing final rest position of the Lexus

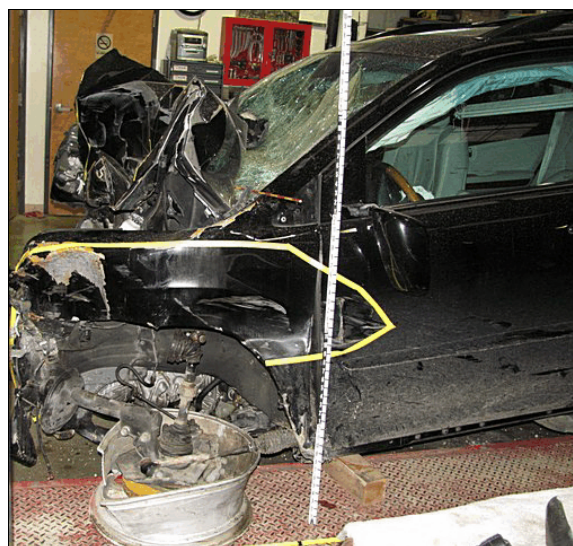
Figure 11: Damage on the left front wheel, suspension, and fender from the impacts with the guardrail posts

Damage Classification: The five impacts with the wooden guardrail posts (events 1-5) produced overlapping damage on the left fender, left front wheel, and left front door (**Figure 11**). One Collision Deformation Classification (CDC) was assigned to describe the totality of the damage from the guardrail posts and was 12FLEE6. The CDCs for the remaining overlapping guardrail post impacts were assigned as 12FLEE99, with 99 indicating an unknown extent zone.

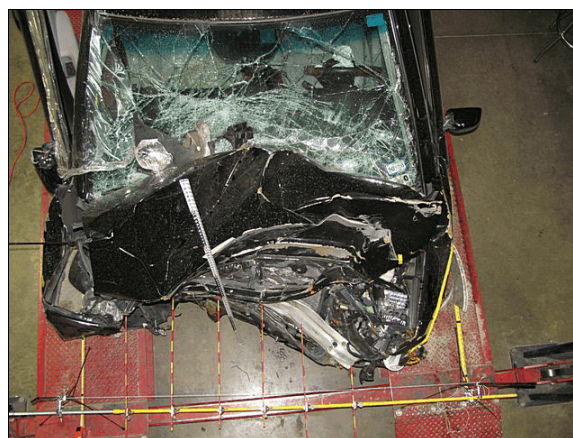
Figure 12: Top view of the front crush profile; the baseline is positioned 43 cm (16.9 in) short of the overall length due to the position of the vehicle on the hydraulic lift

The CDC for the front plane impact with the metal support pole (event 6) was 12FDEW5 (0 degrees). Since there was no evidence that the guardrail posts engaged the bumper bar (**Figure 12**), the Damage Algorithm of the WinSMASH program was used to calculate a Delta V for this impact. The total Delta V was 89 km/h (55.3 mph). The longitudinal and lateral velocity changes were -89 km/h (-55.3 mph) and 0 km/h, respectively. Based on the damage on the vehicle from the metal support pole impact, the results appeared reasonable.

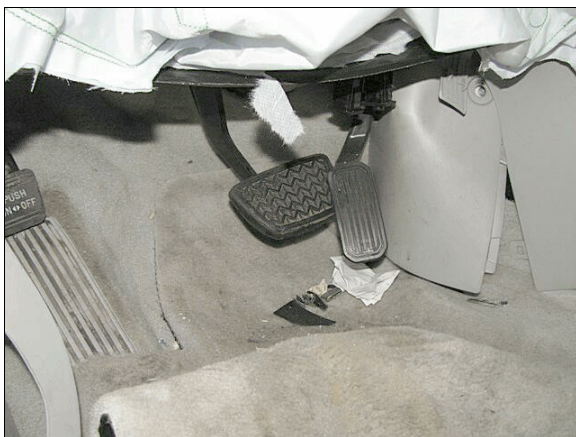
The condition of the accelerator pedal, brake pedal, and driver's floor mat at the time of the SCI inspection is shown in **Figure 13**. The driver's floor mat was secured by the floor mounted attachments and was not free to move. It was laying flat against the toe pan. There was no evidence of interaction between the floor mat and accelerator pedal. The product number on the back of the floor mat was not legible. There was a Lexus logo on the front of the floor mat. The accelerator pedal was rotated to the left and displaced partially over the brake pedal from the damage to the cowl and toe pan. The accelerator pedal was freed from the brake pedal and when depressed, it moved smoothly forward and returned without binding. This test was conducted three times and no binding was detected. There were no heavy abrasions on the face of the accelerator pedal. Abrasions that were present appeared to be related to normal usage (**Figure 14**). The floor mat and carpet were moved aside and the Denso accelerator pedal assembly was photographed (**Figures 15 and 16**). The brake pedal had a normal wear pattern. The inspection of the rear brake rotors and pads revealed no evidence of overheating (**Figures 17 and 18**)

Figure 13: Condition of accelerator pedal, brake pedal, and floor mat at the time of the SCI inspection

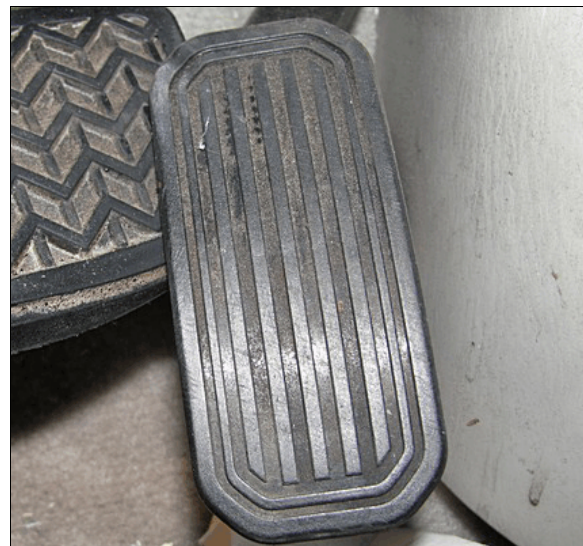
Figure 14: Close view of the accelerator pedal

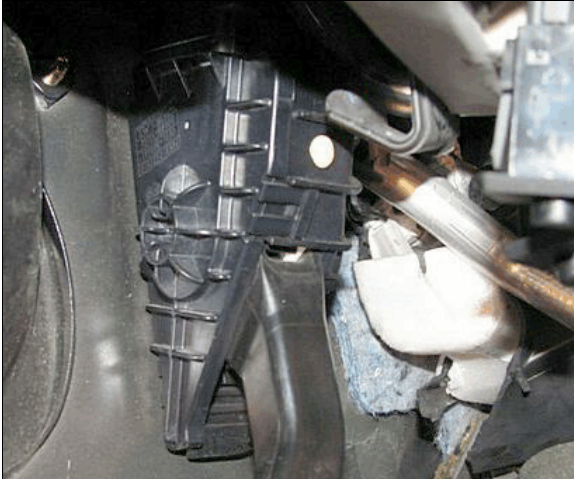
Figure 15: The left side of the Denso accelerator pedal mechanism housing

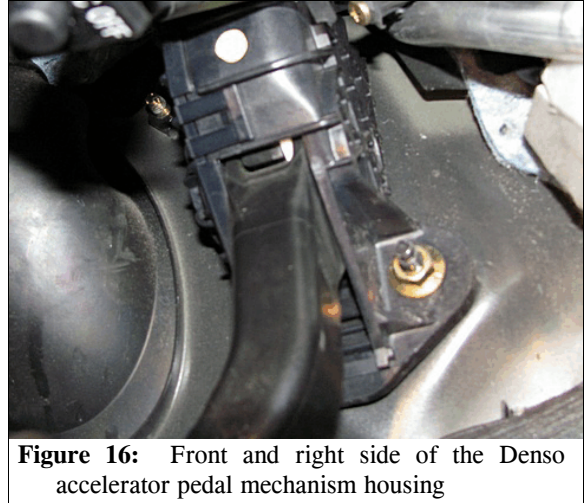
Figure 16: Front and right side of the Denso accelerator pedal mechanism housing

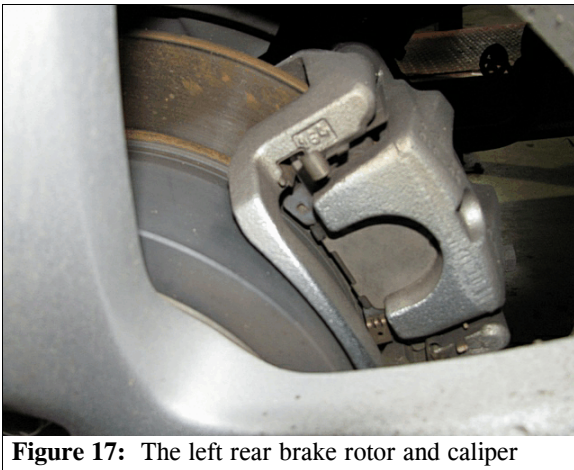
Figure 17: The left rear brake rotor and caliper

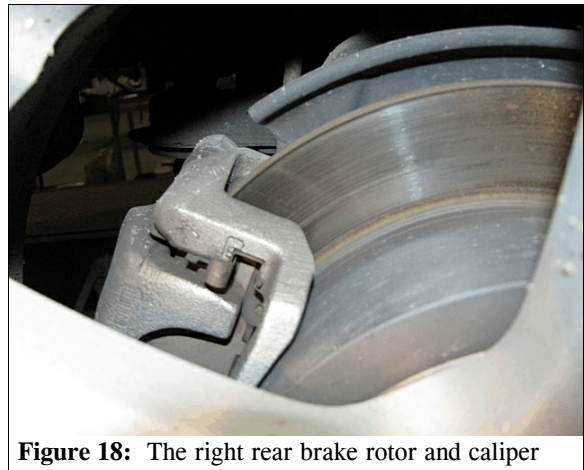
Figure 18: The right rear brake rotor and caliper

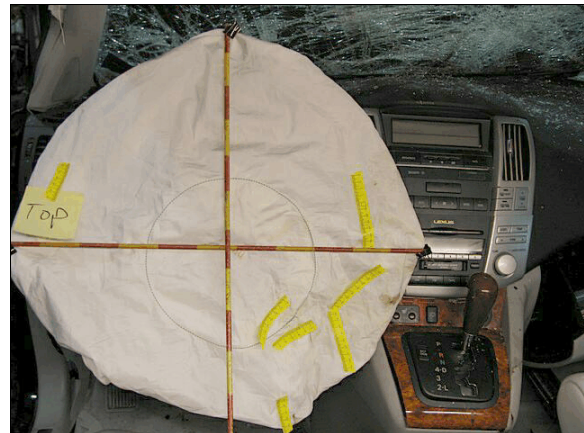
The driver's frontal air bag was located within the steering wheel hub. The module cover was a three flap configuration constructed of pliable vinyl. An inspection of the cover flaps revealed that they opened at the designated tear points and were undamaged. The deployed air bag (**Figure 19**) was 56 cm (22 in) in diameter and had two I-shaped vent ports, each 5 cm (2 in) in length on the back of the air bag at the 11 and 1 o'clock positions. There were what appeared to be two internal tethers, which were sewn in a circular configuration to the center of the air bag. Inspection of the air bag revealed no damage. There were a few scuffs and blood transfer on the bottom of the air bag.

Figure 19: The driver's frontal air bag

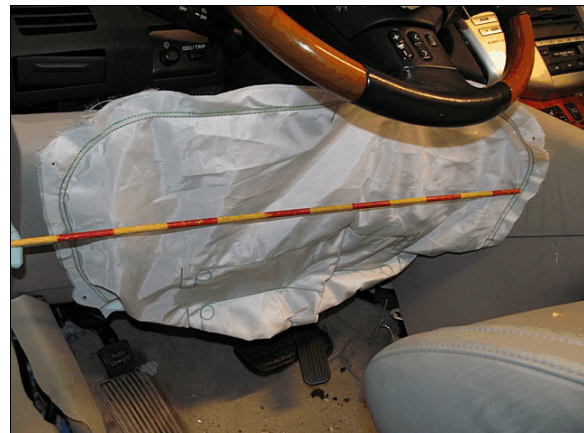
Figure 20: The deployed driver's knee air bag

The driver's knee air bag was located within the lower left instrument panel and deployed through a rectangular module cover. The module cover was 25 cm (9.8 in) in width and 6 cm (2.4 in) in height. It opened at the designated tear points and was undamaged. The deployed knee air bag (**Figure 20**) was 58 cm (22.8 in) in width and 26 cm (10.2 in) in height. While the driver's

knees loaded the air bag during the crash, there was no discernable evidence of contact on the air bag and the air bag was not damaged.

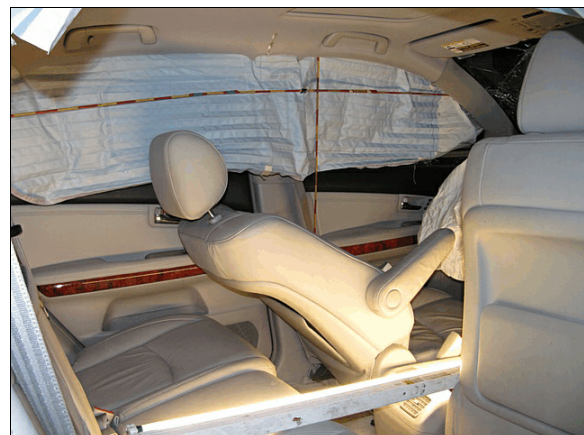
Figure 21: The deployed left IC air bag

The IC air bags were located along the roof side rails inside the headliner and extended from the A-pillar to the C-pillar. There were no external vent ports. The deployed left IC air bag (**Figure 21**) was 166 cm (65.4 in) in width and 40 cm (15.7 in) in height. It was attached to the A-pillar by a 7 cm (2.8 in) nylon rope. There was also a fabric panel at the front of the IC air bag that was 22 cm (8.7 in) in width. There was no gap between the front of the air bag and the window frame. The IC air bag extended 7 cm (2.8 in) below the beltline in the front row and 10 cm (3.9 in) below the beltline in the second row. Inspection of the left IC air bag revealed no discernable evidence of occupant contact and no damage. The right IC air bag was of the same dimensions and features as the left, and also revealed no discernable evidence of occupant contact.

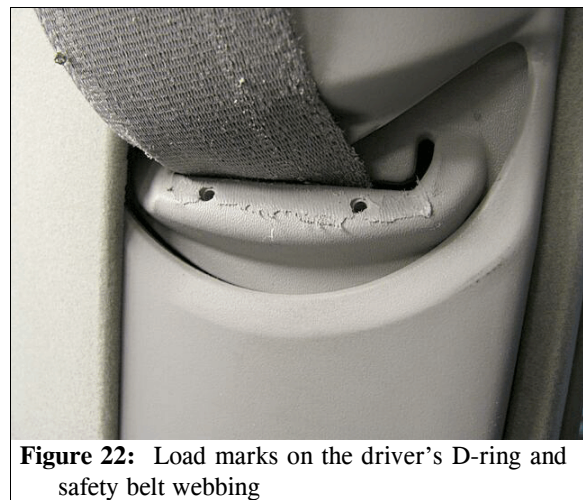
The inspection of the driver's safety belt assembly revealed heavy load abrasions on the belt webbing approximately 18 cm (7.1 in) in length and a heavy load abrasion on the D-ring (**Figure 22**). The stop button was also pulled out of the belt webbing and there was a load abrasion on the latch plate belt guide. The retractor was jammed and the length of belt webbing extending out of the retractor was 145 cm (57.1 in) as measured from the stop button hole to the D-ring. This evidence indicated that the driver was restrained by the lap-and-shoulder belt in this crash.

Figure 22: Load marks on the driver's D-ring and safety belt webbing
