**CALSPAN ON-SITE POTENTIAL UNINTENDED ACCELERATION
CRASH INVESTIGATION
SCI CASE NO.: CA10008**

VEHICLE: 2007 TOYOTA CAMRY

LOCATION: PENNSYLVANIA

CRASH DATE: JANUARY 2010

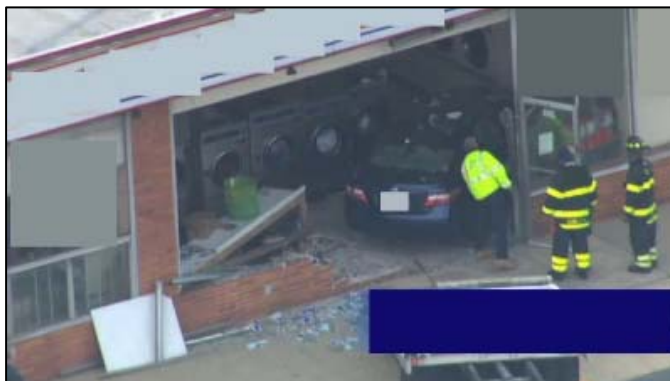
Figure 1: On-scene image of the Toyota at final rest. Image obtained from Internet media coverage.

The Toyota penetrated through the wall and door and came to rest inside the building. **Figure 1** is an on-scene image of the crash site obtained from Internet media coverage of the event. The Toyota sustained minor body panel abrasions and deformation as a result of the crash. The vehicle was towed and impounded by the investigating police department. The driver was transported to a local hospital, examined and subsequently released. She was not injured.

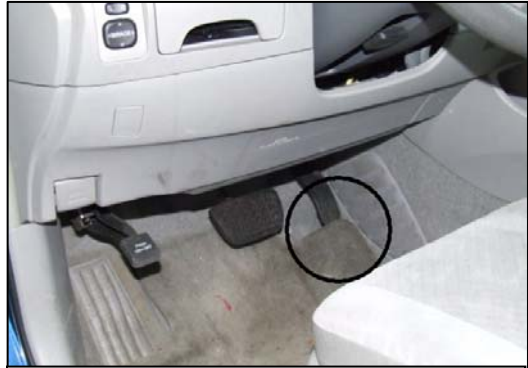
The front positions of the Toyota were equipped with the OEM carpeted floor mats. These mats were not secured to the vehicle by the two hooks that were located at the rear edge of the carpeted floor. The rear aspect of the driver mat was lying on top of the hooks. **Figure 3** is an on-scene police image of the Toyota's driver interior and depicted the post-crash position of the

mat. The forward-most edge of the mat was lying on top of the accelerator pedal. The position of the mat prompted the police investigator to contact the NASS due to his concerns about the floor mat recall.

Figure 3: Post-crash position of the Toyota's OEM carpeted floor mat. Image supplied by the police investigator.

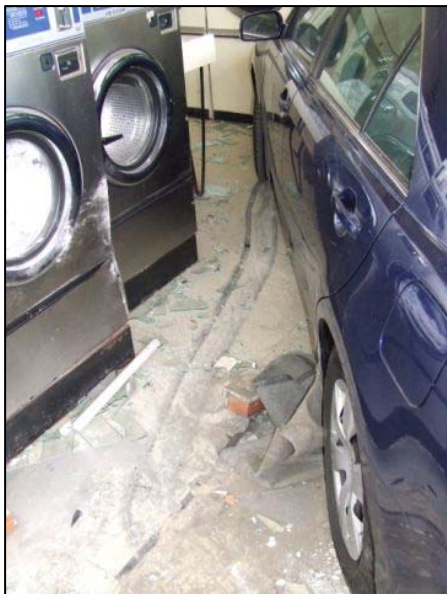
Figure 6: On-scene police image of the Toyota's final rest position and the left front tire mark.

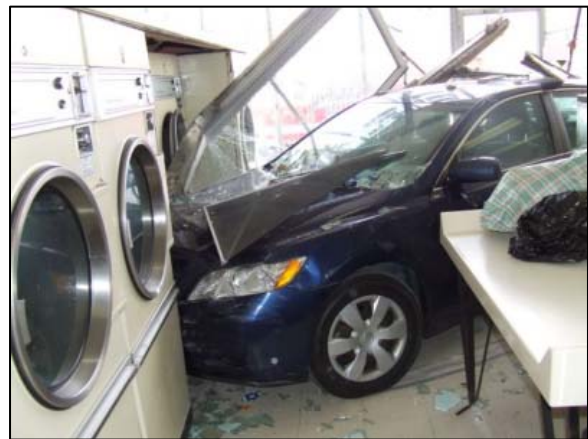
Figure 7: On-scene police image of the Toyota's final rest and the left front tire mark.

Toyota Camry was equipped with 4-wheel ABS brakes. The tire marks were dark and consistent over the entire length. A braking tire mark from an ABS-equipped vehicle has a broken pattern as the braking tire is locked and unlocked by the system. Further, the reconstructed speed of the vehicle during the crash sequence was approximately 16 km/h (10 mph). A braking vehicle that is skidding from a low speed does not generate enough heat at the tire /surface interface to produce dark marks similar to those depicted in the on-scene images.

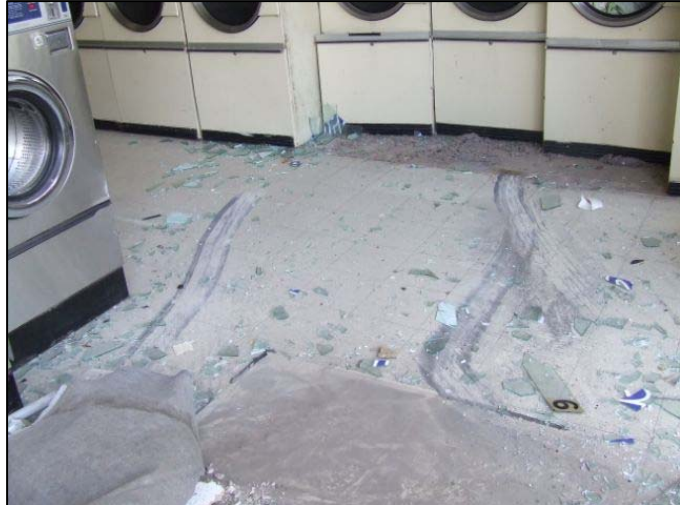
Figure 8: View of the front tire marks after the removal of the Toyota. Image supplied by the police investigator.

Based on the above facts, the marks were most likely generated by an accelerated tire. The sudden change in the friction coefficient, as the tires moved off the carpet to the tiled floor, caused the tires to spin. Additionally, the imaged EDR data indicated that the position of the accelerator pedal changed from “Off” to “Full” during the last second of the recording and the brake remained “Off”. Refer to the Event Data Recorder section below for further information regarding the imaged data.

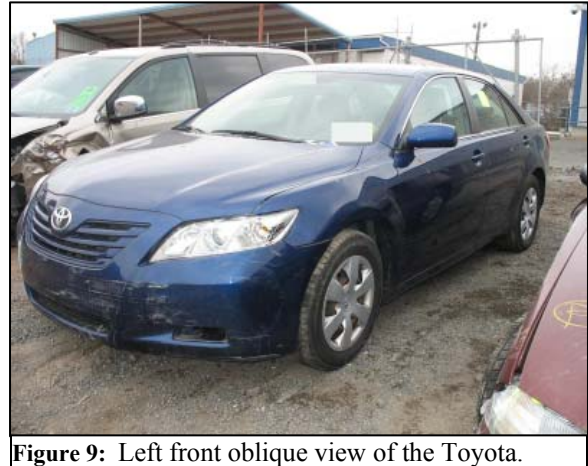
Figure 9 is a left front oblique view of the Toyota. The front, top and side planes of the vehicle sustained minor body panel abrasions and isolated deformation as a result of the crash. The damage extended rearward to the right C-pillar area of the vehicle. There was no residual frontal deformation. An analysis of the crash severity (delta-V) through the use of the WINSMASH program was not possible. The estimated delta-V of the Toyota during the crash sequence was less than 8 km/h (5 mph) based on the physical evidence and SCI field experience.

Figure 9: Left front oblique view of the Toyota.

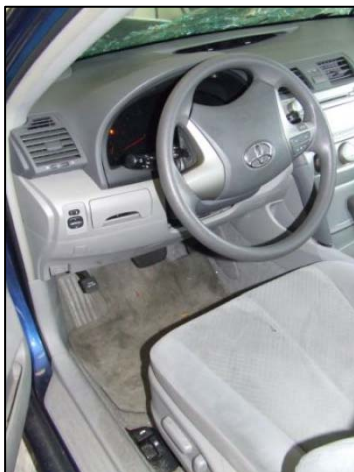
There was no interior damage or intrusion as a result of the crash. At the time of the SCI inspection, the driver seat was adjusted to a rear track position. However, the seat position had been changed during the transfer of the vehicle. The on-scene police images depict the seat in a mid-track position, **Figure 10**.

Figure 10: On-scene police image depicting the mid-track position of the driver's seat.

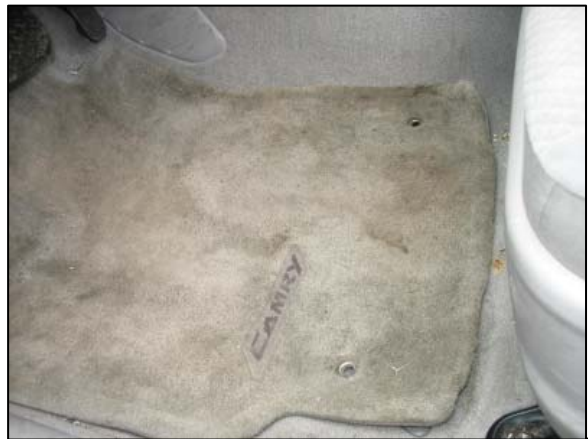
The front interior was equipped with the OEM carpeted floor mats. **Figure 11** is an image depicting the unsecured position of the driver's mat at the time of the SCI inspection. The mat was not secured by the hooks located at the rear aspect of the foot well. The mat was lying on top of the hooks. There was no damage or scuffing noted to the mat. The immediate post-crash position of the mat is depicted in **Figure 3**. The mat was identified by the following number embossed to the rubber on the back side of the mat: *PT206-32060*.

Figure 11: View of the unsecured OEM carpeted floor mat in the driver's foot well. Image taken during the SCI inspection.

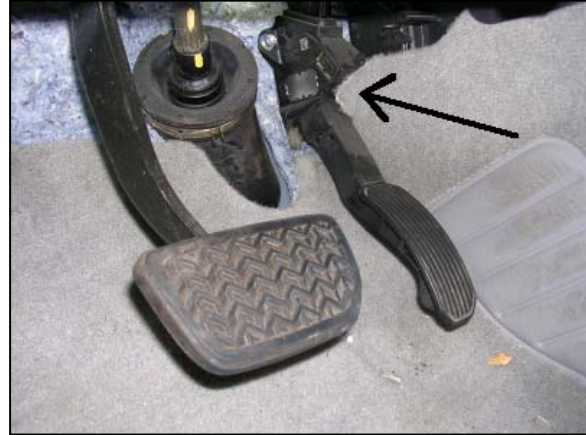
The Toyota was equipped with the CTS accelerator pedal and was subject to the “Sticky Pedal Recall”. The Toyota had not been serviced for the recall prior to crash. **Figure 12** is a view of the accelerator pedal taken during the SCI inspection. The pedal was identified by the following:

A small section of the interior carpet was folded over and lying on top of the upper aspect of the accelerator pedal assembly (denoted by the arrow in the figure). This carpet section should have been tucked in, adjacent to the inboard aspect of the pedal, along the center tunnel. The “dog ear” section was located near the hinge opening of the depressed pedal, but did not snag or interfere with the proper operation of the pedal. The accelerator fully returned to the idle position after each application. It was not possible to get the carpet to impede the pedal’s movement. It is not known how or why the carpet became misplaced.

Figure 12: View of the Toyota’s CTS accelerator pedal.

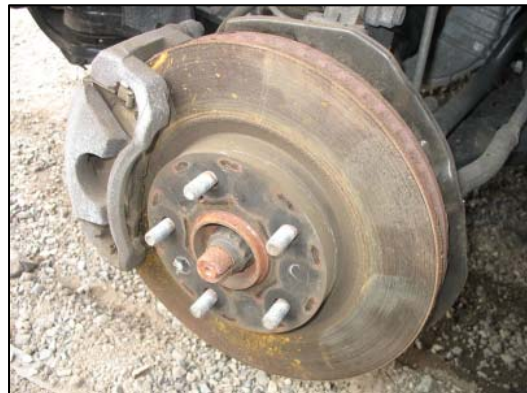
The left front wheel was removed and the brakes were inspected for excessive wear. The surface of the rotor was lightly rusted from extended exposure to the environment. There was no sign of prolonged heating to the rotor or pads. The brake pads had adequate thickness.

Figure 13: View of the Toyota's left front brake rotor.
