Office of Defects Investigation (ODI)
On-Site Potential Unintended Acceleration Investigation
Dynamic Science, Inc. (DSI), Case Number DS10010
2006 Toyota Highlander
Oregon
February 2010

1. Report No. DS10010	2. Government Accession No.		3. Recipient Catalog No.	
4. Title and Subtitle On-Site Potential Unintended Acceleration Investigation			5. Report Date June 23, 2010

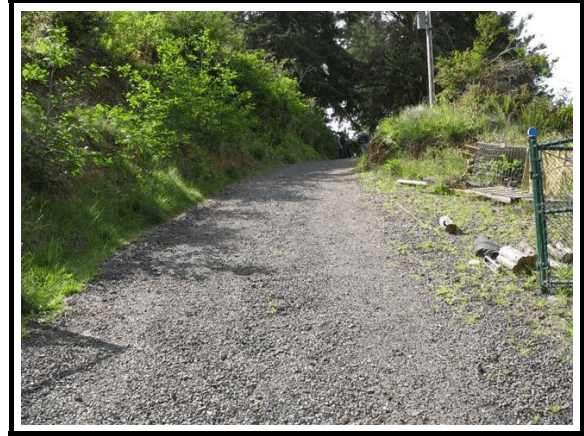
Figure 2. Crash site, westbound view

Prior to the crash the Toyota was traveling in reverse in a westbound direction. The crash site description is based on the vehicle's westbound direction of travel and not on the vehicle's heading orientation. The roadway measured 2.7 m (9.0 ft) in width. In the westbound direction, the roadway curved right at a radius of 190.0 m (623.4 ft) as measured from the right road edge. Beginning at the driveway of the driver's residence, the roadway profile had an uphill grade of 14.1 percent; at 15.2 m (50.0 ft) west of the driveway the uphill grade measured 10.5 percent; and at 30.5 m (100.0 ft) west of the driveway the uphill grade measured 9.8 percent. The Toyota departed the roadway on the right side at 29.7 m and 32.3 m (97.6 ft and 106.0 ft) west of the driveway. The area of departure was determined based on ruts deposited in the gravel at the right roadway edge. The ruts each measured approximately 1.5 m (5.0 ft) in length, were oriented 45 degrees relative to the roadway edge, and were spaced 2.56 m (8.4 ft) apart. The angle of the ruts relative to the roadway indicated the vehicle departed the roadway in a slight clockwise yaw and that the driver was probably braking during the roadway departure. The distance separating the tire ruts were consistent with the vehicle's wheelbase and the marks were deposited by the right side tires.

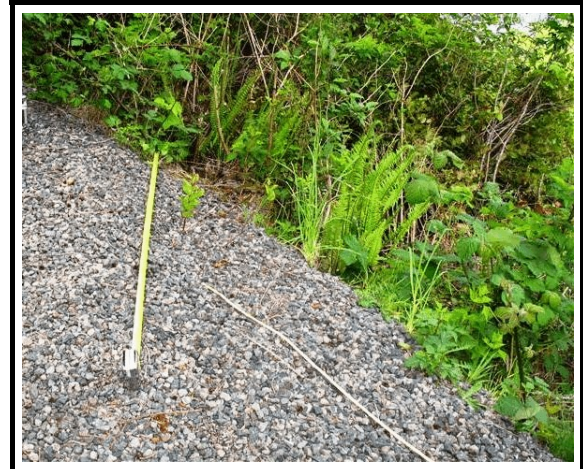
Figure 3. Tape measure showing length and orientation of right roadway edge

by the Toyota's right rear tire at the point of the roadway departure. Based on the length of the tire ruts caused by the tires, the grade of the roadway, and the coefficient of friction of the roadway surface, the vehicle's minimum speed at the time of the roadside departure was estimated to be 13.8-17.5 km/h (8.6 - 10.9 mph)³. The vehicle then departed the roadway.

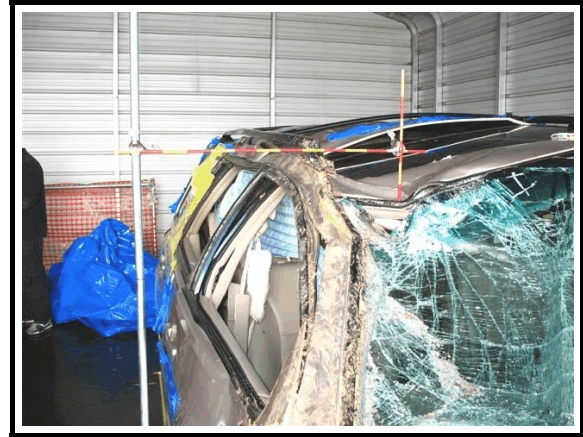
Figure 4. Maximum vertical crush measurement to top plane

Direct damage to the right side began at the right rear bumper corner and extended forward 457.0 cm (179.9 in) to the front right bumper corner. The damage to the right side began at the sill and extended vertically 130.0 cm (51.2 in) to the roof side rail. Maximum lateral crush to the greenhouse was located at the right roof side rail, 77.0 cm (30.3 in) forward of the right rear axle, and measured 11.0 cm (4.3 in). Maximum lateral crush to the right side body panel was located at the front right fender, 37.0 cm (14.6 in) forward of the right front axle, and measured 13.0 cm (5.1 in). Maximum vertical crush to the top plane was located at the right windshield header, 15.0 cm (5.9 in) inboard of the right roof side rail, and measured 9.0 cm (3.5 in) (**Figure 4**). The Collision Deformation Classification (CDC) for the rollover was 00RDAO3.

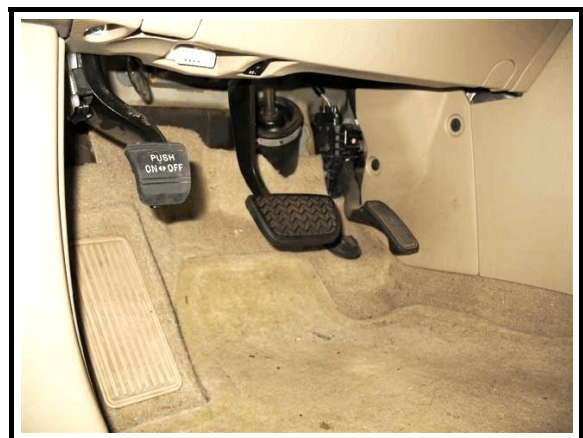
Figure 5. Driver foot controls and floor mat

Figure 5 is an interior view of the driver's foot controls and floor mat as it was initially observed during the vehicle inspection. The foot controls were not damaged during the crash and they operated properly. An original equipment manufacturer (OEM) floor mat was installed and held in place by two retaining clips. The floor mat consisted of a carpeted top side and textured rubber underside. The floor mat was flexible and measured 1.0 cm (0.4 in) thick. The overall

dimensions measured 70.0 cm (27.5 in) in length and 61.0 cm (24.0 in) in width. The floor mat was contoured to fit within the left floor pan. Cutouts at the upper left and right corners of the floor mat yielded space for the dead pedal and accelerator pedal. The floor mat was not damaged; it laid flat and fit closely to the contour of the floor pan. When held in place by the clips, the floor mat did not reach the foot controls or impede their movement.

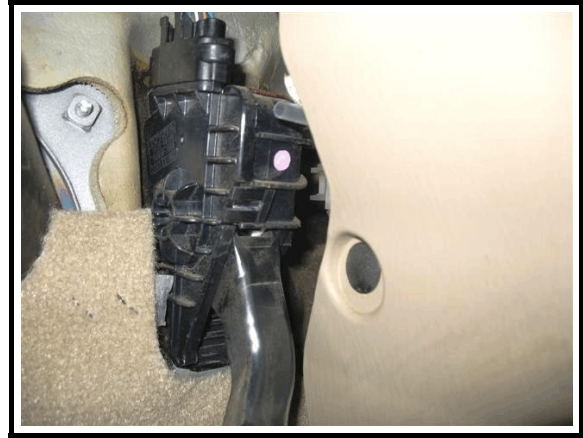
Figure 6. Denso accelerator pedal showing housing assembly

The engine of the Toyota could not be started during the SCI inspection due to damage. The accelerator pedal was inspected for damage and unusual wear patterns and none was observed. The pedal was manufactured by Denso (**Figure 6**), and the left side of the plastic housing was labeled with the following information: Toyota/78120-48090/198800-3050/11G07/3718A2. The bottom edge of the accelerator pedal was located 14.0 cm (5.5 in) above the floor pan and 4.0 cm (1.6 in) above the brake pedal. It was located 2.5 cm (1.0 in) left of the center console and the lateral separation of the accelerator pedal and brake pedal measured 16.5 cm (6.5 in) (**Figure 7**). Its vertical movement was free of obstruction and the amount of friction appeared normal. Additionally, the accelerator pedal yielded no discernable lateral movement.

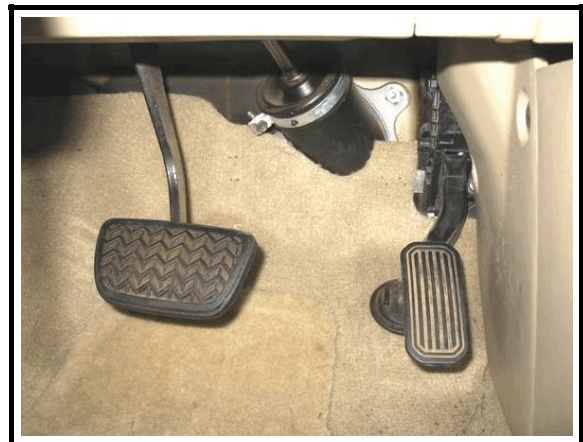
Figure 7. View showing brake pedal and accelerator pedal

The lateral center of the brake pedal was offset to the right of the centerline of the driver's seat cushion and the steering column by 1.5 cm (0.6 in). The brake pedal showed slight wear on the right side of the rubber pad. The brake pedal was depressed three times and it returned to its non-depressed position. The brake pedal's movement was normal and the return spring was strong. Additionally, the vehicle's four disc brake rotors were examined and they exhibited no evidence of excessive heat or wear.
