ON-SITE CHILD SAFETY SEAT INVESTIGATION

CASE NUMBER - IN10010

VEHICLE - 2007 KIA RONDO

CRASH DATE - March 2010

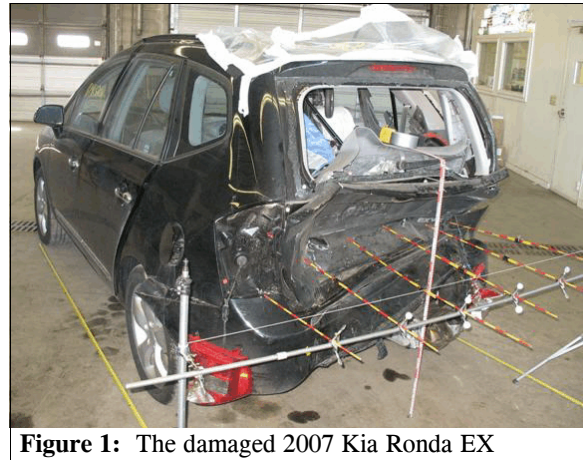
Figure 1: The damaged 2007 Kia Ronda EX

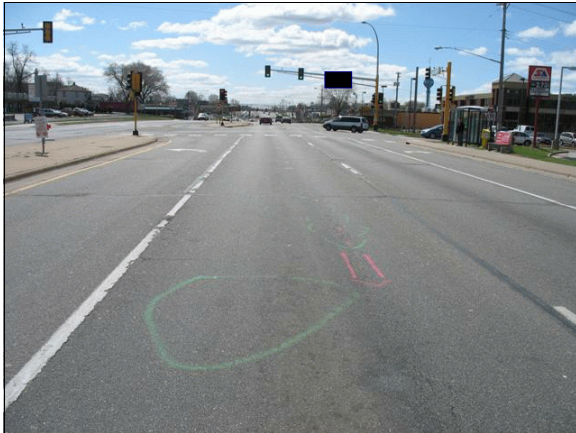
Figure 2: Area of the impact between the Ford and Kia

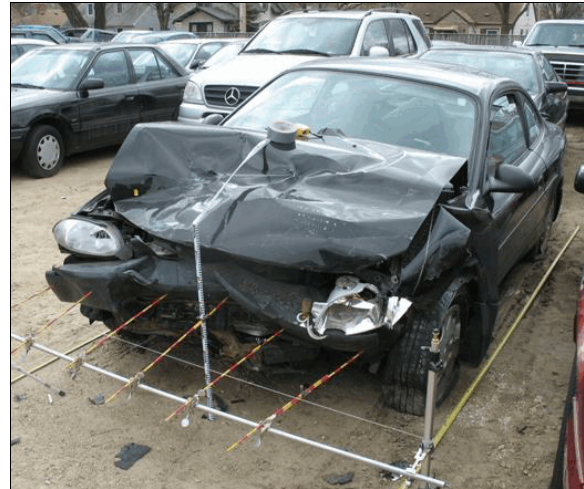
Crash: The front plane of the Ford (**Figure 3**) impacted the back plane of the Kia (**Figure 4**, event 1). The impact projected the Kia forward and the front plane impacted the back plane of the Nissan (event 2). No air bags deployed in the Kia. The Kia remained in its lane and came to final rest 12.5 m (41 ft) south of the point of impact with the Ford. The Ford came to final rest in the left turn lane heading southeast, 15.5 m (51 ft) south of the point of impact (**Figure 5**). The Nissan remained in its lane and came to final rest 6.7 m (22 ft) south of the Kia's final rest position.

Figure 3: Damage on the front plane of the Ford from the impact with the back plane of the Kia

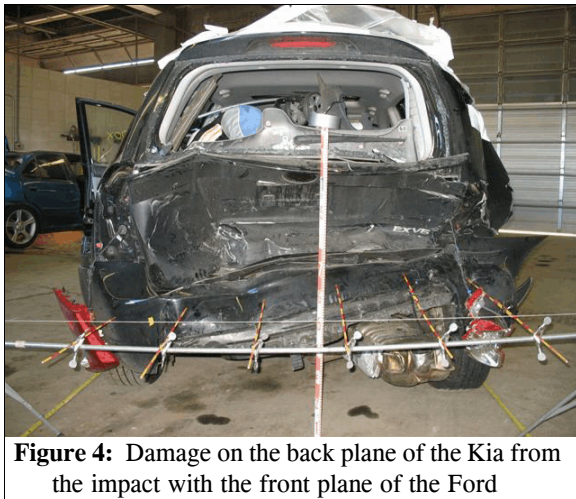
Figure 4: Damage on the back plane of the Kia from the impact with the front plane of the Ford

Exterior Damage: The Kia sustained damage on the back plane during the impact with the Ford. The back bumper, tailgate, right quarter panel, and right taillight assembly were directly damaged. The direct damage began at the back right bumper corner and extended 130 cm (51 in) along the bumper. A second set of crush measurements was taken above the bumper level since the hatch and right quarter panel sustained more crush than the bumper. The maximum residual crush on the bumper was 49 cm (19.3 in) occurring at C₆ (**Figure 6**), while the maximum crush above the bumper was 62 cm (24.4 in) also occurring at C₆. The right side wheelbase was reduced 9 cm (3.5 in) and the left side wheelbase was reduced 1 cm (.4 in). There was induced damage on both quarter panels, the backlight, and tailgate. The table below presents the average of the crush at the bumper and above bumper levels.

Damage Classification: The Kia's Collision Deformation Classification was 06BDEW3 (180 degrees) for the impact with the Ford and 12FDEW1 (0 degrees) for the impact with the Nissan. The Damage Algorithm of the WinSMASH program calculated the Kia's total Delta V for the back plane impact as 42 km/h (26.1 mph). The longitudinal and lateral velocity changes were 42 km/h (26.1 mph) and 0 km/h, respectively. Based on the damage on the Ford and Kia, the results appeared reasonable. The Missing Vehicle algorithm calculated the Kia's total Delta V for the front impact with the Nissan as 14 km/h (8.7 km/h). The longitudinal and lateral velocity changes were -14 km/h (-8.7 mph) and 0 km/h, respectively. Based on the damage on the Kia, the results appeared reasonable.

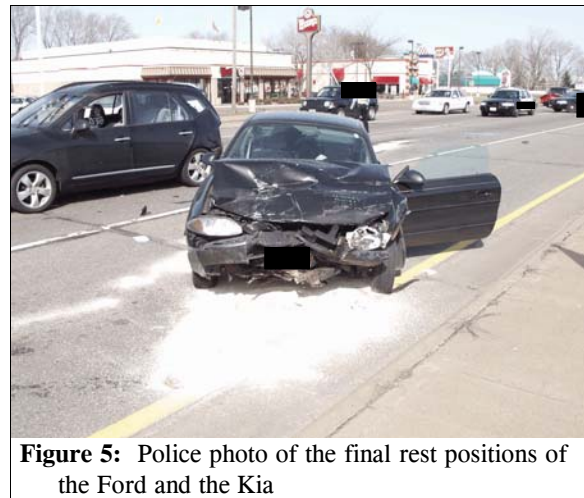
Figure 5: Police photo of the final rest positions of the Ford and the Kia

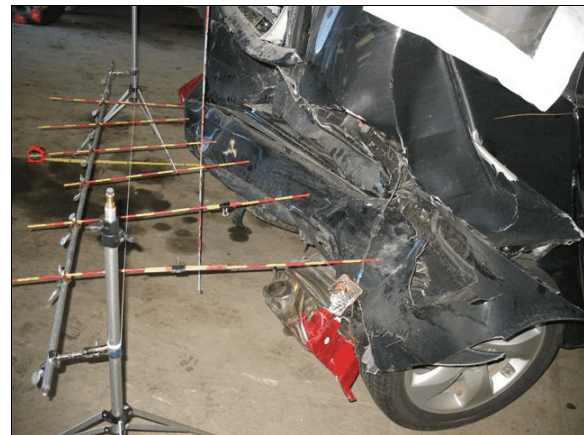
Figure 6: Right side view of the crush on the back bumper of the Kia

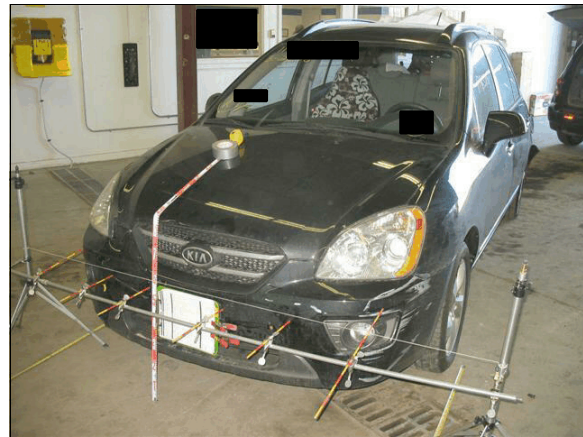
The Kia sustained front plane damage on the bumper during the impact with the Nissan. The direct damage began at the front left bumper corner and extended 123 cm (48.4 in) along the front bumper (**Figure 7**). The crush measurements were taken at the bumper level and the residual

maximum crush was 4 cm (1.6 in) at C₁. There was no induced damage. The following table presents the front crush profile.

Figure 7: Damage on the front plane of the Kia from the impact with the back plane of the Nissan

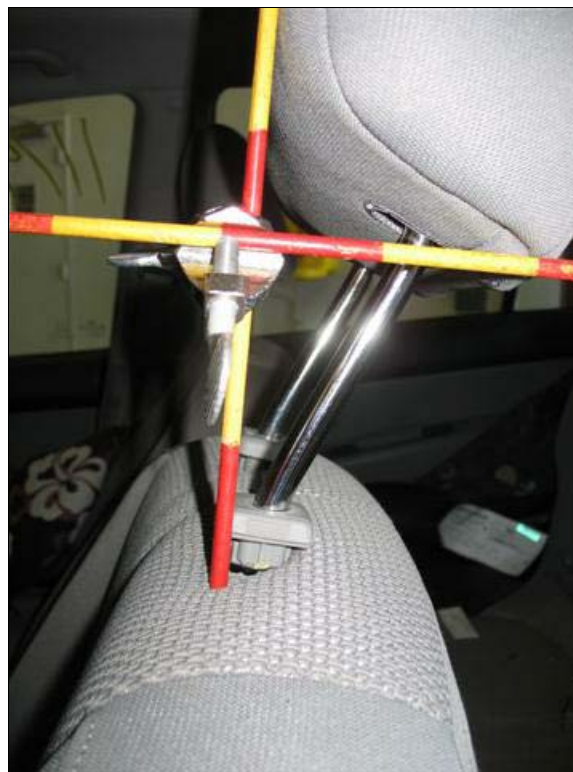
Vehicle Interior: The inspection of Kia's interior revealed that the driver's head restraint was displaced rearward 5.5 cm (2.2 in) from contact by the driver's head (**Figure 8**). A police on-scene photo showed that the driver's seat back was also displaced rearward (**Figure 9**). There was no deformation of the steering wheel or compression of the energy absorbing steering column. There was no discernable evidence of occupant contact in the second row.

Figure 8: Driver's deformed head restraint

The back plane impact with the front of the Ford displaced the driver of the Kia rearward, opposite the 6 o'clock direction of force. He contacted the seat back and head restraint, which bent the head restraint posts 6 cm (2.4 in) rearward and displaced the seat back rearward to a recline angle of approximately 45 degrees. The driver was redirected forward and loaded the safety belt when the front plane of the Kia impacted the back plane of the Nissan. The driver then rebounded backward into the seat.

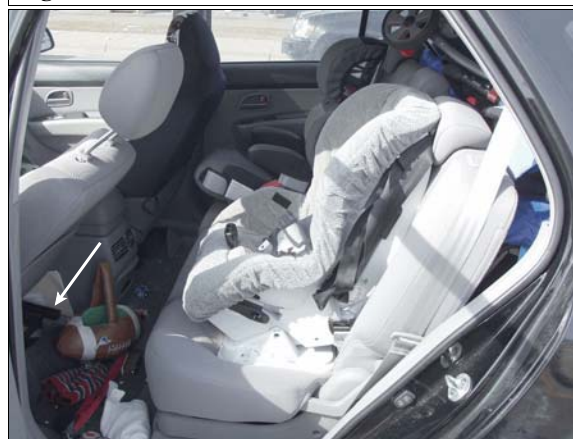
Figure 9: Police on-scene photo showing the position of the driver's seat back and the second row left CRS; driver's seat was moved to the full forward track position (arrow) when the child was removed from the vehicle; CRS in second row right seat position was not occupied at time of crash

The inspection of the second row left safety belt assembly revealed a few usage marks. Police information and a police on-scene photograph (**Figure 9**) indicated that this safety belt was not used to secure the CRS. The CRS was secured with the CRS's lower anchor. The tether was not used.

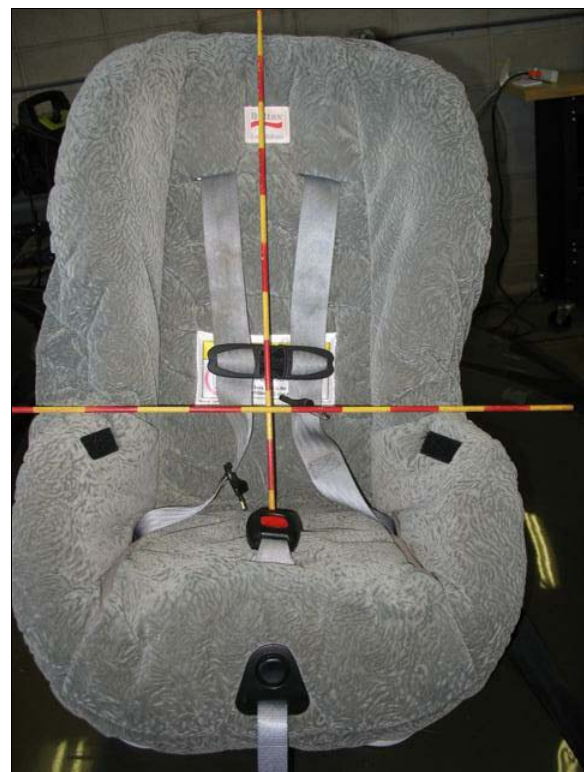
The Kia's second row left passenger (14-month-old, male; unknown height and weight) was seated in a Britax Roundabout convertible CRS (**Figure 10**) restrained by the internal 5-point harness. The CRS was manufactured on January 31, 2005 and the model number was E9L0285. The CRS was used in the forward facing position. When used in this position, the CRS was designed for children who weigh between 9 and 18 kg (20 and 40 lbs) and whose height is 102 cm (40 in) or less.

Figure 10: The Britax Roundabout convertible CRS

Inspection of the CRS revealed no damage or stress marks on the shell and base. There were no load marks present on the harness strap webbing, latch plates, or buckle. There were no discernable occupant contact marks on the CRS.

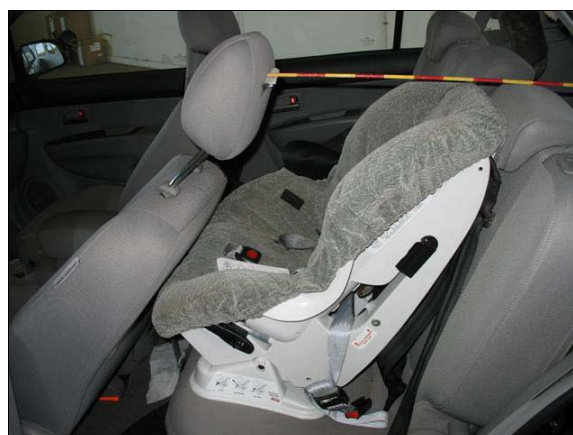
Figure 11: CRS placed in the Kia at the SCI inspection and driver's seat back positioned to contact the CRS; the distance from the head restraint to the back of the CRS was approximately 35 cm (13.8 in)

The impact on the back plane of the Kia (event 1) displaced the child rearward, within the CRS opposite the 6 o'clock direction of force. He contacted the seat back of the CRS shell probably causing the traumatic brain injury. According to the driver's statement to the investigating police officer, the driver's seat back was displaced rearward and struck the CRS (Figure 11). The child probably contacted the driver's head restraint during rebound from the first event and/or the secondary impact with vehicle 3. The driver and a passer-by removed the child from the CRS and vehicle. The passer-by was a nurse and performed CPR on the child until emergency medical personnel arrived.

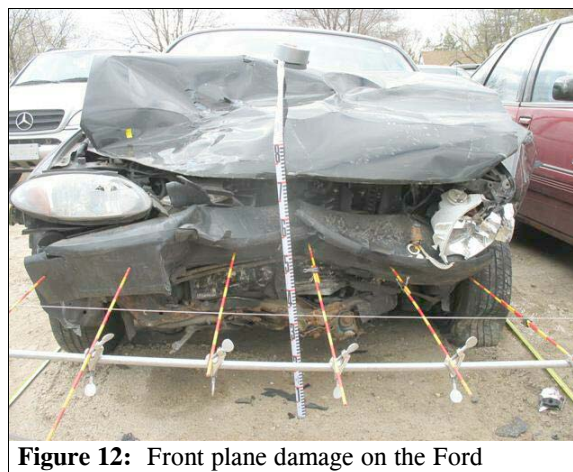
Exterior Damage: The Ford sustained front plane damage during the impact with the Kia. The front bumper, bumper fascia, hood, grille, left headlamp/turn signal assembly, left fender, and left front wheel were directly damaged. The direct damage began at the front left bumper corner and extended 100 cm (39.4 in) along the front bumper (Figure 12). The crush measurements were taken at the bumper level and the maximum residual crush was 54 cm (21.2 in) occurring at C₃. The left side wheelbase was reduced 7 cm (2.8 in) and the right side wheelbase was extended 2 cm (0.8 in). The induced damage involved the hood, both fenders, and the windshield. The table below presents the front crush profile.

Figure 12: Front plane damage on the Ford

Damage Classification: The Ford’s CDC for the front plane impact (event 1) was 12FDEW3 (0 degrees). The damage algorithm of the WinSMASH program calculated the Ford’s total Delta-V as 55 km/h (34.2 mph). The longitudinal and lateral velocity changes were -55 km/h (-34.2 mph) and 0 km/h, respectively. Based on the damage to both vehicles, the results appeared reasonable.

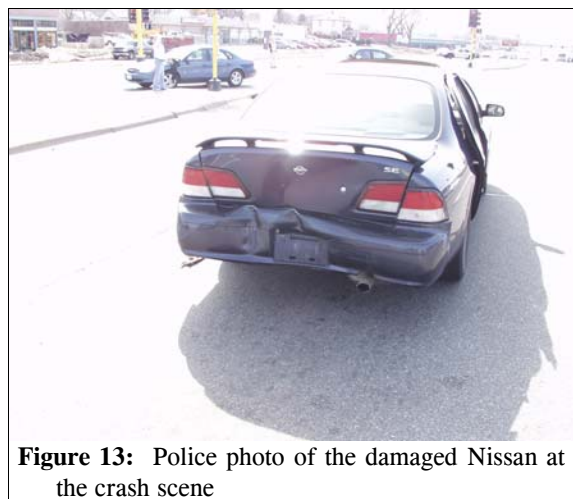
Damage Classification: The Nissan’s CDC for the back plane impact (event 2) was 06BDEW1 (180 degrees). The CDC was based on a police on-

Figure 13: Police photo of the damaged Nissan at the crash scene

scene photograph of the vehicle (**Figure 13**). The Missing Vehicle algorithm of the WinSMASH program calculated the Nissan's total Delta V for the front impact with the Nissan as 15 km/h (9.3 mph). The longitudinal and lateral velocity changes were 15 km/h (9.3 mph) and 0 km/h, respectively. These results appeared reasonable.
