CALSPAN ON-SITE MOTORCOACH FIRE INVESTIGATION

SCI CASE NUMBER: CA10012

VEHICLE: 2001 MOTOR COACH INDUSTRIES (MCI) MODEL E4500

INCIDENT DATE: MARCH 2010

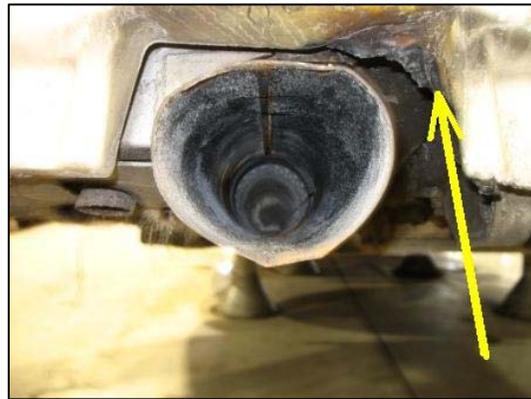
The exterior damage involved charring and melting of the bumper fascia cutout over the tailpipe. The top right corner area of the cutout was melted with charring and smoke staining radiating outward and upward from this area (**Figure 5**). The remainder of the bumper fascia was intact and undamaged.

Figure 5. Fire damage to the bumper fascia.

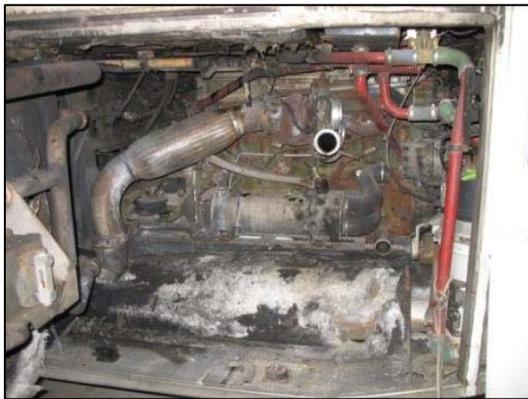
The fire presumably originated in the muffler and caused extreme heat. The heat melted the fiberglass heat shield that was positioned over the horizontally mounted muffler, causing the heat shield to sag and come into contact with the muffler. The shield ignited and the fire burned through the shield into the left side engine compartment at the location of the cooling system.

The rear outboard aspect of the fiberglass reinforced heat shield was fragmented and holed. The forward area around the exhaust pipe from the turbocharger was burned through and the inboard side was burned to near full-thickness (**Figure 6**).

Figure 6. Fire/heat related damage to the exhaust system heat shield.

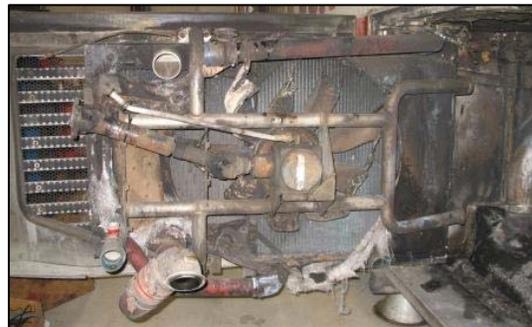
The cooling system was positioned in close proximity to this heat shield. The lower aspect of the fan shroud was burned at the 4-8 o'clock positions. The burn pattern extended vertically upward and consumed the tips of the fan blades and the top of the fan shroud (**Figure 7**). The lateral aspects of the fan shroud were charred.

Figure 7. Fire damage to the cooling system.

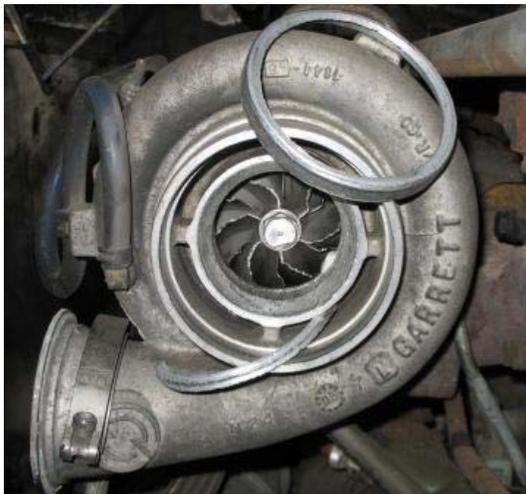
Intake air to the turbocharger was provided from the fresh air intake and through a radiator-mounted heated air exchanger utilizing separate ducting. The intake impeller side of the turbocharger was fitted with an aluminum deflector designed to channel the airflow into the intake impeller. The impeller blades engaged and damaged this deflector, separating it from the pressed fit within the intake opening. Fragments of this deflector were found in the intake port of the turbocharger (**Figure 8**). **Figure 9** is a view of an exemplar turbocharger with damaged impeller blades and the deflector in place.

Figure 8. Damaged intake impeller and separated air deflector.

The post-fire inspection of the turbocharger determined that the impeller shaft was slightly deformed. The impeller shaft could easily be rotated by hand with a noticeable wobble to the intake impeller. The waste gate linkage remained operational.

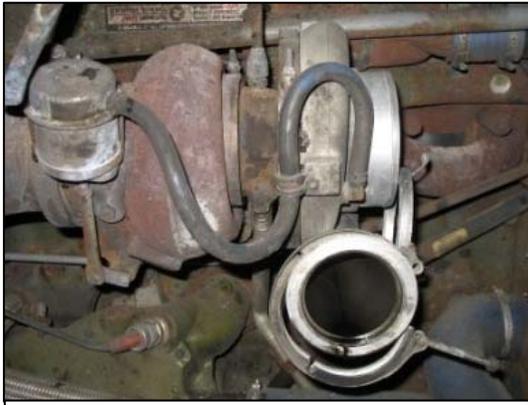
The turbocharger was not removed from the engine or disassembled. It was suspected that the bronze oil bearing was worn resulting in the wobble to the impeller shaft. The presumed bearing damage resulted in oil leaking into the exhaust side of the turbocharger and into the exhaust system. Wet oil was present in the warm air intake port of the turbocharger (**Figure 10**).

Figure 10. Oil present in the warm air intake port of the turbocharger.

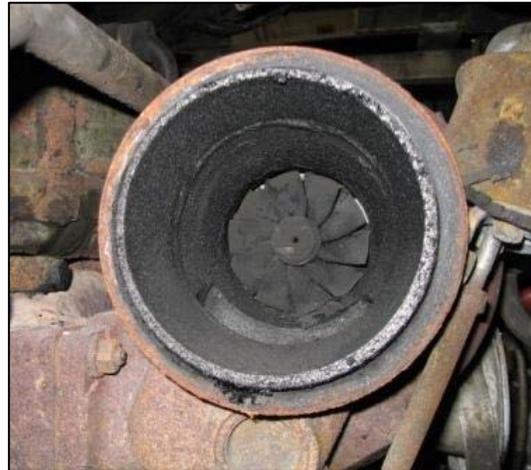
The exhaust side impeller of the turbocharger was intact and undamaged. The blades were covered with a layer of carbon. The exhaust housing port yielded heavy, oil soaked, carbon deposits (**Figure 11**).

Figure 11. Carbon and oil deposits on the exhaust impeller and port of the turbocharger

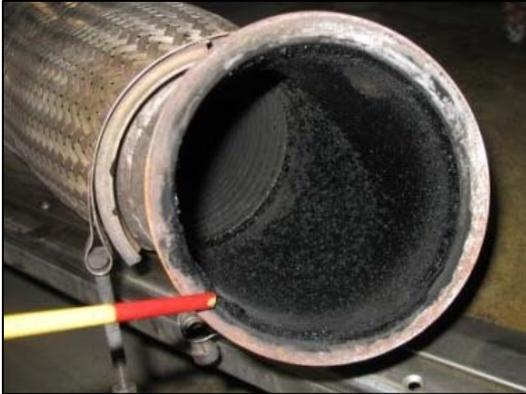
The exhaust pipe on the outboard side of the turbocharger was not physically damaged. The pipe was removed for inspection. This was accomplished by loosening the clamps and removing the pipe. The inside surface of the flange above the flexible coupling contained black, oil soaked deposits of carbon (**Figure 12**). The downstream end of the exhaust pipe contained heavy black carbon deposits without a noticeable presence of oil.

Figure 12. Oil and carbon deposits on the turbocharger exhaust pipe.

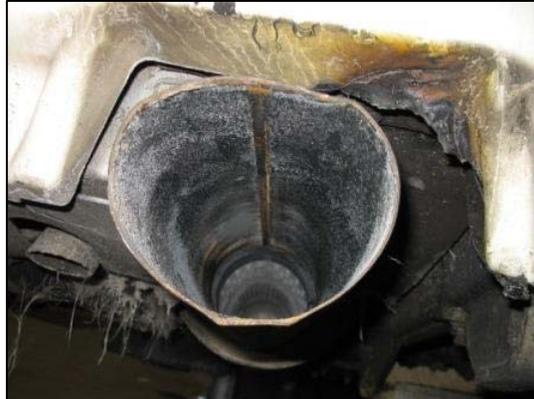
The tailpipe was free of carbon deposits (**Figure 13**). This was the result of either the fire within the muffler which burned the deposits clean, or the result of the firefighters spraying water in the exhaust system to cool the system, thus flushing away the deposits.

Figure 13. Inside view of the condition of the tailpipe.

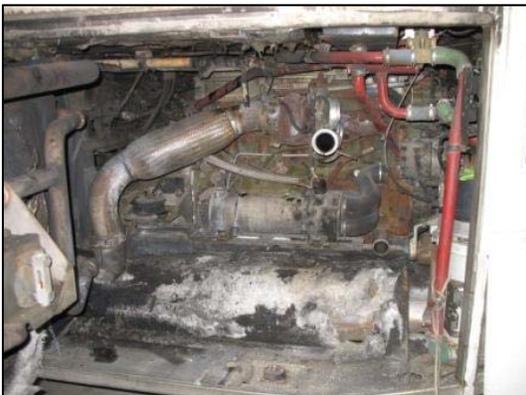
The SCI investigation determined that the origin of this fire was in the left rear engine compartment area around the exhaust system. Oil leaked from the turbocharger into the muffler, igniting within the exhaust system. The oil leak resulted from a worn or damaged internal bronze oil bearing within the turbocharger. This resulted in a wobble to the impeller shaft which damaged the oil seals. Oil leaked under pressure into the exhaust side of the turbocharger and into the exhaust system. The combination of high heat generated by the turbocharger and the heat of the exhaust ignited the oil. The fire was contained within the muffler; however, the heat generated by the fire melted the fiberglass heat shield located over the top of the muffler. This shield sagged and came into contact with the hot surface of the muffler (**Figure 14**). The shield ignited and the fire burned upward within the left side of the engine compartment. The fire subsequently spread to the cooling system fan and the electrical and plumbing components located above within this compartment (**Figure 15**). The fire was detected early in the event and was contained to the left side engine compartment.

Figure 14. Muffler heat shield damage.

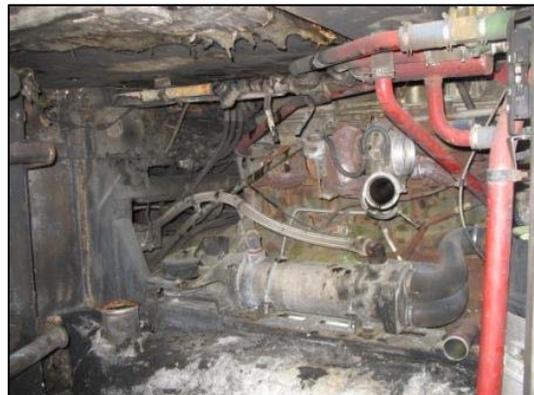
The fire burned upward and consumed the wire loom and wire insulation. Evidence of high heat was present on the forward wall of the left side engine compartment and to the sheet metal shield located at the top of the opening. These shields contained the fire within this left side compartment.

Figure 15. Fire damage to the forward left side engine compartment.
