ON-SITE CHILD RESTRAINT SYSTEM INVESTIGATION

CASE NUMBER - IN10017
LOCATION - MISSOURI
VEHICLE - 1995 DODGE NEON
CRASH DATE - May 2010

1. <i>Report No.</i> IN10017		2. <i>Government Accession No.</i>		3. <i>Recipient's Catalog No.</i>	
4. <i>Title and Subtitle</i> On-Site Child Restraint System Investigation Vehicle - 1995 Dodge Neon Location - Missouri			5. <i>Report Date:</i> November 30, 2010

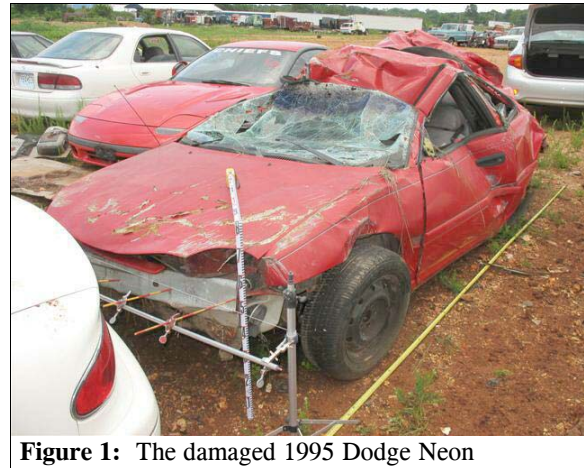
Figure 1: The damaged 1995 Dodge Neon

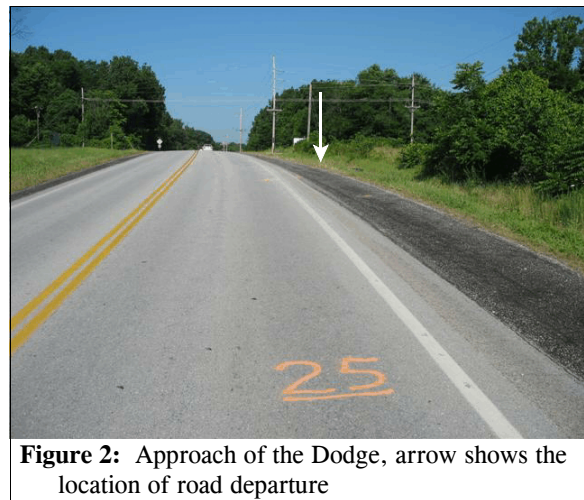
Pre-Crash: The Dodge was occupied by an unrestrained 17-year-old male driver, a 19-month-old female second row left passenger, and a 19-month-old male second row right passenger. Both second row passengers were restrained in forward facing CRSs. The driver was traveling west in a left curve (**Figure 2**). He stated during the SCI interview that he lived in the area and was familiar with the roadway. He was traveling at approximately 89 km/h (55 mph) when the vehicle lost traction on the wet roadway. The vehicle began to rotate counterclockwise and the driver initiated a right steering maneuver. The vehicle

Figure 2: Approach of the Dodge, arrow shows the location of road departure

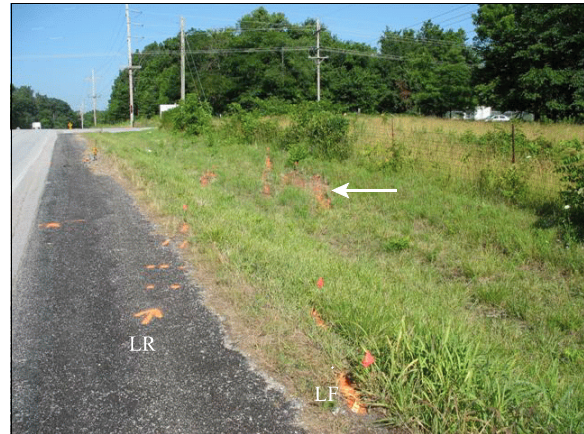
then began to rotate clockwise and departed the right side of the roadway (**Figure 3**) where the crash sequence took place.

Figure 3: Roadway departure into ditch; arrow shows divot from front undercarriage impact

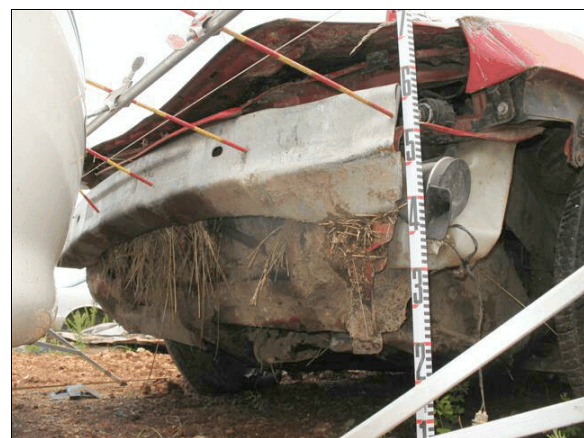
Crash: The vehicle traveled airborne across a ditch. The front undercarriage (**Figure 4**) impacted the back slope of the ditch (event 1, **Figure 3**) 6.6 m (21.6 ft) east of the edge of the roadway. The vehicle continued to rotate clockwise across a distance of approximately 7.2 m (23.6 ft) as the left side wheels furrowed into the ground. The left side plane impacted a fence (event 2) as the vehicle began to rollover left side leading (event 3). The vehicle impacted a utility pole guy wire (event 4) with the top and left side planes (**Figure 5**) during the first 2 quarter turns of the rollover. The vehicle continued to rollover through a field a distance of approximately 33.5 m (109.8 ft) where the left side plane impacted a second fence (event 5) located on the west edge of the field adjacent to a north-south roadway. The vehicle landed on its top plane on the roadway after rolling over a total of 10 quarter turns. It slid backwards on its top across the roadway to final rest in a ditch on the west side of the north-south roadway heading southeast. The vehicle traversed a total distance of 73.6 m (241.4 ft) from the initial roadway departure to the final rest position.

Figure 4: Damage on the Dodge's front undercarriage and bumper from the ground impact, each increment on the rods in 5 cm (2 in)

Exterior Damage Event 1: The Dodge sustained damage on the undercarriage forward of the front wheels during the impact with the back slope of the ditch. The front bumper was also displaced vertically 9 cm (3.5 in) and crushed rearward 8 cm (3.1 in) by this impact. There was no vertical displacement of the frame members.

Damage Classification Event 1: The Collision Deformation Classification (CDC) for the undercarriage impact was 00UFDW2. The damage severity was minor based on the extent of the damage.

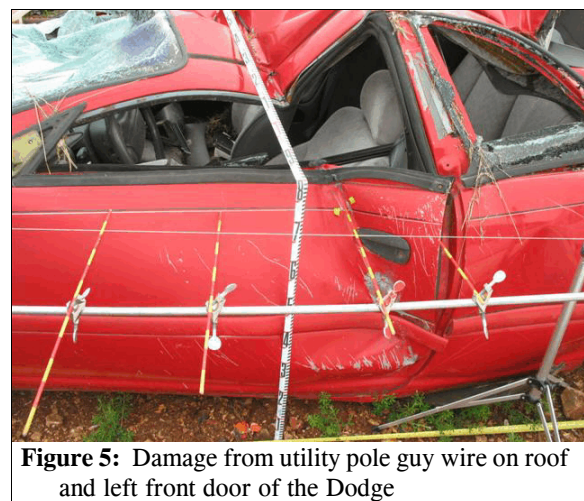
Figure 5: Damage from utility pole guy wire on roof and left front door of the Dodge

Exterior Damage Event 4: The top plane and left front door sustained damage during the impact with the utility pole guy wire (event 4). The direct damage was 3 cm (1.2 in) in width and extended from the right A-pillar across the roof and onto the rear portion of the left front door. The left roof side rail was crushed 35 cm (13.8 in), while the left front door was crushed 23 cm (9.1 in) by this impact.

Damage Classification Event 4: The CDC for the guy wire impact was 00TPDN4. The WinSMASH program could not be used on this event since non-horizontal impacts and impacts on the roof are out of scope for the program. Based on the extent of the crush, the severity of the damage was severe.

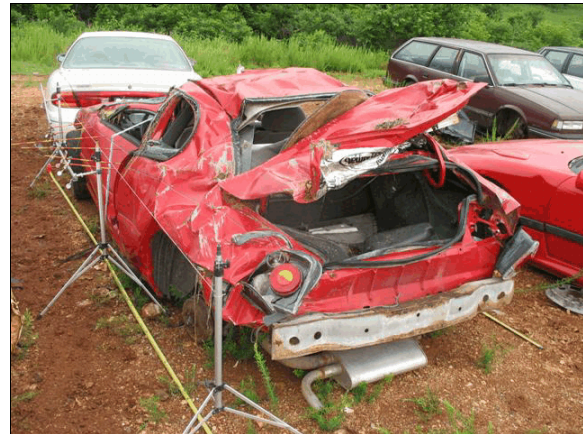
Exterior Damage Event 3: The top and both side planes (**Figures 6 and 7**) sustained damage during the rollover (event 3). The direct damage on the left side plane extended from the left

fender to the left quarter panel and involved the pillars and the left roof side rail. The direct damage on the right side plane was intermittent and involved the right fender, right front door, and quarter panel. The direct damage on the top plane began on the hood 70 cm (27.6 in) forward of the front axle and extended the full length of the top plane. The full width of the roof, 110 cm (43.3 in) was also directly damaged. The maximum lateral crush (**Figure 8**) was 15 cm (5.9 in) and occurred on the left C-pillar. The maximum vertical crush also occurred on the left C-pillar and was 16 cm (6.3 in). The Dodge's left side wheelbase was extended 2 cm (0.8 in) and the right side wheelbase was unchanged.

Damage Classification Event 3: The CDC for the rollover damage was 00TDD03. The WinSMASH program could not be used on this event since rollovers are out of scope for the program. Based on the extent of the crush on the roof, the severity of the damage from the rollover was moderate.

Figure 6: Damage on the left side plane and top plane from the rollover

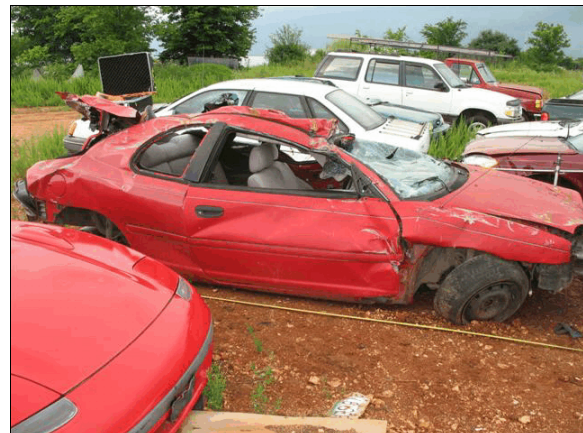
Figure 7: Damage on the top and right side planes from the rollover

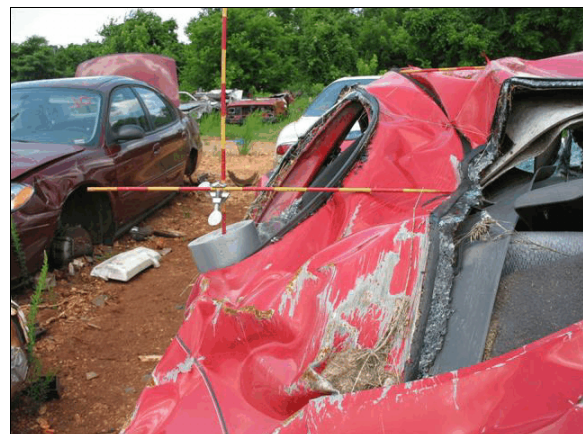
Figure 8: The maximum vertical and lateral crush from the rollover

The Dodge sustained 27 intrusions of the passenger compartment. The most severe intrusions in the driver's space involved the left roof side rail, window frame, and roof, which intruded vertically 35 cm (13.8 in), 34 cm (13.4 in), and 26 cm (10.2 in), respectively. The most severe intrusions into the second row left passenger space involved the left C-pillar, backlight header, and roof which intruded vertically 23 cm (9.1 in), 20 cm (7.9 in), and 18 cm (7.1 in), respectively. The right C-pillar intruded laterally 5 cm (2 in) and the roof intruded vertically 9 cm (3.5 in) into the second row right passenger's space.

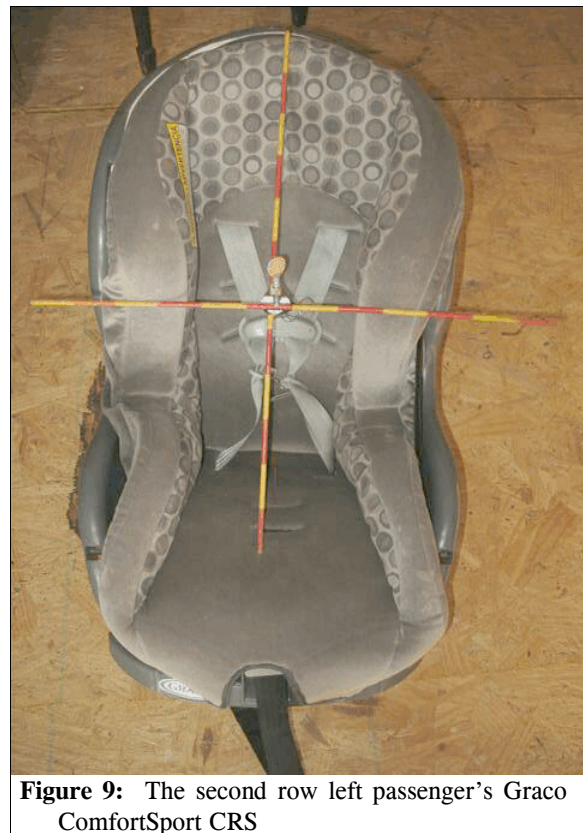
The inspection of the CRSs was conducted at the driver's residence. The Dodge's second row left passenger was seated in a convertible Graco ComfortSport CRS (**Figure 9**). The CRS was manufactured on June 24, 2009 and the model number was 1757846. The CRS was equipped with a 5-point harness and a harness retainer clip, which was positioned at the stomach level. There were 3 harness strap slots and the harness straps were adjusted to the highest position. The CRS was not equipped with lower anchor straps and no locking clip was present. There was a top tether, but it was not in use during the crash. The CRS was used the forward facing position. When used in this position, the CRS was designed for children who weigh between 9 and 18 kg (20 and 40 lbs) and were 102 cm (40 in) or less in height. The passenger's height and weight were 86 cm (34

Figure 9: The second row left passenger's Graco ComfortSport CRS

The CRS was constructed of a one-piece plastic shell and was covered with a padded fabric cover 1 cm (0.4 in) thick. The seat back was fitted with a 1 cm (0.4 in) thick styrofoam liner and a 2 cm (0.8 in) thick foam padding. The CRS was also equipped with a recline stand. The manufacturer's instructions specified that the recline stand was to be secured in the upright position when the CRS was used in the forward facing position. The driver stated that the CRS was secured in the vehicle without the recline stand in the upright position.

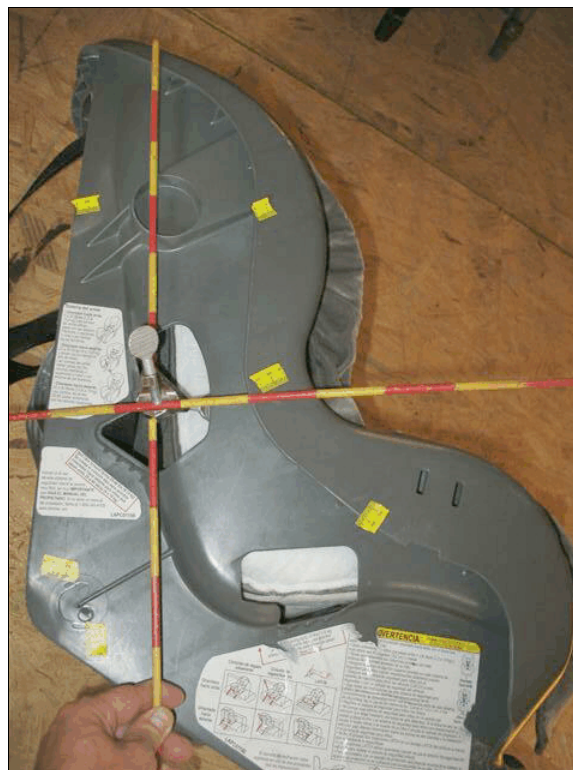
Inspection of the CRS revealed stress marks on the plastic shell on the right side (**Figure 11**) front bottom, and left bottom. The plastic shell was otherwise undamaged. Some minor abrasions from the vehicle's safety belt were also found on the forward facing belt path on each side of the CRS. The crotch strap and buckle were detached from the CRS and were found undamaged in the vehicle. The bottom of the CRS and the metal bracket in which the crotch strap was anchored were also undamaged. The driver stated that the crotch strap became detached during the crash and the child came out of the CRS. Following the crash, the driver found the child in the second row laying on the roof.

Figure 11: Yellow tape shows locations of small stress marks in the plastic shell

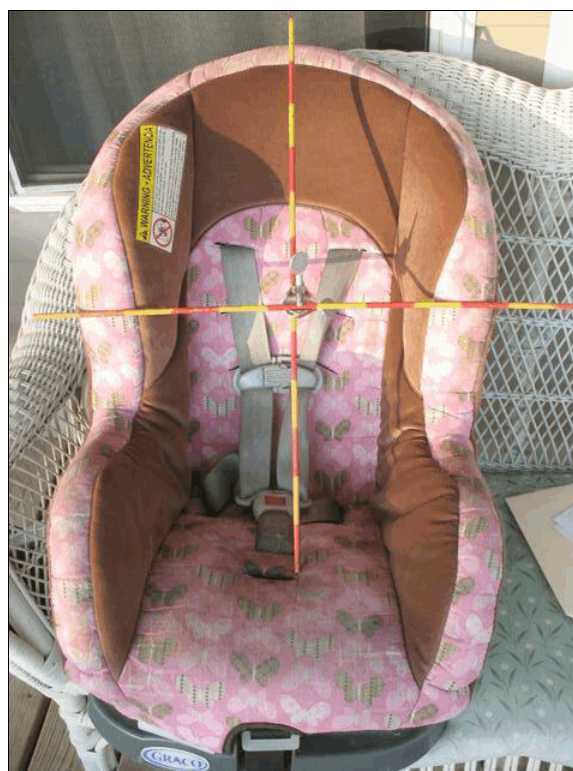
The second row right passenger was also seated in a convertible Graco ComfortSport CRS (**Figure 12**). The CRS was manufactured on June 25, 2009 and the model number was 1757845. The CRS was equipped with the same features as the second row left CRS. The CRS was used in the forward facing position. When used in this position, the CRS was designed for children who weigh between 9 and 18 kg (20 and 40 lbs) and were 102 cm (40 in) or less in height. The passenger's height was 61 cm (24 in) but his

Figure 12: The second row right passenger's Graco ComfortSport CRS

weight is unknown. The CRS was secured in the vehicle by the lap-and-shoulder belt. The harness retainer clip was positioned at the stomach level and the harness straps were adjusted to the highest position. This CRS was secured in the vehicle with the recline stand in the stowed position, contrary to the manufacturer's instructions.

Inspection of the CRS revealed a few minor stress marks on the plastic shell on the bottom and both sides. The plastic shell was otherwise undamaged. There was no discernable evidence of loading of the harness straps.
