On-Site Certified Advanced 208-Compliant Air Bag Investigation
Dynamic Science, Inc. (DSI), Case Number DS10017
2011 Toyota Camry
California
July 2010

1. Report No. DS10017	2. Government Accession No.	3. Recipient Catalog No.	
4. Title and Subtitle On-Site Certified Advanced 208-Compliant Air Bag Investigation		5. Report Date March 11, 2011

Dynamic Science, Inc.
Crash Investigation
Case Number: DS10017

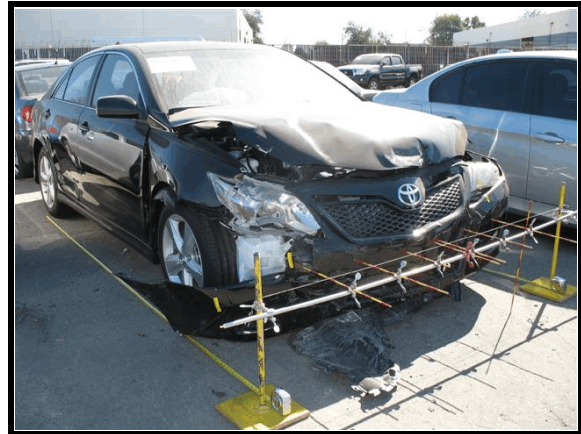
The focus of this Certified Advanced-208 Compliant (CAC) investigation was the deployed air bags in a 2011 Toyota Camry (**Figure 1**). A CAC vehicle is certified by the manufacturer to be compliant with the Advanced Air Bag portion of Federal Motor Vehicle Safety Standard (FMVSS) No. 208. This three-vehicle crash occurred in July 2010 in the state of California within an offset four-leg intersection. The subject vehicle was being driven by a restrained 61-year-old male; the front right occupant was a 56-year-old female. Two other vehicles were involved in the crash: a 2002 Saturn SL1 being driven by a 44-year-old male and a 1999 Dodge Durango being driven by a 60-year-old male.

Figure 1. Subject vehicle, 2011 Toyota Camry

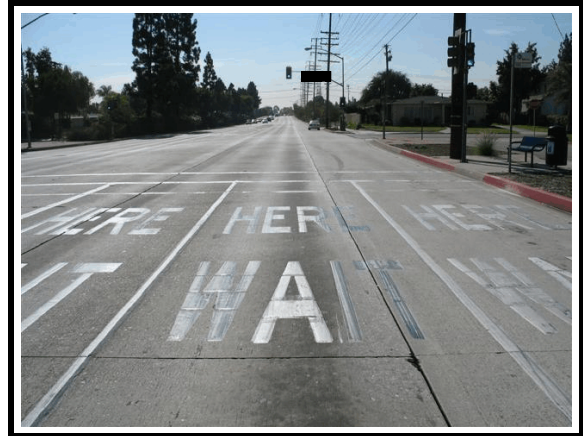
Figure 2. Eastbound approach for Toyota

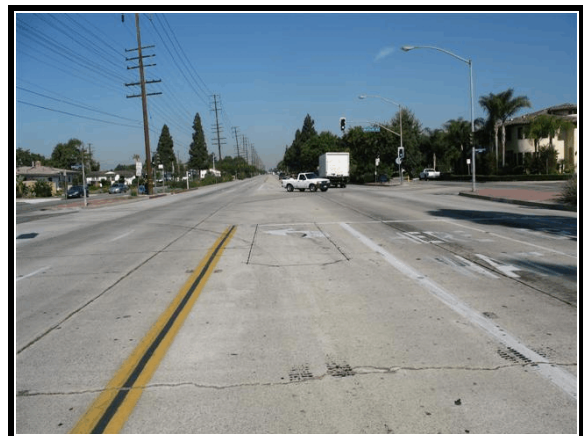
Figure 3. Westbound approach for Saturn

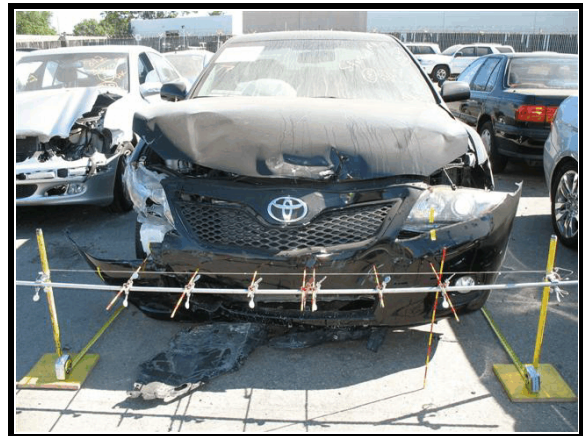
The frontal damage began at the left front bumper corner and extended 178.0 cm (70.0 in) to the right across the entire front bumper width (**Figure 4**). The height of the direct damage measured 89.0 cm (35.0 in) from the ground. The bumper fascia had been dislodged and had also been compressed with the bumper backing bar and then had restituted (**Figure 5**). The width of the backing bar measured 118.0 cm (46.4 in) and was used as the Field L when measuring the crush profile.

Figure 4. Frontal damage, 2010 Toyota Camry

Six crush measurements were measured along the backing bar as follows: $C_1 = 11.0$ cm (4.3 in), $C_2 = 18.0$ cm (7.0 in), $C_3 = 28.0$ cm (11.0 in), $C_4 = 22.0$ cm (8.7 in), $C_5 = 18.0$ cm (7.0 in), $C_6 = 16.0$ cm (6.3 in). Maximum crush was located at C_3 . The Collision Deformation Classification (CDC) for Event 1 was 11FDEW2.

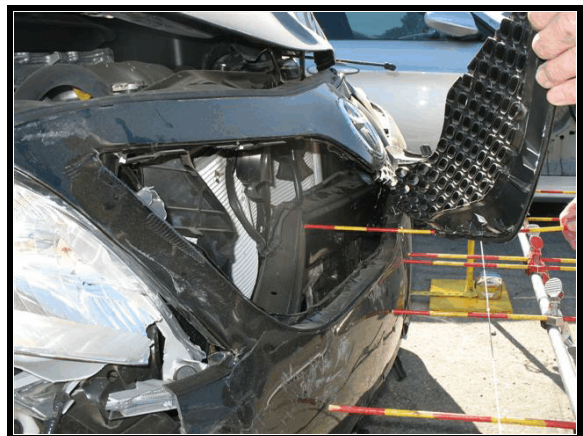
Figure 5. Side view of bumper fascia and backing bar

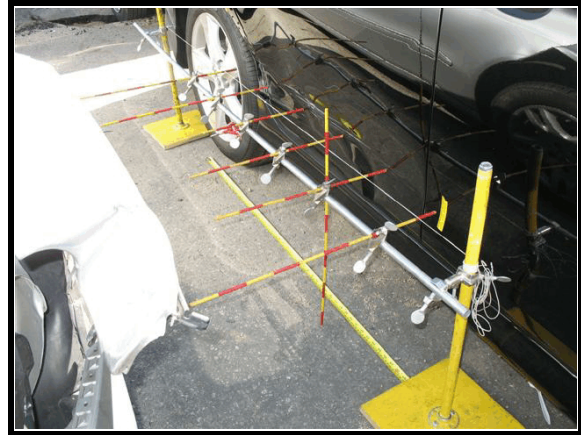
The right side damage began 25.0 cm (9.8 in) forward of the rear axle and extended 98.0 cm (38.6 in) forward (**Figure 6**). Six crush measurements were documented along the lower door as follows: $C_1 = 0$ cm, $C_2 = 2.0$ cm (0.8 in), $C_3 = 2.0$ cm (0.8 in), $C_4 = 2.0$ cm (0.8 in), $C_5 = 2.0$ cm (0.8 in), $C_6 = 0$ cm. The Collision Deformation Classification (CDC) for Event 2 was 03RPLW1.

Figure 6. Right side damage

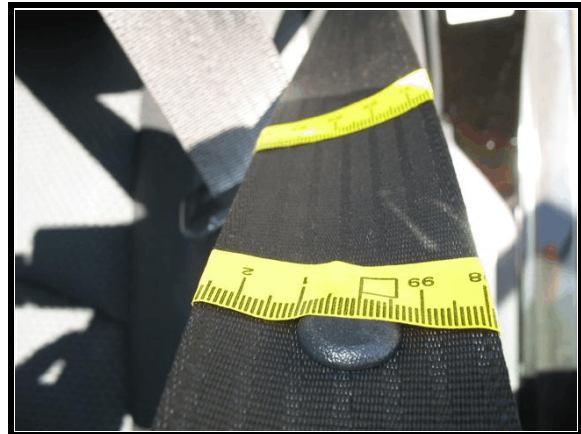
The driver's safety belt adjustable D-ring anchorage was in the full-up position and the latch plate was scratched indicating historical usage. The safety belt retractor pretensioner actuated during the crash and was spooled out at the time of the SCI vehicle inspection. The safety belt webbing and latch plate revealed evidence of occupant loading. The webbing exhibited scuff marks measuring 4.0 x 4.0 cm (1.6 x 1.6 in) that

Figure 7. Driver's safety belt webbing showing scuffs near stop button

began at the stop button (**Figure 7**). The EDR reported that the belt switch status for the driver was belted. Based on the vehicle inspection it was determined that the front left safety belt was used to restrain the driver during the crash.

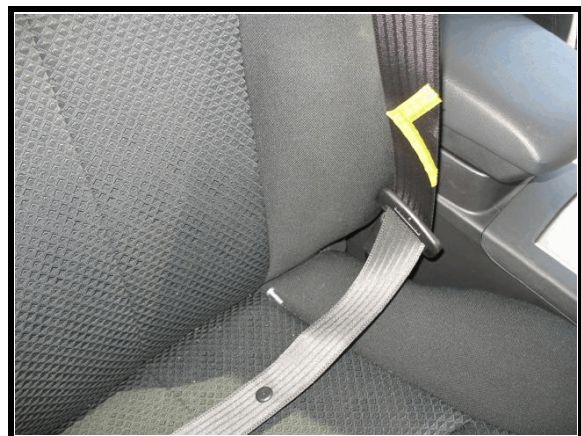
Figure 8. Front right occupant's safety belt showing load mark near the latch plate

The front row passenger's safety belt adjustable D-ring was in the full-down position and the latch plate was scratched indicating historical usage. The safety belt webbing and latch plate revealed evidence of occupant loading. The webbing exhibited scuffs measuring 1.0 x 1.0 cm (0.4 x 0.4 in) along the edge 31.0 cm (12.2 in) above the stop button (**Figure 8**). The EDR reported that the belt switch status for the passenger was belted. Based on the vehicle inspection it was determined that the front right safety belt was used to restrain the front right occupant during the crash.

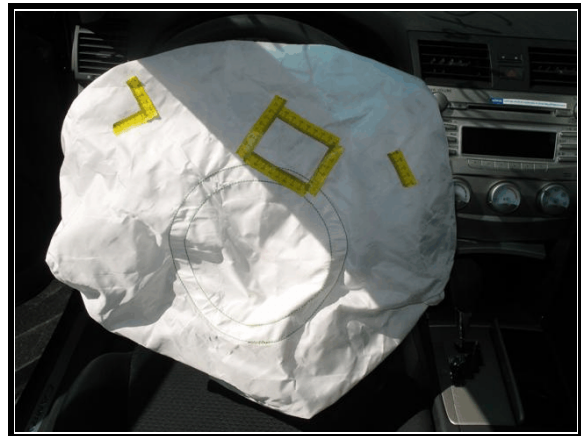
Figure 9. Driver's air bag

The driver's air bag module was located in the steering wheel hub (**Figure 9**), and the air bag deployed through Y-configured module cover flaps. The flaps opened at their tear points and were not damaged. The air bag was circular in shape and measured 58.0 cm (22.8 in) in diameter in its deflated state. The air bag had two internal tethers that terminated at the bag's front center. There were two vent ports that measured 3.0 cm (1.2 in) in diameter that were located at the 11 and 1 o'clock positions on the air bag's back panel.

The air bag exhibited loading evidence in the form of dark scuff marks that were probably deposited from the module cover flap as the air bag deployed. A scuff mark that measured 1.0 x 2.0 (0.4 x 0.8 in) was located in the upper left quadrant 24.0 cm (9.4 in) from the center of the air bag. A group of black scuff marks that measured 6.0 x 4.0 cm (2.4 x 1.6 in) were located in the upper right quadrant 12.0 cm (4.7 in) from the center of the air bag. A 1.0 cm (0.4 in) scuff mark was located in the upper right quadrant 18.0 cm (7.0 in) from the center of the air bag.

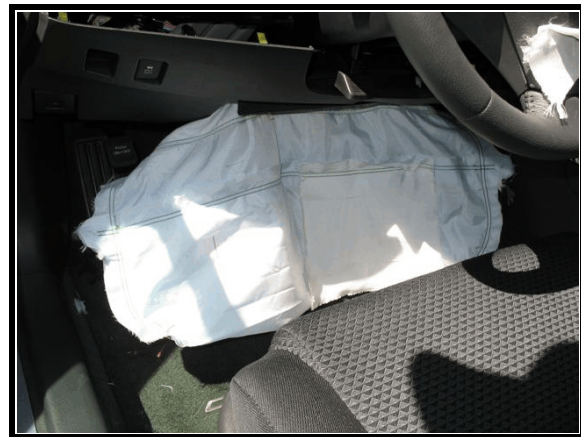
Figure 10. Driver's knee air bag

The driver's knee air bag was located in the lower instrument panel and deployed through a single rectangular module cover flap (**Figure 10**). The air bag was generally rectangular in shape and measured 30.0 cm (11.8 in) in height and 60.0 cm (23.6 in) in width. There was a 20.0 x 20.0 cm (7.8 x 7.8 in) sail on the front side and there were no tethers or vent ports. The air bag was not damaged and there was no evidence of occupant loading.

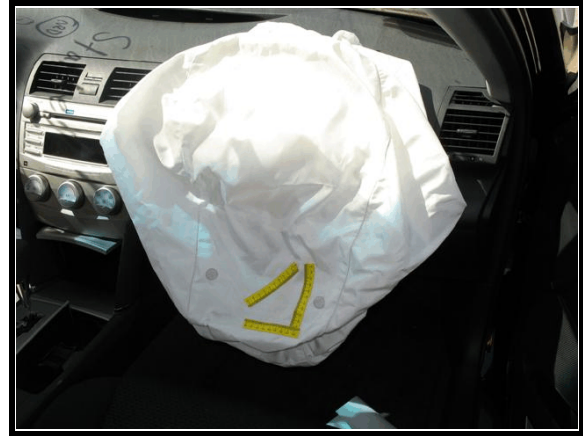
Figure 11. Front right passenger air bag

The front passenger air bag was located in the top of the instrument panel and deployed through a single rectangular module cover flap (**Figure 11**). The air bag was rectangular in shape and measured 35.0 cm (13.8 in) in width and 65.0 cm (25.6 in) in height. The bag had a maximum excursion of 50.0 cm (19.6 in). It was configured with 6.0 cm (2.4 in) vent ports at the 2 and 10 o'clock positions and was not tethered.

The air bag exhibited loading evidence in the form of make-up transfer. The 2.0 x 4.0 cm (0.8 x 1.6 in) transfer was located in the lower right quadrant 17.0 cm (6.7 in) right of the center line.

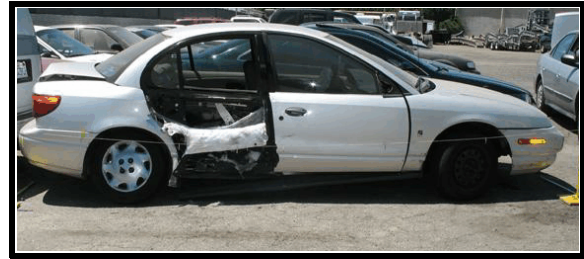
The direct damage to the right side began 82.0 cm (32.2 in) forward of the front axle and extended rearward 346.0 cm (136.2 in) (**Figure 12**). The damage from the front impact with the Toyota and the subsequent sideslap overlapped damage from a previous crash. The damage from the various impacts could not be separated in the field and the crush profile was measured to include all damage. Later, the damage was estimated mathematically using known damage and damage locations from the striking subject vehicle. For the impact with the front of the Toyota (Event 1) the crush profile at the mid-door level was as follows: $C_1 = 0$ cm, $C_2 = 5.0$ cm (1.9 in), $C_3 = 11.0$ cm (4.3 in), $C_4 = 19.0$ cm (7.4 in), $C_5 = 16.0$ cm (6.3 in), and $C_6 = 0$ cm. The maximum crush was located between C_4 and C_5 and measured 22.0 cm (8.7 in). The plastic fascia on the right rear door was displaced and the right rear tire was canted inward. The height of the maximum door crush measured 51.0 cm (20.0 in), the sill height was 23.0 cm (9.0 in), and the Door Sill Differential (DSD) was 14.0 cm (5.5 in). The CDC was 02RPEW2.

Figure 12. Right side damage, 2002 Saturn SL2

The estimated CDC for the sideslap was 03RFLW1.
