On-Site Side Air Bag Investigation
Dynamic Science, Inc. (DSI), Case Number DS10018
2008 Toyota Scion xB
Nevada
July 2010

1. Report No. DS10018	2. Government Accession No.		3. Recipient Catalog No.	
4. Title and Subtitle On-Site Side Air Bag Investigation			5. Report Date March 3, 2011

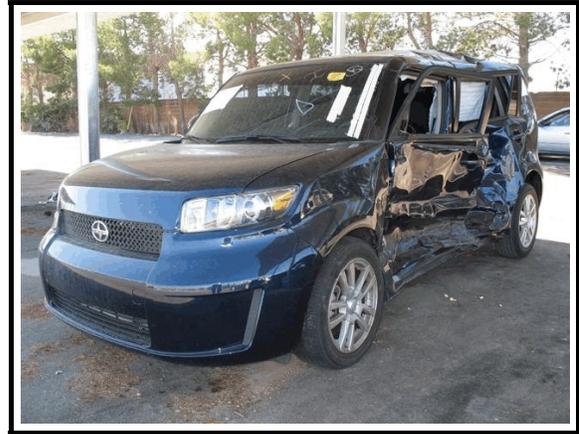
Figure 1. Subject vehicle, 2008 Toyota Scion xB

The Toyota sustained direct and induced damage to the left side and induced damage to the roof. The left front tire sustained a 2.0 cm (0.8 in) superficial cut and a 2.0 cm (0.8 in) rim scuff. The front right tire was flattened and de-beaded and the left side view mirror was displaced from the side door panel. The direct damage to the left side began 35.0 cm (13.8 in) forward of the left rear axle, extended forward 204.0 cm (80.3 in), and ended 21.0 cm (8.3 in) aft of the left front axle. The direct damage extended vertically from the sill to the belt line and measured 79.0 cm (31.1 in). The Field L began 8.0 cm (3.2 in) forward of the left rear axle, extended 236.0 cm (92.9 in) forward, and ended 16.0 cm (6.3 in) aft of the left front axle.

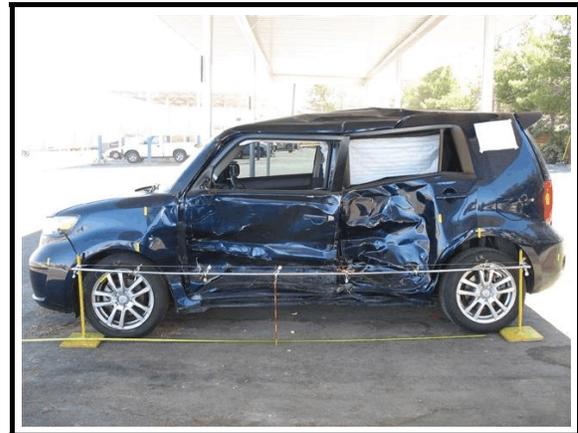
Figure 3. Side impact crush measurement, subject vehicle

Six crush measurements were taken at mid-door level (**Figure 3**) as follows: $C_1 = 0$ cm, $C_2 = 7.0$ cm (2.8 in), $C_3 = 28.0$ cm (11.0 in), $C_4 = 13.0$ cm (5.1 in), $C_5 = 13.0$ cm (5.1 in), $C_6 = 0$ cm. Maximum crush was located 102.0 cm (40.2 in) forward of the rear axle at C_3 . The Collision Deformation Classification (CDC) for Event 1 was 10LPEW3.

The vehicle-to-vehicle impact resulted in direct damage to the Toyota's left A-pillar, B-pillar and side doors. The height of maximum door crush measured 47.0 cm (18.5 in), the sill height measured 26.0 cm (10.2 in), and the Door Sill Differential (DSD) was 24.0 cm (9.4 in).

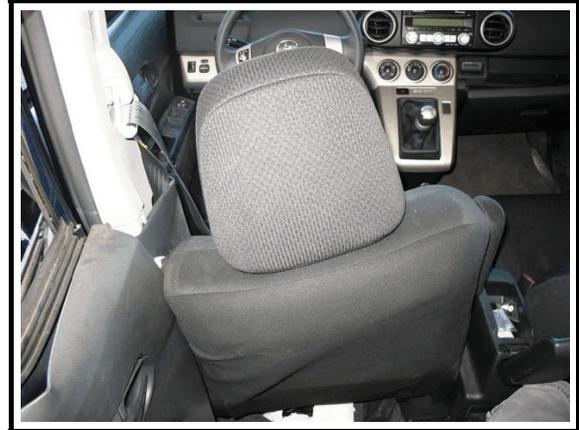
The Toyota sustained moderate interior damage resulting from impact forces, intrusion, and occupant contacts. The left front and rear side glass were disintegrated and the left side of the windshield was fractured. The left side doors were jammed shut and the front left window frame was deformed 26.0 cm (10.2 in) outboard resulting in integrity loss. The occupant compartment was reduced in size by lateral intrusion of the left side door panels, B-pillar, sill, roof side rail, front left seat back and cushion, front center console and left instrument panel (IP). It was reduced in size by vertical intrusion of the front left seat cushion and roof, and by longitudinal intrusion of the front left seat back. The front left safety belt components and the deployed left seat-mounted side impact air bag revealed scuff marks resulting from occupant loading, and the deployed left IC air bag was cut during post-crash activities. The front left door panel was scuffed and the steering column trim cover was displaced. Additionally, the front left seat cushion, seat back (**Figure 4**), and the center console were deformed by intrusion.

Figure 4. Driver's seat back deformed by left side intrusion, subject vehicle

The front left door panel and left B-pillar intruded laterally into the occupant compartment displacing and deforming the driver's seat cushion and seat back. The seat cushion was displaced laterally 10.0 cm (3.9 in) to the right, its leading edge was displaced vertically 4.0 cm (1.2 in) upward, and its forward-facing orientation was displaced 10 degrees counterclockwise. The seat back was displaced laterally 13.0 cm (5.1 in) to the right and its orientation was displaced 15 degrees counterclockwise. The driver's left hip contacted the rear lower quadrant of the left door panel causing a left hip contusion. His right hip contacted the center console, displacing it to the right. The Toyota was

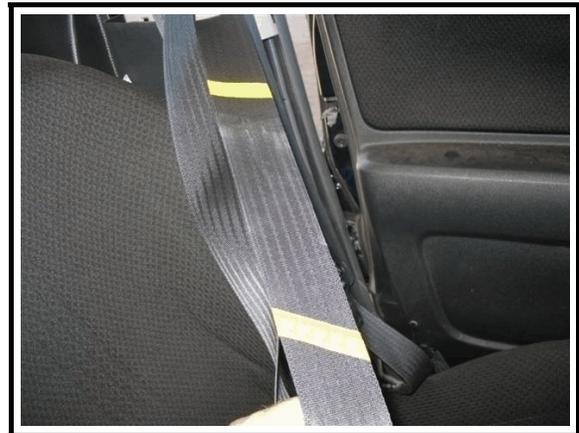
The driver's safety belt adjustable D-ring was set to the full-down position and the latch plate was scratched indicating historical usage. The safety belt retractor pretensioner had actuated during the crash and the webbing was locked in the spooled-out position. The safety belt webbing showed 20.0 cm (7.9 in) of scuff marks beginning 115.0 cm (45.3 in) above the stop button where the webbing was routed through the D-ring when it was loaded by the driver (**Figure 5**). The latch plate cover and D-ring also showed scuff marks from occupant loading. Based on the vehicle inspection it was determined that the front left safety belt was used to restrain the driver during the crash.

Figure 5. Driver's safety belt showing scuff marks, subject vehicle

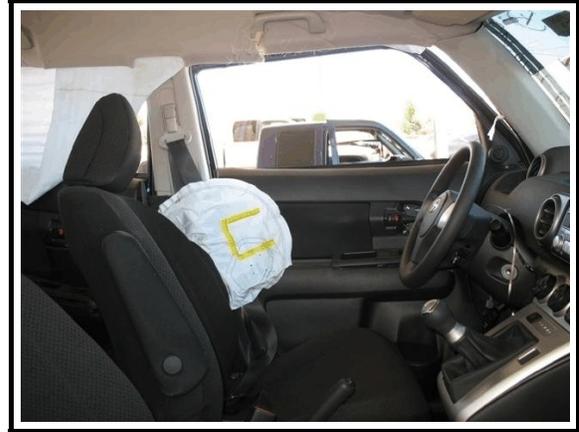
Figure 6. Deployed left seat-mounted side impact air bag, subject vehicle

The left seat-mounted side impact air bag deployed at impact from the outboard aspect of the driver's seat back. The air bag was semicircular in shape measuring 42.0 cm (16.5 in) in height and 30.0 cm (11.8 in) in width. In its post-deflated state, the air bag excursion covered the left B-pillar and rear upper quadrant of the door panel including the armrest. The inboard panel of the air bag showed a 6.0 x 7.0 cm (2.4 x 2.8 in) area of scuff marks located 8.0 cm (3.1 in) aft of its forward edge and 15.0 cm (5.9 in) below the top edge (**Figure 6**). The outboard panel showed a 2.0 x 5.0 cm (0.8 x 2.0 in) scuff mark located mid-level at the forward aspect. The scuff marks were deposited by occupant loading during the crash.

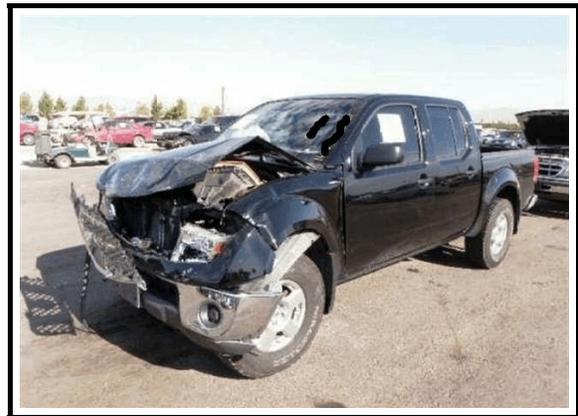
Figure 7. Other vehicle, 2008 Nissan Frontier (auction facility photo)

The Nissan sustained damage to the front end, hood, forward aspect of the left and right front fenders, and engine compartment during the crash. The front grille and bumper fascia were displaced from the vehicle and the hood was buckled. This inspection was photo-based so no specific damage measurements were possible. The Nissan's estimated CDC based on photographs was 12FDEW2.
