On-Site Child Restraint System Investigation  
Dynamic Science, Inc. (DSI)  
Case Number DS10019  
2002 Mercury Mountaineer  
Utah  
September 2010

**Dynamic Science, Inc.**  
**Crash Investigation**  
**Case Number: DS10019**

This on-site Child Restraint System (CRS) investigation focused on the occupants and the booster seat in 2002 Mercury Mountaineer that was involved in a single vehicle rollover crash (**Figure 1**). The crash occurred in September 2010 at 0225 hours. The vehicle was being driven by a restrained 32-year-old male. The front right seat was occupied by a restrained 11-year-old female. The second row left seat was occupied by a 4-year-old female seated in a booster seat. The second row middle seat was initially occupied by a 1-year-old female seated in a forward-facing CRS, but prior to the crash this occupant had been removed from the CRS and was being held by the 32-year-old female second row right occupant (the child's mother). The third row right seat was occupied by a 6-year-old female.

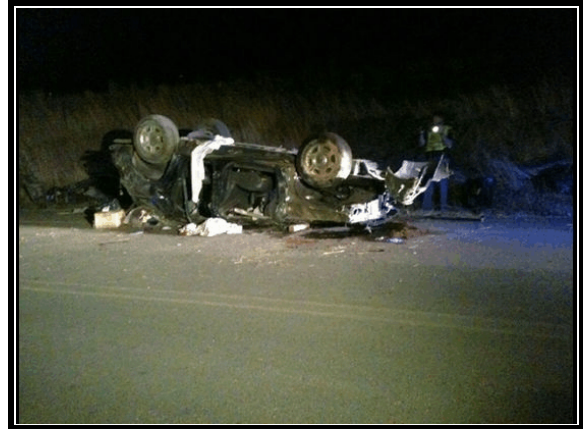
**Figure 1.** 2002 Mercury Mountaineer at final rest (internet photo)

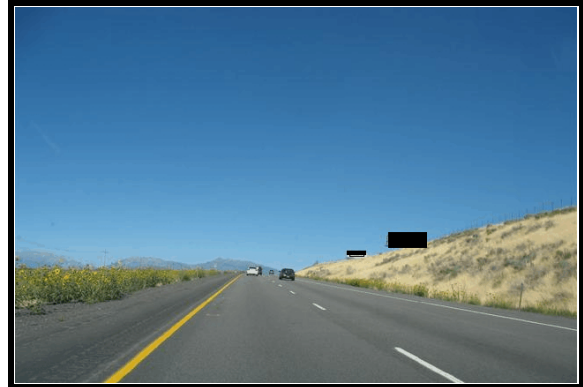
**Figure 2.** Northbound approach to left side roadway departure

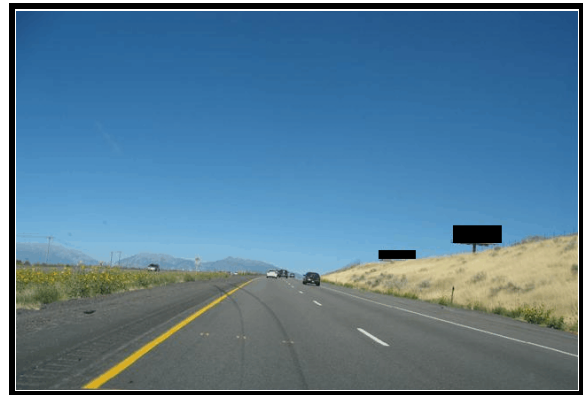
The Mercury was traveling northbound in the left lane of the interstate highway. The vehicle drifted onto the left side shoulder and crossed over the rumble strip (**Figure 3**). The driver steered the vehicle to the right back onto the travel lane, lost control, over-corrected back to the left, and began a counterclockwise rotation. The vehicle departed the roadway and entered the median while rotating. The police calculated a speed of 138 km/h (86 mph)<sup>1</sup> at the area of roadway departure based on a tire yaw mark in the northbound travel lane.

**Figure 3.** Left side roadway departure

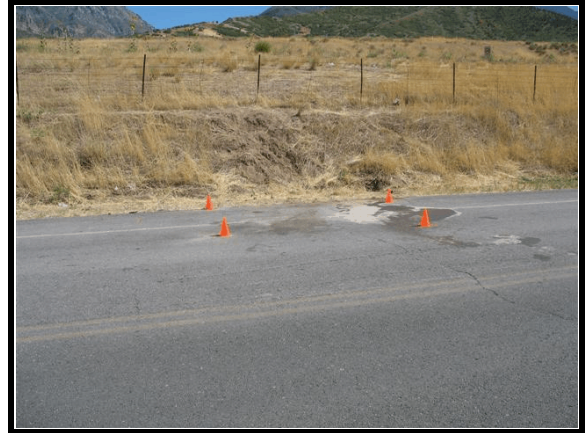
The vehicle continued rolling as it crossed a grass-covered embankment, impacted a barbed wire fence (Event 2), traveled down a short embankment, and came to rest in the southbound travel lane of frontage road (**Figure 4**).

**Figure 4.** Final rest and impacted barbed wire fence (looking east)

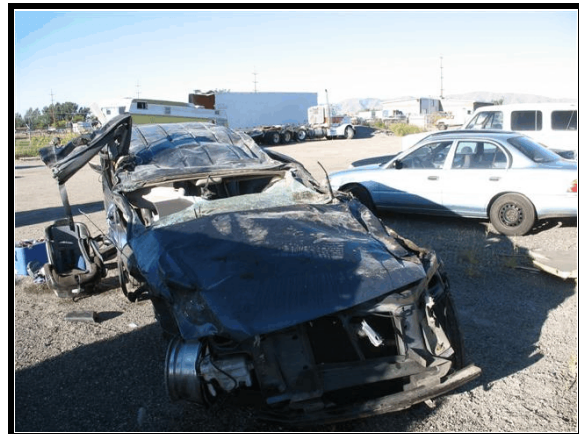
The Mercury sustained direct and induced damage to the right, left, front, and top planes (**Figure 5**). The right front rim was fractured and displaced and the tire was missing at the time of the inspection. The right and left plastic fender panels and the front bumper fascia were displaced. At the time of the inspection, all the doors including the hatch had been removed by rescue personnel.

The direct damage to the right side began at the right front bumper corner and extended rearward 420.0 cm (165.3 in) to the rear bumper corner. The damage extended from the frame to the roof rail and measured 119.0 cm (46.8 in) in height. The direct damage to the top began at the leading edge of the hood and extended rearward 414.0 cm (162.9 in) and measured 125.0 cm (49.2 in) in width. There was direct contact to the displaced front bumper fascia that began at the right front bumper corner and extended 50.0 cm (19.7 in) to the left. The maximum vertical crush was located at the left A-pillar and measured 48.0 cm (18.9 in) (**Figure 6**). The maximum lateral crush was located at the left B-pillar and measured 53.0 cm (20.8 in).

**Figure 5.** 2002 Mercury Mountaineer rollover damage

The Collision Deformation Classification (CDC) for the rollover (Event 1) was 00TDDO5.

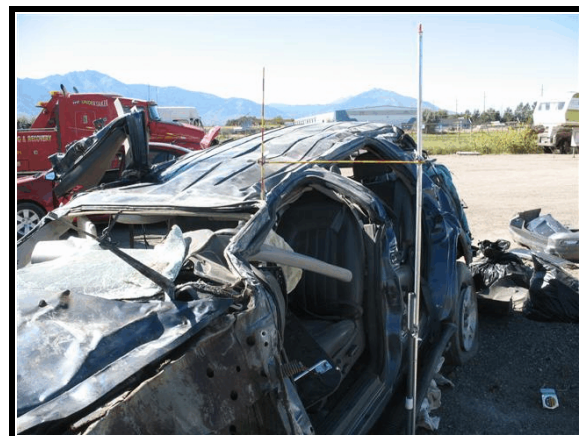
**Figure 6.** Maximum vertical crush

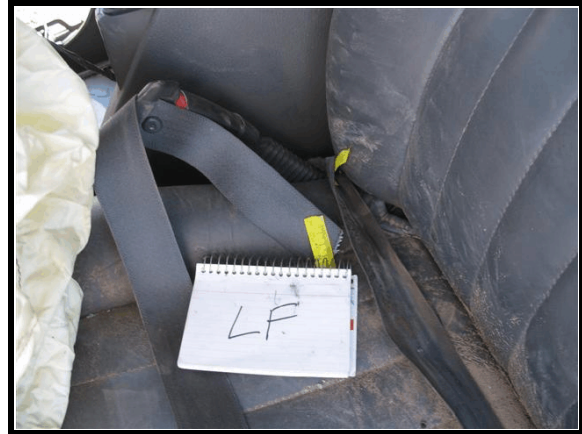
The driver's safety belt D-ring anchorage was in the full-up position, the latch plate was scratched indicating historical usage, and blood deposits were located on the lap portion of the belt. The latch plate was found inserted in the buckle and the belt webbing had been cut during extrication activities (**Figure 7**). The belt had been cut at the shoulder 122.0 cm (48.0 in) from the stop button and at the lap 27.0 cm (10.6 in) from the stop button. The shoulder portion of the belt was locked in place due to pretensioner actuation. Based on the vehicle inspection, the belt was used to restrain the driver during the crash.

**Figure 7.** Driver's safety belt

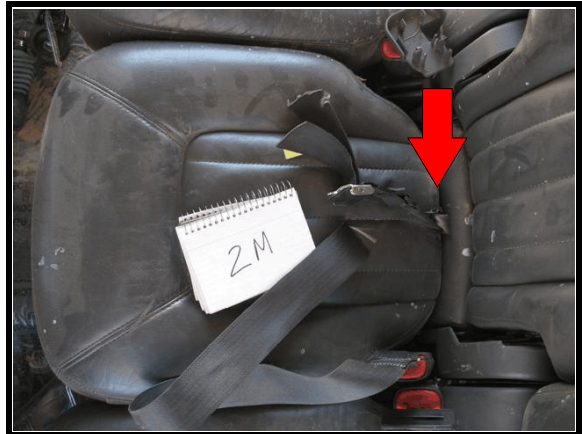
**Figure 8.** Top tether attached to compartment strap

The center position lap belt was used to anchor the Dorel Safety 1<sup>st</sup> CRS in the forward-facing position. The lap belt was routed through the forward-facing belt path. The top tether strap was

hooked to the storage compartment strap (**Figure 8**). The lap belt and the tether strap had been cut by rescue personnel. The CRS was not occupied at the time of the crash.

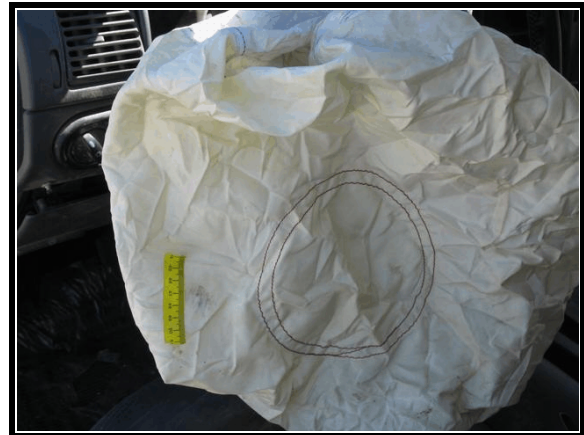
The left frontal air bag deployed from the steering wheel hub at an unknown point during the rollover sequence (**Figure 9**). It was circular in shape and measured 62.0 cm (24.4 in) in diameter from seam to seam. The air bag was configured with two vent ports on the back panel and a single internal tether attached to the center of the frontal panel. A skin oil transfer measuring 4.0 x 4.0 cm (1.6 x 1.6 in) was located in the bottom left quadrant 13.0 cm (5.1 in) from the center of the bag. A 2.0 x 2.0 cm (0.8 x 0.8 in) skin oil transfer was located near the center of the air bag face. A 4.0 x 3.0 cm (1.6 x 1.2 in) black scuff was located in the bottom right quadrant 15.0 cm (5.9 in) from the center.

**Figure 9.** Driver's frontal air bag

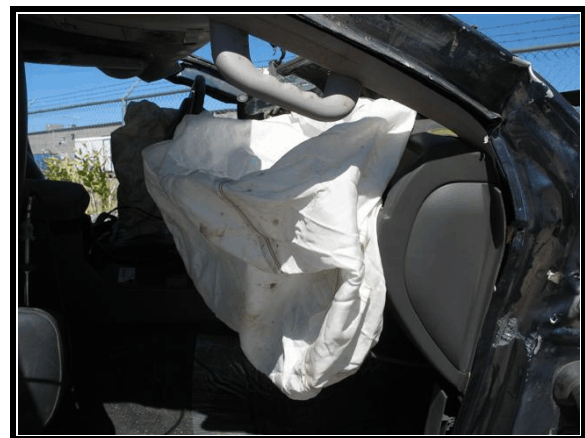
The right frontal air bag deployed from the top right IP (**Figure 10**). The air bag measured 44.0 cm (17.3 in) in width and 54.0 (21.2 in) in height. The air bag was configured with two vent ports on the side panels. There was no evidence of damage or occupant loading on the air bag.

**Figure 10.** Front right passenger air bag

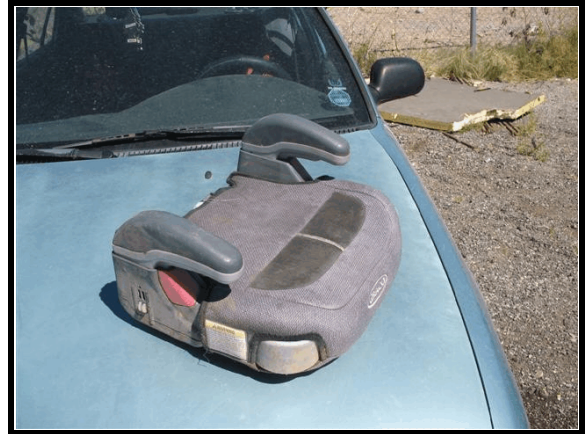
The Mercury's second row left seat position was occupied by a 4-year-old female seated in a gray Graco TurboBooster forward-facing belt positioning BSS (**Figure 11**). The vehicle lap and shoulder belt was being used in combination with the BSS. The TurboBooster is available with or without a detachable high back support. During the vehicle inspection, no back for the BSS was located and evidence of the back support being in use has never surfaced.

**Figure 11.** Graco TurboBooster BSS

Inspection of the BSS revealed dirt and fluid stains on the seat cushion indicating historical usage. There was mud on both sides of the BSS. There were scuffs across the top of both armrests that likely were a result of being in contact with the ground post-crash.

Based on the child's age, it was appropriate to use the BSS without the back support. It is not known if the child met the height and weight requirements.

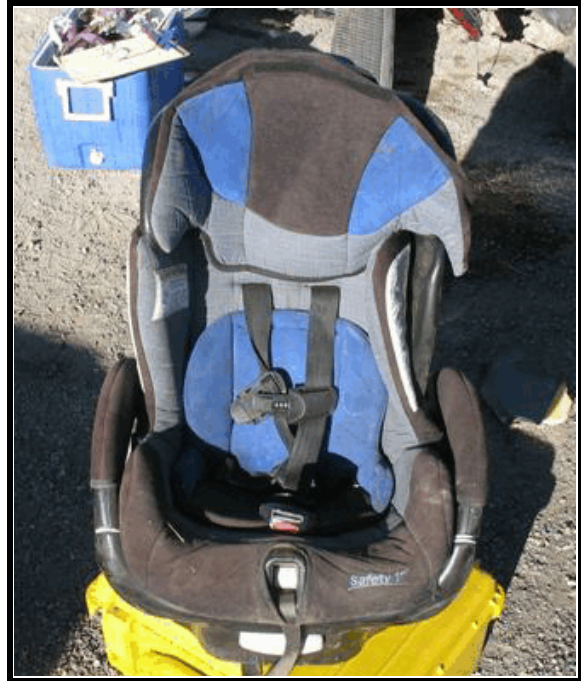
The 1-year-old child had been seated in a Cosco/Dorel Safety 1<sup>st</sup> Scenera convertible CRS (**Figure 12**), but had been removed from the seat by the second row right occupant prior to the crash. The seat was identified by the Model No. 22-160-WAL and was manufactured on July 28, 2004. The seat was designed to be used forward-facing or rear-facing. In the forward-facing orientation the seat was designed for children who weighed between 9-18 kg (20-40 lbs), whose height was between 73-103 cm (29-40 in), and who were older than one year. In the rear-facing orientation the seat was designed for children weighing between 2-16 kg (5-35 lbs) and whose height is between 48-91 cm (19-36 in). The seat was designed with a 5-point harness with 3 shoulder harness positions; at the time of the crash the shoulder harness straps were routed through the middle slots. The seat back was designed to be adjustable and could be raised or lowered depending upon the size of the child; at the time of the crash the seat back was locked into its lowest position. The seat was anchored to the vehicle using the vehicle lap belt. The top anchorage strap had been improperly attached to a looped strap that is used to open a storage area beneath the seat cushion.

**Figure 12.** Cosco/Dorel Safety 1<sup>st</sup> CRS

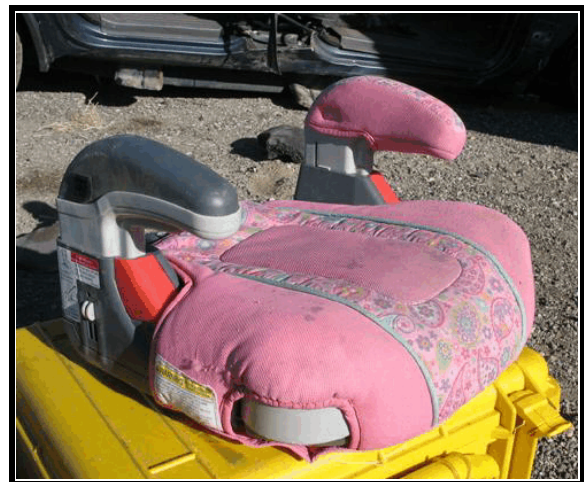
The Graco TurboBooster was lying in the third row seat during the vehicle inspection (**Figure 13**). The police report indicated that the third row occupant was not using any restraints.

**Figure 13.** Graco TurboBooster BSS

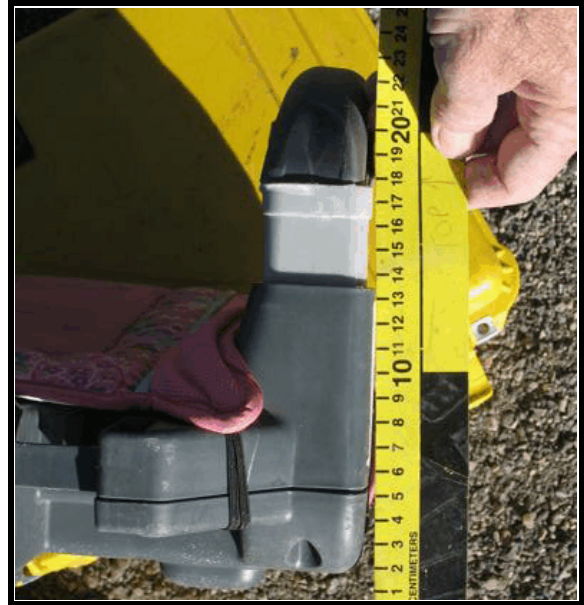
Inspection of the BSS revealed dirt and fluid stains on the seat cushion indicating historical usage. The cloth cover for the right armrest was missing and there were stress marks on the arm rest indicating that it had been damaged at some point during the crash (**Figure 14**).

**Figure 14.** Stress marks to right arm rest

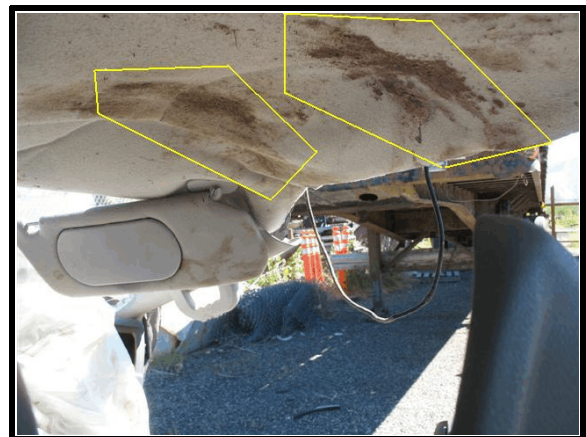
The 11-year-old female front right occupant was seated in an unknown posture and was restrained by the vehicle’s lap and shoulder belt. As the vehicle began to roll, this occupant was displaced in multiple directions. Two areas of head contact related blood and scuffing were documented: the first measured 20.0 x 30.0 cm (7.8 x 11.8 in) and was located on the roof aft of the A-pillar and the second measured 25.0 x 40.0 cm (9.8 x 15.7 in) and was located on the roof 20.0 cm (7.8 in) aft of the first area (**Figure 15**). The front right restrained occupant came to rest in her seat upside down. She was pronounced dead at the scene. The police reported that the area of injury was to her head. An autopsy was not conducted and a certificate of death was obtained. In the certificate the cause of death was listed as a head injury as a result of multisystem trauma.

**Figure 15.** Scuffs and blood contacts to right side roof area

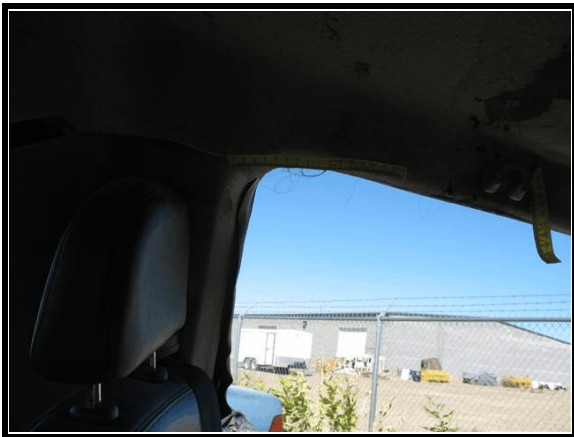
The 4-year-old female second row left occupant was seated in an unknown posture on a belt-positioning BSS and was restrained by the vehicle’s lap and shoulder belt. As the vehicle began to roll, this occupant was displaced in multiple directions. During the rollover, this occupant’s head contacted the left roof, roof rail, and left window frame (**Figures 16-17**). The second row left restrained occupant came to rest in her seat upside down. She was pronounced dead at the scene. The police reported that the area of injury was to her head. An autopsy was not conducted and a certificate of death was obtained. In the certificate the cause of death was listed as a head injury or as a consequence of multisystem trauma.

**Figure 16.** Blood and hair transfer to left roof and side rail

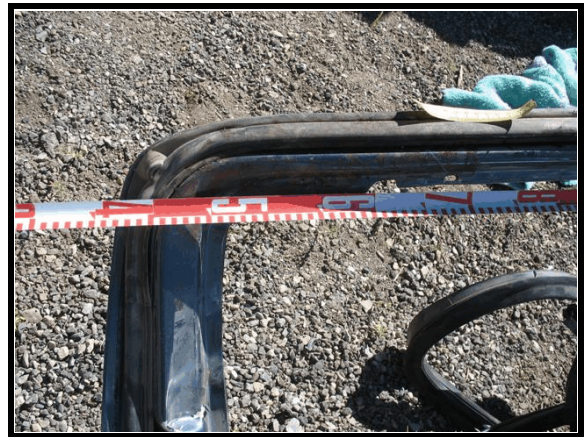
**Figure 17.** Contact to left upper window frame

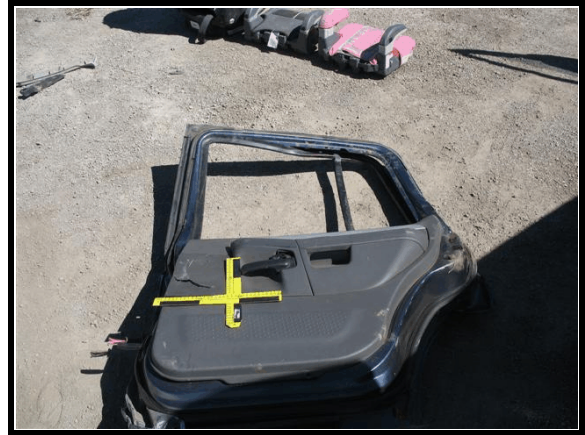
The 32-year-old female second row right occupant was seated in an unknown posture and was not restrained by the vehicle's lap and shoulder belt. Prior to the crash, she had taken Occupant 04 out of the CRS and was either holding the child or had her in her lap. She came out of her seat during the rollover. Near the conclusion of the eighth quarter roll she was fully ejected from the vehicle through the second row right window. There was contact to the forward upper quadrant of the door (**Figure 18**) and the window frame was bowed outward. She came to rest on the right shoulder of the southbound roadway. The police reported that the area of injury was to her head. She was transported by helicopter to an area trauma center with serious injuries.

**Figure 18.** Second row right door contacts

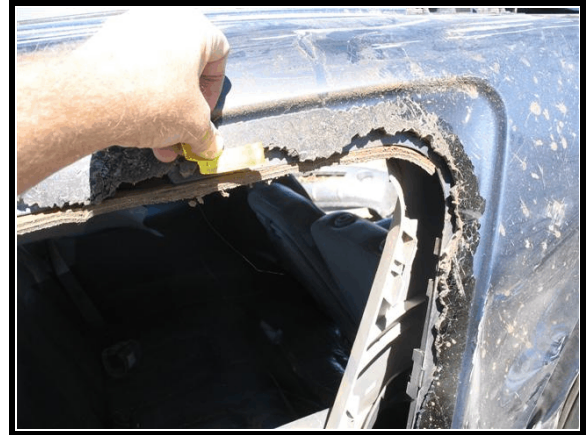
The 6-year-old female third row right occupant was seated in an unknown posture and was not restrained by the vehicle's lap and shoulder belt. She came out of her seat during the rollover. She was fully ejected from the vehicle through the side window (**Figure 19**) between the third and fourth quarter-turns. She initially came to rest on the inboard lane of the southbound roadway but was moved to the shoulder area by a bystander who feared she might be struck by southbound traffic. She was transported by helicopter to an area trauma center. She sustained abrasions to the right elbow, back, toes, and abdomen that were likely a result of contact with the ground after the ejection.

**Figure 19.** Hair deposit along upper window frame
