CALSPAN ON-SITE MOTORCOACH FIRE INVESTIGATION

SCI CASE NO.: CA10019

VEHICLE: 2005 MOTOR COACH INDUSTRIES (MCI) MODEL J4500

INCIDENT DATE: MAY 2010

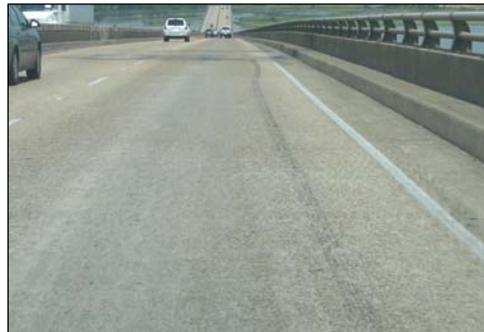
Figure 7. Approach of the motorcoach to the incident site and the right tag axle tire mark.

mark was present on the outboard travel lane of the asphalt road surface at a location consistent with the position a right side tire (**Figure 7**). The tire mark extended for an estimated distance of 0.8 km (0.5 mi). The narrow bridge did not have adequate shoulders for the driver to safely stop on the bridge. The driver activated the hazard warning lights and slowed down as he continued to drive with the intent to cross the bridge and safely stop the motorcoach off of the roadway. These actions were in accordance with the motorcoach company's safety procedures. The driver further stated that he did not detect a warning from the SmarTire system.

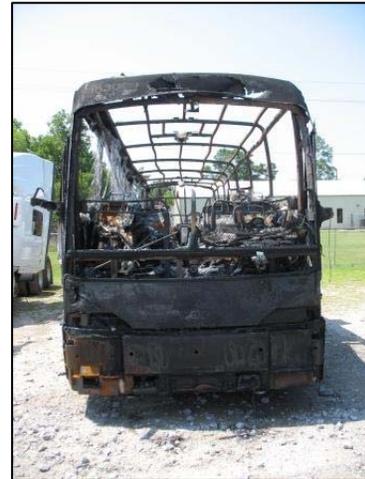
All frontal components including the windshield glazing, bumper fascia, and painted surfaces were burned by the fire (**Figure 8**). The upper fiberglass panel above the windshields was burned full-thickness at the center area and had begun to collapse inward. The outer portions remained intact, although the paint had burned off. In the upper right corner, a portion of the identifying motorcoach number remained discernable. Both windshields were completely consumed. The lower portions of the windshield gaskets were charred, but remained in place. All other sections of the gaskets were completely consumed by the fire. The lower 56 cm (22 in) of the extruded aluminum center divider between the two windshields remained intact. The upper aspect of this support was completely melted. All windshield wiper components were melted. The fiberglass paneling below the windshields was charred but intact. The bumper fascia was completely burned. The structural bumper beam remained intact and was soot covered, but void of all paint. The headlamp, turn signal, and marker light assemblies were completely melted. There was no evidence of high heat in the frontal area of the coach.

Figure 8. Frontal view of the MCI motorcoach.

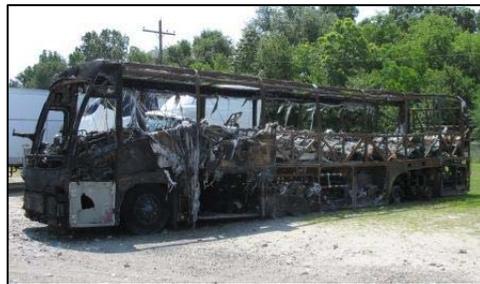
The left side of the motorcoach sustained extensive damage with near total consumption of all materials excluding the frame (**Figure 9**). The majority of the exterior body panels and glazing were completely consumed by the fire. The aluminum window frames and the rubber gaskets were completely consumed. The inner panel of the access door at the lower forward portion of the motorcoach remained intact, located between the lower A and B-pillar. This door provided

Figure 9. Left side view of the motorcoach.

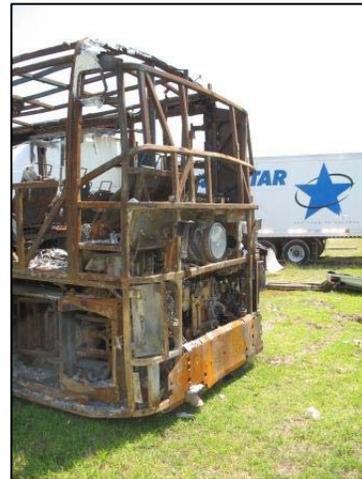
All of the back mounted components were completely burned by the fire (**Figure 10**). The composite rear bumper fascia was completely consumed as were all taillight and marker light assemblies. The engine compartment door was fiberglass with a steel frame that was top hinged. The external panel was totally consumed and the door framework was in the open position at the time of the SCI inspection. The upper fiberglass panels above the engine compartment were completely burned with exposure of the structural frame of the motorcoach. This framework was minimally distorted by heat; however, there was no evidence of high heat oxidation.

Figure 10. Back plane of the motorcoach.

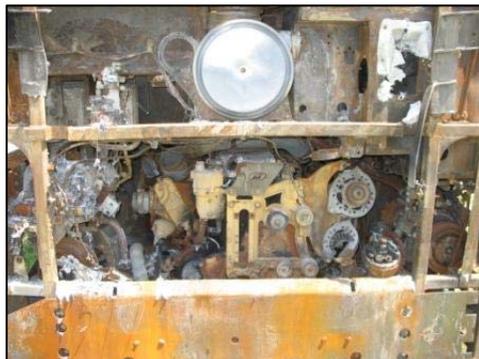
Within the engine compartment, all belts, hoses, wires, connectors, insulation, and other combustible material were completely consumed by the fire. The fiberglass valve cover was charred and burned through at several locations. The majority of the aluminum components were burned and melted. The mounts to the lower of two alternators had melted and separated. The turbocharger was intact and displayed no evidence of high heat, and the exhaust pipe to the muffler was intact and in place. A normal amount of soot was present inside the exhaust tailpipe. Some paint residue remained on the air intake cover over the engine. **Figure 11** is an overall view of the engine compartment.

Figure 11. Overall view of the engine compartment.

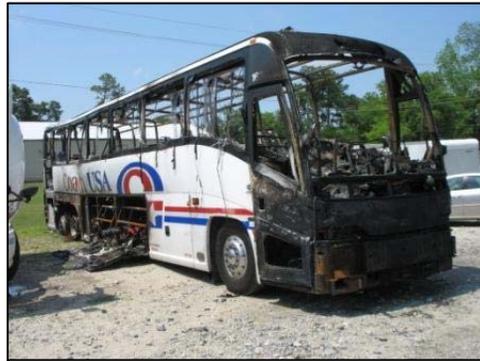
The right side of the motorcoach sustained extensive damage above the level of the beltline. The body panels below the beltline remained intact with scattered charring and blistering of the painted surfaces (**Figure 12**). The body panel at the location of the right E-pillar was bowed as a result of partial separation due to heat. All of the glazing panels melted with glass fragments remaining at the corners. The aluminum window frames were predominately intact with scattered melting and distortion of the material. The wheelchair access door to the passenger compartment was completely consumed by the fire. The panel covering the wheelchair lift, that was located below floor level, remained intact. The upper aspect had been broken away by the firefighters during the extinguishment activities. The fiberglass fairing and spray shields above the right rear axle positions were consumed by the fire.

Figure 12. Right side view of the motorcoach.

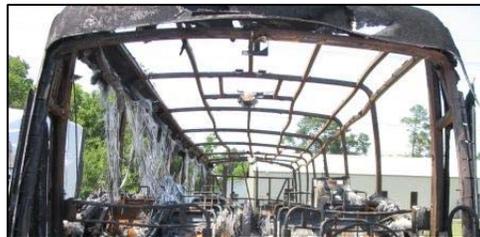
The exterior roof of the motorcoach was constructed of aluminum panels with overlap riveted joints at each pillar location. The fire consumed the entire roof, exposing the steel framework. The intensity of the fire warped the lateral roof bows and the longitudinal supports. The most notable damage to the lateral bows occurred between the C- and H-pillars. Extensive deflection of the longitudinal supports was most prevalent between the F- and G-pillars, the area over the rear axle locations (**Figure 13**). The two plastic emergency roof exits were completely burned.

Figure 13. Heat deformation to the lateral and longitudinal roof structure.

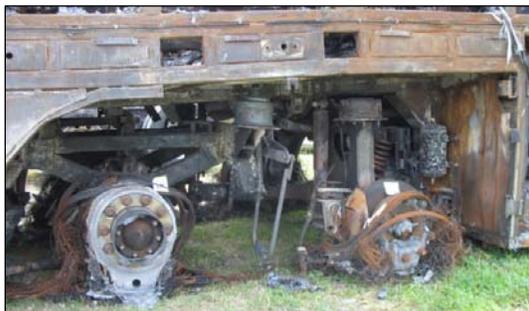
Figure 14. Tire and wheel remains at the left rear axle positions.

The outer left drive axle wheel was burned/melted with the bolt pattern area remaining intact. The molten aluminum cooled to a puddle at the bottom aspect of the wheel. Fragments of the tire remained at the bottom of the tread. The inner aluminum wheel at the left drive axle position was completely melted. The inboard left drive axle tire was completely consumed by the fire with the wire bead and steel tread ply remaining. The left tag axle wheel was melted with a minimal amount of wheel remaining at the lower bolt

pattern area. The tire was completely burned with the wire reinforcements remaining at the axle position. **Figure 14** is an overall view of the left rear tires and wheels.

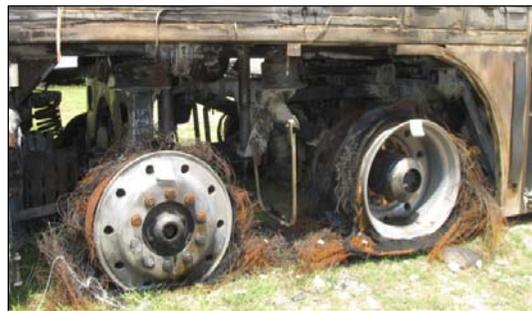
Figure 15. Remaining tire and wheel material at the right rear axle positions.

At the right drive axle outboard position, the outboard aluminum wheel was burned through at the 7-9 o'clock position, outboard of the hub. The inner aspect of the wheel was consumed by the fire. The outer sidewall of the outboard right drive tire was burned; however, the bead area was partially intact on the remaining wheel. Fragments of the tire tread remained at the 6 o'clock position. The majority of the inner right drive axle wheel was consumed by the fire with a minimal amount of the wheel remaining at the upper outboard bead area. The inner tire was completely burned. The hubometer was affixed to the right drive axle. The steel housing survived the fire, but the face and odometer reading were destroyed.

The majority of the right tag axle tire was consumed by the fire. The rubber bead area remained at the outer aspect at the 3-5 o'clock position. The inboard aspect of the right tag axle wheel was completely burned. The outer profile of the wheel was intact with melting of the wheel at the 6 o'clock position as viewed at the time of the inspection. **Figure 15** is a view of the right rear tires and wheels.

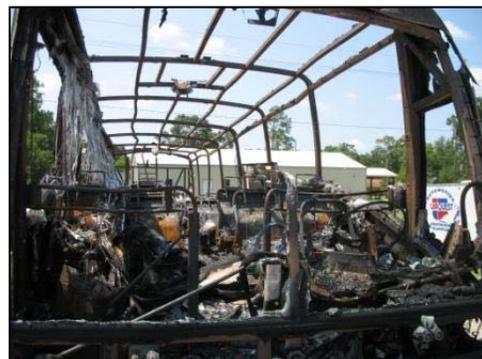
The fire spread to the interior of the motorcoach and consumed all combustible materials and components (**Figure 16**). The aircraft-style overhead storage compartments and components were completely burned. The ceiling of the motorcoach was consumed and the plywood floor was completely burned. The seat cushions, fabric and composite armrests were burned. The tubular seat frames remained with all falling rearward as the recline mechanisms released due

Figure 16. Overall view of the burned interior of the motorcoach.

to fire damage. The most extensive damage to the seat frames was noted in the area of the drive axle at rows 10-11 on the right and rows 9-12 on the left side.

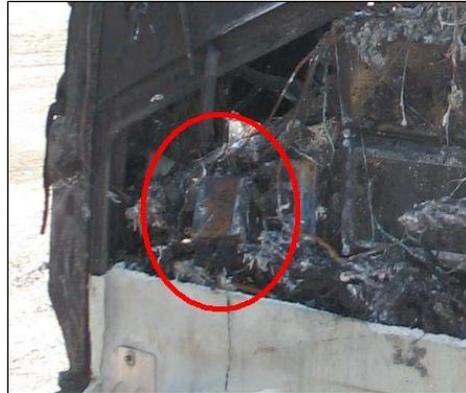
The SmarTire Wireless Gateway receiver was found severely burned among the remnants within the left front electrical panel outboard of the driver's position. The receiver is highlighted in **Figure 17**. The electrical connections remained intact to the receiver, though the unit was burned with probable destruction of the internal circuit board.

Figure 17. Remnants of the SmarTire receiver

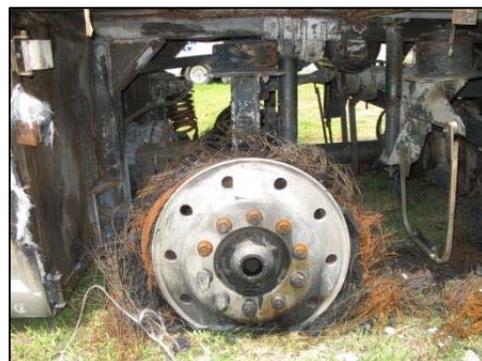
The dragging tire mark at the scene extended for an estimated distance of 0.8 km (0.5 miles) and terminated at the burn pattern on the road surface that was the point of rest for the motorcoach. The location of the tire mark on the road surface was consistent with the position of the right tag axle tire.

Figure 18. Right tag axle wheel, tire remnants, and the adjacent undercarriage.

The dragging right tag axle tire self-combusted due to increased friction against the road surface. The remote location of the motorcoach prevented disassembly and a thorough inspection of the wheel end to determine if wheel bearing and/or brakes contributed to the dragging tire. Once the fire was detected and the driver slowed the motorcoach to a stop at the high-point of the bridge, the wind aided the fire as it spread to the left side of the motorcoach and forward. The fire burned through the plywood floor forward of the rear axles and entered the interior of the motorcoach. The opened right front door provided venting, drawing the fire forward into the passenger compartment. The wind, directing the fire left, prevented the right side of the motorcoach from becoming totally involved. **Figure 18** is an overall view of the right tag axle tire and wheel.

Determination of Origin: The first witnesses to this incident were several passengers at the rear of the coach that reported hearing a loud noise, and verified by the driver who reported seeing a “wobble” in the right tag axle tire. Passengers then detected the odor of smoke and the driver also reported fire visible in his right side mirror. One of the chaperones also tried to extinguish the fire at the right rear of the vehicle. Examination of the exterior of the vehicle shows the coach to be almost completely consumed with the most amount of damage on the left rear side. Since there are multiple witness accounts that the fire started on the right side of the coach, the greatest amount of damage observed is not indicative of the origin, but rather due to the progression of the fire as aided by wind. In addition, the scene also shows a right side rear tire mark extending an estimated half mile. This tire mark agrees with the witness accounts. The area of origin is therefore determined to be at the right rear tag axle wheel end.

Determination of Cause: The cause of this fire is consistent with a tire fire in the right rear tag axle. The root cause of the tire fire cannot be determined as the wheel end was not disassembled and the brakes, wheel seals, and bearings were not inspected.
