**CALSPAN ON-SITE MOTORCOACH ROLLOVER CRASH INVESTIGATION
SCI CASE NO.: CA10020**

VEHICLE: 1997 MCI MODEL 102-DL3 MOTORCOACH

LOCATION: NEW JERSEY

CRASH DATE: JUNE 2010

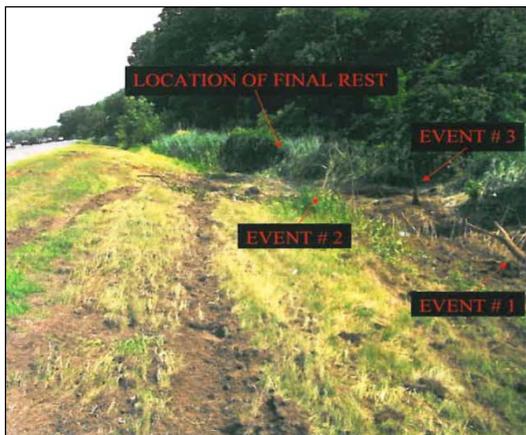
The right rear area of the motorcoach impacted, fractured, and uprooted the three trees (**Figure 8**) that were located at the bottom of the slope over a longitudinal distance of (5.5 m (18 ft)). The tree impacts did not alter the trajectory of the motorcoach as it continued to yaw approximately 10 degrees CCW. The right side tires furrowed deep into the soft dirt of the roadside which tripped the vehicle into a right side leading rollover event. The motorcoach yawed approximately 40 degrees CCW and traveled 171.5 m (563 ft) from the point of lane departure to the trip point. The motorcoach overturned into tall cattails and vegetation, which resulted in a soft rollover event (**Figure 9**). The vehicle completed one-quarter turn onto its right side and slid approximately 8 m (26 ft) to final rest.

Figure 8: Motorcoach crash site.

Damage to the back plane was limited to the separation of the bumper fascia at the right corner and lateral buckling of the fiberglass paneling at the upper right corner, near the roofline, as seen in **Figure 8**. The engine compartment doors and the access door to the top-mounted radiators and air conditioning condenser remained closed and operational post-crash.

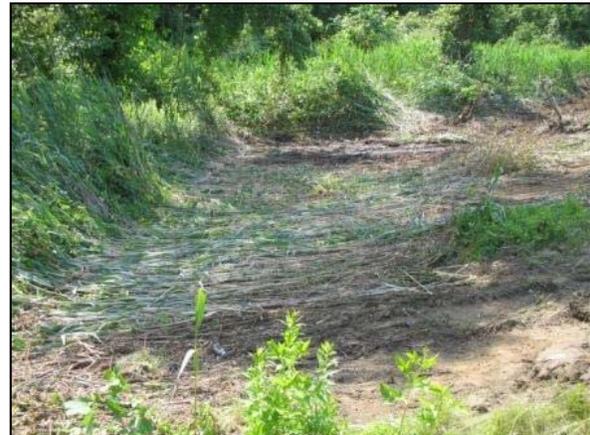
Figure 9: Rollover and final rest position of the motorcoach.

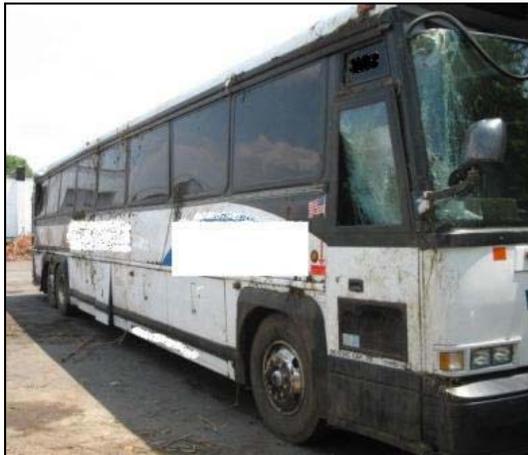
The exterior of the motorcoach sustained damage to its right, front, and back planes as a result of the side impacts and subsequent rollover. Minor severity damage was located on the right side (**Figure 10**) from the initial small diameter tree impacts. The damage consisted of isolated minor crush and inward buckling of the lower body-panel fascia, sill, and rear-axle area polymer fender flare. The tree impact damage was overlapped by the subsequent rollover; however, based on scene evidence and vehicle damage patterns, the three tree impacts were located as follows: (Event 1) immediately aft of the rear tag axle area with corresponding damage to the sill; (Event 2) immediately forward of the right drive axle with corresponding sill and lower body-paneling damage; (Event 3) within the right rear axle area with corresponding polymer fender flare damage above the tag axle location. The rollover damage was distributed across the entire right side of the motorcoach, with induced damage to the front and back planes.

Figure 10: View of right side plane rollover damage.

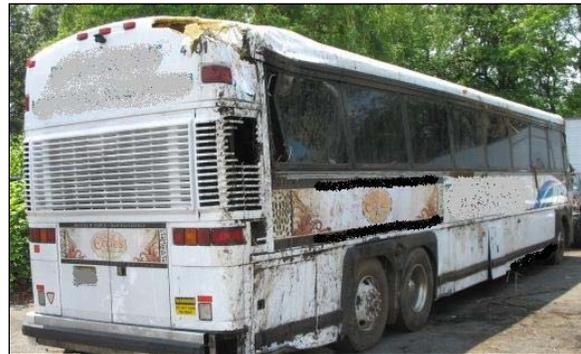
Figure 11: Right rear oblique view of the motorcoach.

The right side body damage consisted of isolated dents with mud and grass embedded into the body panels and glazing frames (**Figure 11**). The forward-hinged right front door remained closed, intact and operational, although the laminated upper glazing was fractured and partially separated from its gasket mount. The right A-pillar was displaced laterally 3 cm (1.25 in) at the juncture with the side rail. The luggage compartment doors and the doors to the mechanical compartments remained closed and operational post-crash. The side glazing panels at pillars B through I remained closed and intact, and were not fractured. The eighth glazing panel was fractured by a tree impact or recovery efforts. The integrity of the right side structure remained as there was no separation or displacement of the body panels. The lateral crush to the right roof side rail area between the right H and I pillar locations was due to tree and recovery efforts. The lateral crush was approximately 7 cm (3 in) based on interior intrusion dimensions.

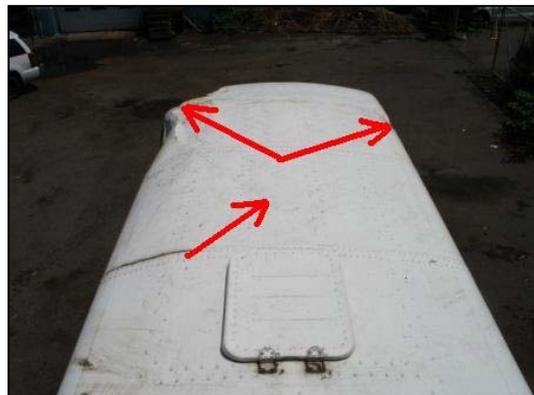
The roof of the motorcoach was constructed of aluminum body panels riveted to the lateral and vertical members of the roof structure. **Figure 12** is a view of the roof looking aft from the rear roof exit area. The roof panels remained intact with no separation or crash related damage. The roof at the back of the motorcoach was compressed laterally on each side from tow straps used during the recovery efforts of the vehicle. The tow straps were attached to the right sill area and extended over the roof of the motorcoach. A diagonally oriented crease from a tow strap began at the midline of the roof aft of the rear

Figure 12: Roof damage from towing activities.

roof exit at the H-pillar area, and extended to the back right corner. The second tow strap was attached to the same sill location and routed laterally across the roof resulting in damage to both roof side rail areas. The right rear roof area was crushed laterally and the composite body panel was fractured.

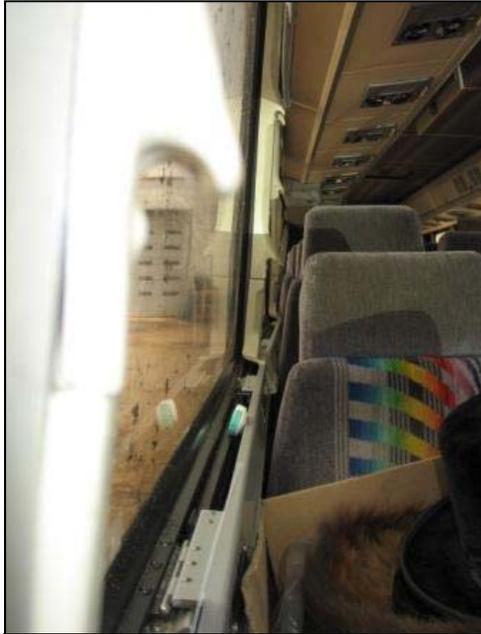
The interior damage to the motorcoach was limited to the lateral intrusions of the right side components. The following table provides a listing of the lateral intrusions at the specific pillar location and the vertical position of the intrusion as documented during the SCI inspection. **Figures 13 and 14** are longitudinal views of the lateral intrusions on the right side interior.

Interior Intrusion			
Pillar/ Position	Vertical Position of the Intruded Pillar/ Component	Intrusion Extent	Direction
A	Roofline	2.5 cm (1 in)	Lateral
A	Beltline	1 cm (0.5 in)	Lateral
B	Roofline	0 cm (0 in)	Lateral
C	Below overhead storage compartments	1 cm (0.5 in)	Lateral
C	Beltline	4 cm (1.5 in)	Lateral
D	Below overhead storage compartments	1 cm (0.5 in)	Lateral
D	Beltline	5 cm (2 in)	Lateral
D	Floor	2.5 cm (1 in)	Lateral
E	Below overhead storage compartments	0 cm (0 in)	Lateral
E	Beltline	1 cm (0.5 in)	Lateral
F	Below overhead storage compartments	0 cm (0 in)	Lateral
G	Below overhead storage compartments	2 cm (0.75 in)	Lateral
H	Below overhead storage compartments	4 cm (1.5 in)	Lateral
I	Below overhead storage compartments	7.5 cm (3 in)	Lateral

Figure 13: Rear view of the lateral intrusions along the right side of the interior.

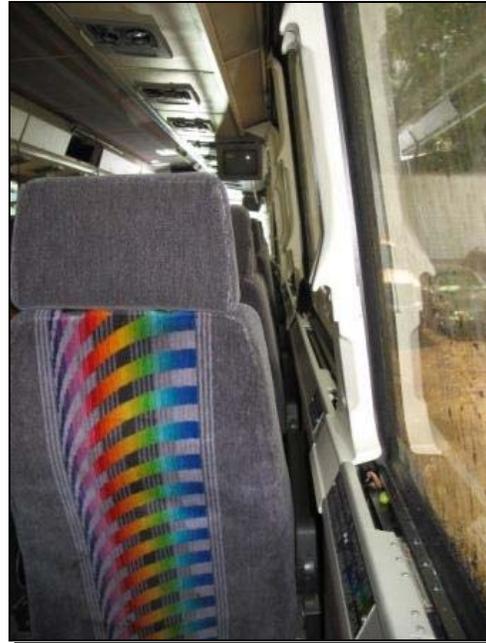
Figure 14: Interior view of the right lateral intrusions looking forward.

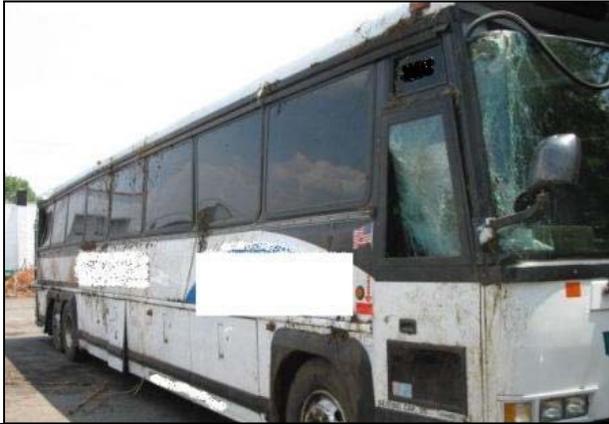
The right side glazing consisted of two right front door panels, eight large rectangular passenger compartment panels, and one narrow vented glazing panel for the restroom area. The forward seven rectangular passenger compartment panels measured 81 cm (32 in) in height by 132 cm (52 in) in width. The side glazing panels were manufactured by Laird Plastics in September 1996, were constructed of AS5 Almacoat 2000 single pane glass, and labeled DOT 393, M-505 AS5. The eighth (rear) glazing panel was 81 cm (32 in) in height by 102 cm (40 in) in width and was of the same material and construction as the forward seven panels. The vented restroom glazing was 81 cm (32 in) in height by 25 cm (10 in) in width. All of the large side glazing panels remained intact and were not damaged. The narrow restroom panel was disintegrated. **Figures 15 and 16** are views of the right side glazing status.

Figure 15: Rear view of the right side glazing status.

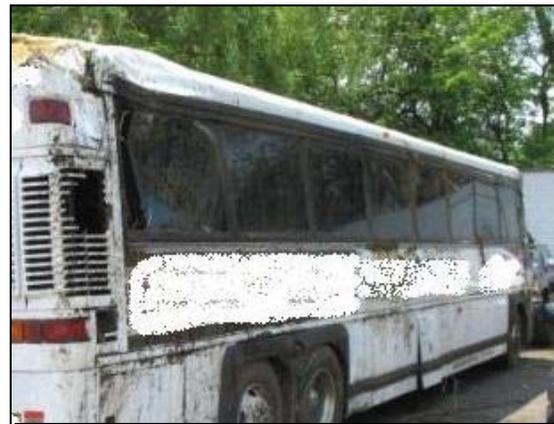
Figure 16: Forward view of the right glazing status.
