**CALSPAN ON-SITE MOTORCOACH ROLLOVER CRASH INVESTIGATION
SCI CASE NO.: CA10020**

VEHICLE: 1997 MCI MODEL 102-DL3 MOTORCOACH

LOCATION: NEW JERSEY

CRASH DATE: JUNE 2010

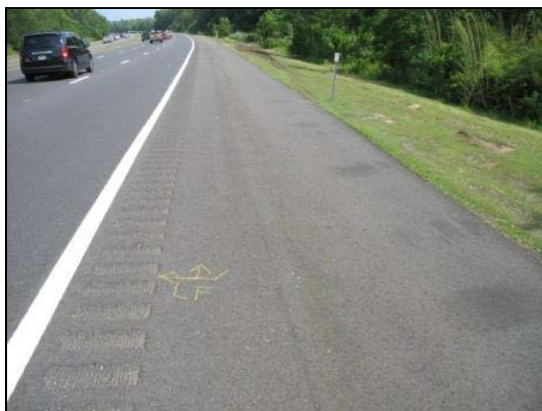
The left side tires began to mark on the asphalt road surface approximately 50 m (164 ft) south of the initial point of departure from the travel lane (**Figure 6**). The vehicle traveled another 25 m (82 ft) prior to exiting the outboard edge of the shoulder onto the grass roadside. The combination of the steering input, brake application, and negative slope of the roadside induced a counterclockwise (CCW) yaw to the motorcoach approximately 37 m (121 ft) from the point of departure from the shoulder. The vehicle's trajectory and travel distance was evidenced by deep tire marks in the soft grass surface. The motorcoach's center of gravity (CG) continued in a southerly direction as it yawed approximately 30 degrees CCW over a distance of 54 m (177 ft) to impact with the small diameter trees. **Figure 7** is an off-road view of the motorcoach's trajectory across the roadside.

Figure 6: Departure of the motorcoach onto the west shoulder.

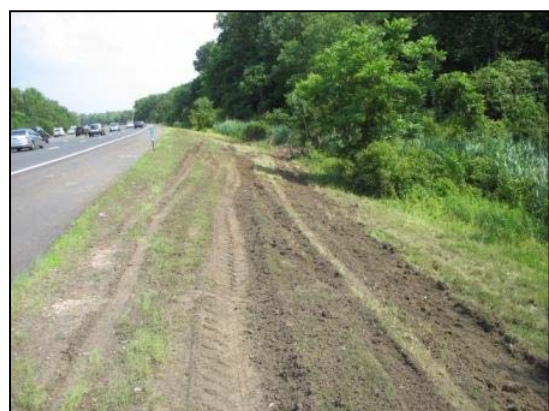
Figure 7: Trajectory and CCW yaw of the motorcoach across the roadside slope.

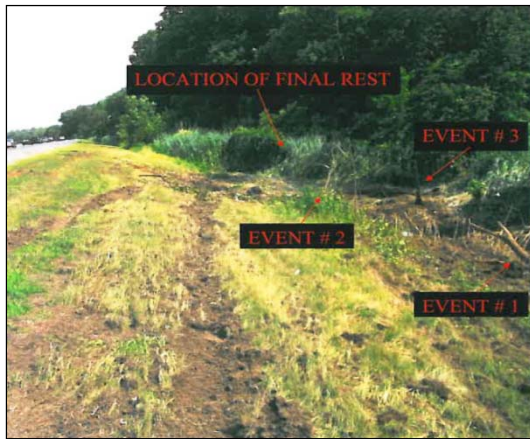
The right rear area of the motorcoach impacted, fractured, and uprooted the three trees (**Figure 8**) that were located at the bottom of the slope over a longitudinal distance of (5.5 m (18 ft)). The tree impacts did not alter the trajectory of the motorcoach as it continued to yaw approximately 10 degrees CCW. The right side tires furrowed deep into the soft dirt of the roadside which tripped the vehicle into a right side leading rollover event. The motorcoach yawed approximately 40 degrees CCW and traveled 171.5 m (563 ft) from the point of lane departure to the trip point. The motorcoach overturned into tall cattails and vegetation, which resulted in a soft rollover event (**Figure 9**). The vehicle completed one-quarter turn onto its right side and slid approximately 8 m (26 ft) to final rest.

Figure 8: Motorcoach crash site.

Damage to the back plane was limited to the separation of the bumper fascia at the right corner and lateral buckling of the fiberglass paneling at the upper right corner, near the roofline, as seen in **Figure 8**. The engine compartment doors and the access door to the top-mounted radiators and air conditioning condenser remained closed and operational post-crash.

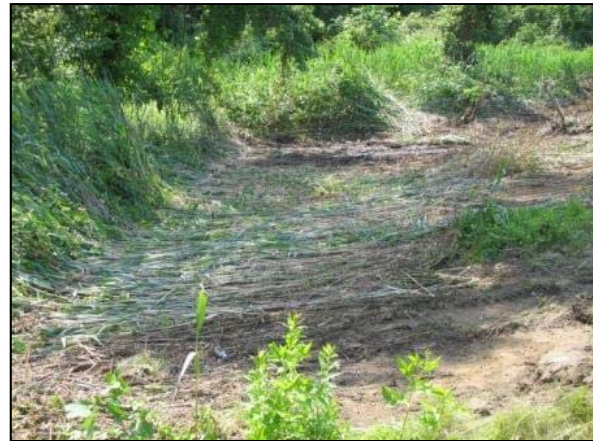
Figure 9: Rollover and final rest position of the motorcoach.

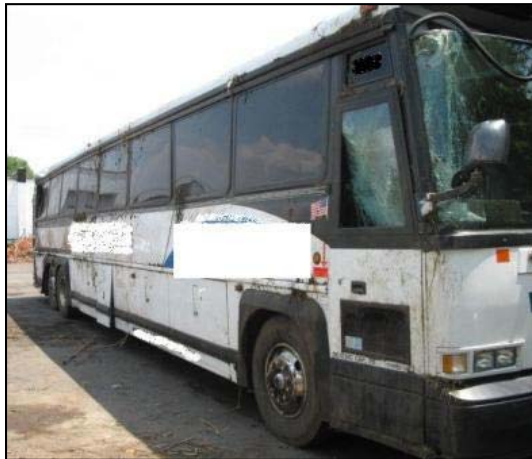
The exterior of the motorcoach sustained damage to its right, front, and back planes as a result of the side impacts and subsequent rollover. Minor severity damage was located on the right side (**Figure 10**) from the initial small diameter tree impacts. The damage consisted of isolated minor crush and inward buckling of the lower body-panel fascia, sill, and rear-axle area polymer fender flare. The tree impact damage was overlapped by the subsequent rollover; however, based on scene evidence and vehicle damage patterns, the three tree impacts were located as follows: (Event 1) immediately aft of the rear tag axle area with corresponding damage to the sill; (Event 2) immediately forward of the right drive axle with corresponding sill and lower body-paneling damage; (Event 3) within the right rear axle area with corresponding polymer fender flare damage above the tag axle location. The rollover damage was distributed across the entire right side of the motorcoach, with induced damage to the front and back planes.

Figure 10: View of right side plane rollover damage.

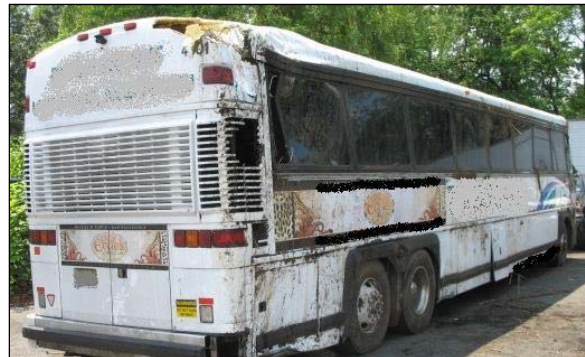
Figure 11: Right rear oblique view of the motorcoach.

The right side body damage consisted of isolated dents with mud and grass embedded into the body panels and glazing frames (**Figure 11**). The forward-hinged right front door remained closed, intact and operational, although the laminated upper glazing was fractured and partially separated from its gasket mount. The right A-pillar was displaced laterally 3 cm (1.25 in) at the juncture with the side rail. The luggage compartment doors and the doors to the mechanical compartments remained closed and operational post-crash. The side glazing panels at pillars B through I remained closed and intact, and were not fractured. The eighth glazing panel was fractured by a tree impact or recovery efforts. The integrity of the right side structure remained as there was no separation or displacement of the body panels. The lateral crush to the right roof side rail area between the right H and I pillar locations was due to tree and recovery efforts. The lateral crush was approximately 7 cm (3 in) based on interior intrusion dimensions.

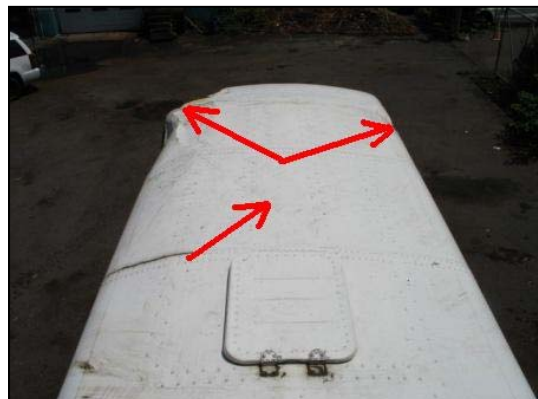
The roof of the motorcoach was constructed of aluminum body panels riveted to the lateral and vertical members of the roof structure. **Figure 12** is a view of the roof looking aft from the rear roof exit area. The roof panels remained intact with no separation or crash related damage. The roof at the back of the motorcoach was compressed laterally on each side from tow straps used during the recovery efforts of the vehicle. The tow straps were attached to the right sill area and extended over the roof of the motorcoach. A diagonally oriented crease from a tow strap began at the midline of the roof aft of the rear

Figure 12: Roof damage from towing activities.

roof exit at the H-pillar area, and extended to the back right corner. The second tow strap was attached to the same sill location and routed laterally across the roof resulting in damage to both roof side rail areas. The right rear roof area was crushed laterally and the composite body panel was fractured.

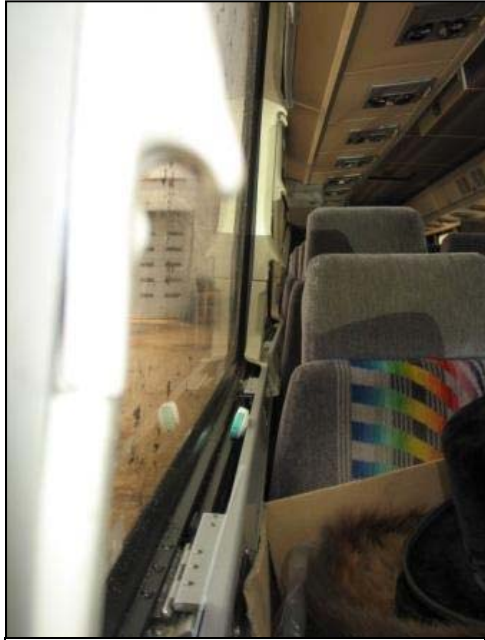
The interior damage to the motorcoach was limited to the lateral intrusions of the right side components. The following table provides a listing of the lateral intrusions at the specific pillar location and the vertical position of the intrusion as documented during the SCI inspection. **Figures 13 and 14** are longitudinal views of the lateral intrusions on the right side interior.

Interior Intrusion			
Pillar/ Position	Vertical Position of the Intruded Pillar/ Component	Intrusion Extent	Direction
A	Roofline	2.5 cm (1 in)	Lateral
A	Beltline	1 cm (0.5 in)	Lateral
B	Roofline	0 cm (0 in)	Lateral
C	Below overhead storage compartments	1 cm (0.5 in)	Lateral
C	Beltline	4 cm (1.5 in)	Lateral
D	Below overhead storage compartments	1 cm (0.5 in)	Lateral
D	Beltline	5 cm (2 in)	Lateral
D	Floor	2.5 cm (1 in)	Lateral
E	Below overhead storage compartments	0 cm (0 in)	Lateral
E	Beltline	1 cm (0.5 in)	Lateral
F	Below overhead storage compartments	0 cm (0 in)	Lateral
G	Below overhead storage compartments	2 cm (0.75 in)	Lateral
H	Below overhead storage compartments	4 cm (1.5 in)	Lateral
I	Below overhead storage compartments	7.5 cm (3 in)	Lateral

Figure 13: Rear view of the lateral intrusions along the right side of the interior.

Figure 14: Interior view of the right lateral intrusions looking forward.

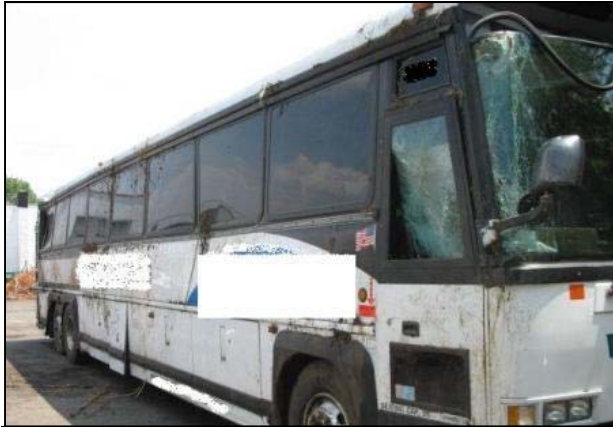
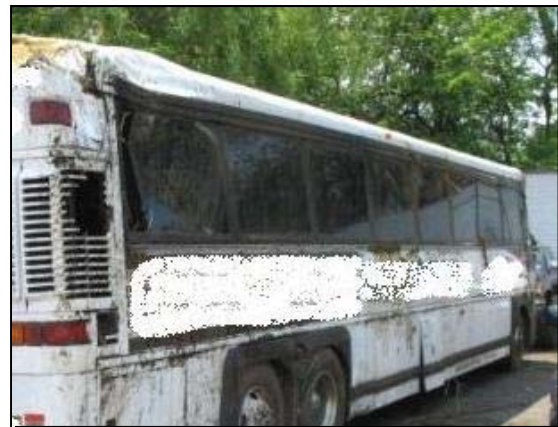
The right side glazing consisted of two right front door panels, eight large rectangular passenger compartment panels, and one narrow vented glazing panel for the restroom area. The forward seven rectangular passenger compartment panels measured 81 cm (32 in) in height by 132 cm (52 in) in width. The side glazing panels were manufactured by Laird Plastics in September 1996, were constructed of AS5 Almacoat 2000 single pane glass, and labeled DOT 393, M-505 AS5. The eighth (rear) glazing panel was 81 cm (32 in) in height by 102 cm (40 in) in width and was of the same material and construction as the forward seven panels. The vented restroom glazing was 81 cm (32 in) in height by 25 cm (10 in) in width. All of the large side glazing panels remained intact and were not damaged. The narrow restroom panel was disintegrated. **Figures 15 and 16** are views of the right side glazing status.

Figure 15: Rear view of the right side glazing status.

Figure 16: Forward view of the right glazing status.
