On-Site Rollover Investigation
Dynamic Science, Inc. (DSI), Case Number DS10020
2005 Toyota Tundra
Colorado
September 2010

1. Report No. DS10020	2. Government Accession No.		3. Recipient Catalog No.	
4. Title and Subtitle On-Site Rollover Investigation		5. Report Date April 12, 2011

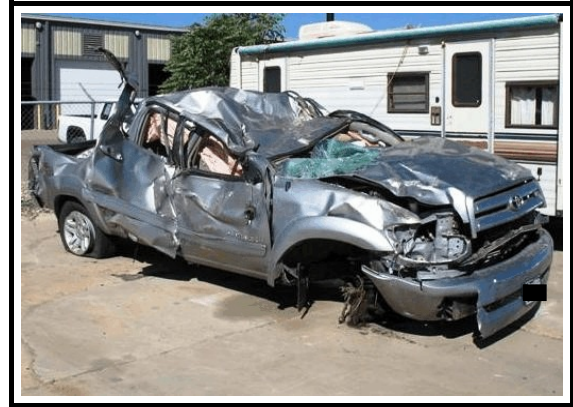
Figure 1. Subject vehicle, 2005 Toyota Tundra

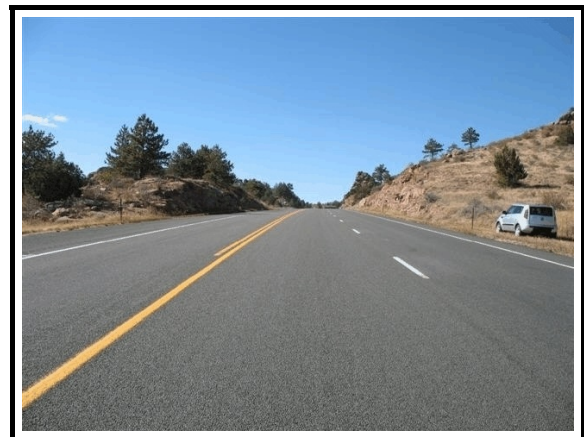
The crash occurred on a three-lane north/south state highway (**Figure 2**) at 0510 hours in September 2010. At the time of the crash the weather was clear and the roadway was dry. The temperature at the nearest reporting station was 10.8° C (51.5° F) and winds were calm. The roadway consisted of two northbound lanes and one southbound lane separated by a double solid/dashed yellow painted stripe. The two northbound lanes measured 3.5 m (11.5 ft) and 3.7

Figure 2. Crash site showing northbound approach of subject vehicle

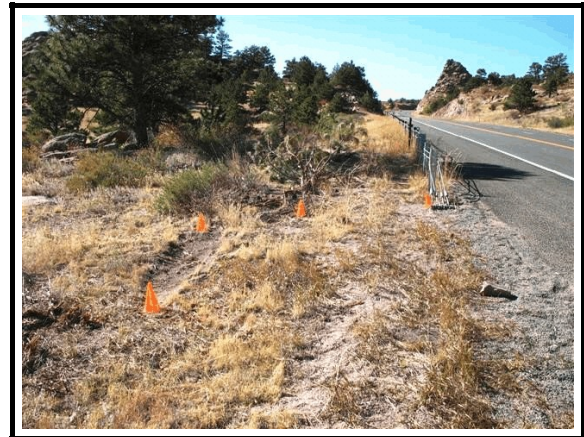
Figure 3. Crash site showing locations of tire furrow (left), tree impact (center) and cable rail barrier impact (right)

During the first quarter-turn, the vehicle's right side impacted a tree (Event 3) and a cable rail barrier (Event 4) (**Figure 3**). The tree measured 23.0 cm (9.0 in) in diameter and it was fractured at 2.3 m (7.5 ft) above grade. Additionally, the impact uprooted the tree trunk. Damage to the cable rail barrier was not documented because it had been repaired prior to the scene inspection. The vehicle continued rolling for an additional 21.7 m (71.2 ft) and impacted a second tree measuring 18.0 cm (7.0 in) in diameter (Event 5). The vehicle continued to overturn as it traveled down a descending embankment. It came to rest on its wheels and facing south at the base of the embankment. From the trip point to final rest the vehicle rolled a total of twelve quarter-turns and traveled 47.0 m (154.0 ft). During the fifth quarter-turn, the rear right-seated occupant was ejected from the vehicle through the right side rear door, which came open during the crash. The occupant came to rest on the ground

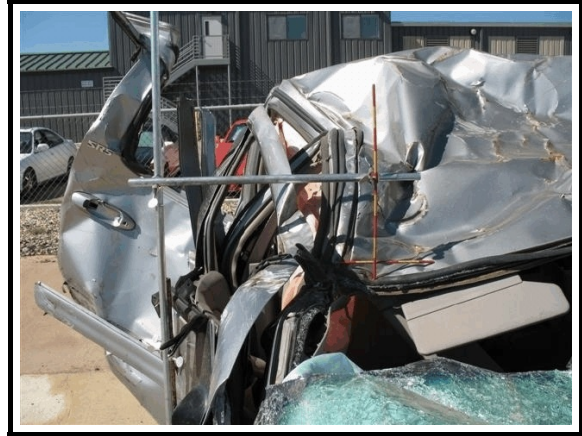
Maximum vertical crush to the greenhouse was located on the right windshield header at 10.0 cm (3.9 in) inboard of the right roof side rail and measured 42.0 cm (16.5 in) (**Figure 4**). The CDC for Event 2 was 00TDDO4.

Figure 4. Maximum vertical crush to greenhouse documentation

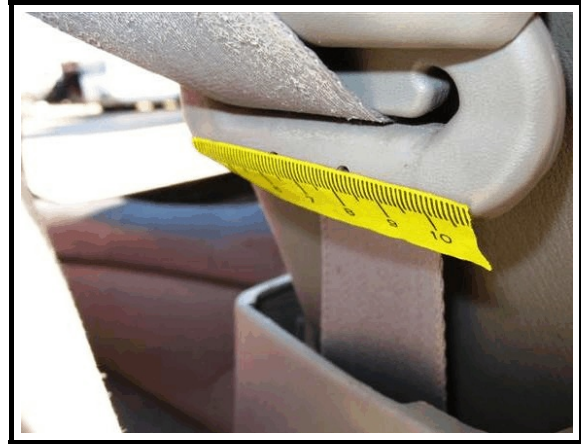
a 6.0 cm (2.4 in) segment beginning 106.0 cm (41.7 in) above the stop button and the D-ring showed occupant loading marks (**Figure 5**). Based on the vehicle inspection the front right safety belt was used by this occupant.

Figure 5. Front right occupant's safety belt webbing and D-ring showing evidence of loading

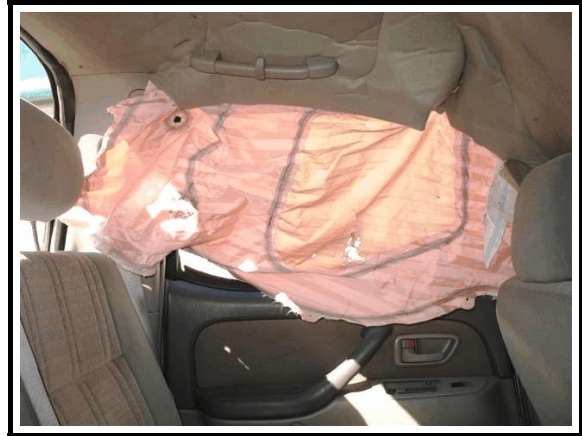
The second row sector of the IC air bag covered the side glass except for a 3.0 x 8.0 cm (1.2 x 3.1 in) section in the rear lower corner at the C-pillar. The air bag was configured with two tethers at the rearward aspect. The upper tether was located at the roof side rail and the lower tether was located 15.0 cm (5.9 in) above the bottom of the window frame. The tethers were spaced 26.0 cm (10.2 in) apart in their post-inflated state and were fixed in place. The lower tether prevented the left side IC air bag from providing full coverage of the side glass and upper door panel (Figure 7). The air bag had holes and abrasions measuring 10.0 x 15.0 cm (3.9 x 5.9 in) located in the outboard panel that were caused by ground contact during the rollover.

Figure 6. Left IC air bag second row sector

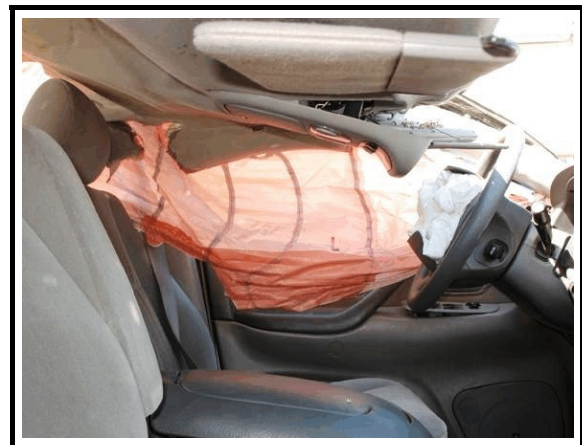
The left IC air bag deployed from the left roof side rail above the first (Figure 6) and second rows. The IC air bag measured 180.0 cm (70.9 in) in length and 52.0 cm (20.5 in) in overall height. At the A-pillar, B-pillar, and C-pillar, the bottom edge of the air bag curved upward where measured 40.0 cm (15.7 in) in length. The front row sector of the IC air bag completely covered the side glass and it extended 5.0 cm (2.0 in) below the bottom edge of the side glass.

Figure 7. Left IC air bag first row sector

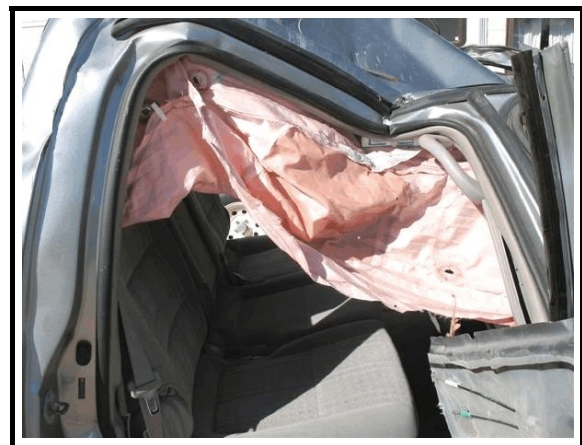
The right IC air bag deployed from the right roof side rail above the front and second rows. A blood transfer on the air bag was probably deposited by the front right occupant. In its post-inflated state, the two rearward tethers of the right IC air bag were positioned close together at the roof side rail (Figure 8) preventing the air bag's rearward sector from extending vertically to the bottom of the

Figure 8. Right IC air bag second row sector

side glass. The air bag's lower sector overlapped the upper sector yielding a length of coverage measuring 32.0 cm (12.6 in) versus 40.0 cm (15.7 in) for the left IC air bag. This configuration revealed an uncovered section of the window opening measuring approximately 20.0 cm (7.9 in) in height and 60.0 cm (23.6 in) length. Additionally, the lower tether had a 5.0 cm (2.0 in) tear where it was connected to the air bag. Efforts to move the tether lower down on the C-pillar and extend the air bag vertically were unsuccessful. Since the right rear door opened during the rollover, the right IC air bag's lack of medium coverage did not contribute to the ejection of the occupant.
