ON-SITE OFFICE OF DEFECTS INVESTIGATION POTENTIAL UNINTENDED ACCELERATION INVESTIGATION

CASE NUMBER - IN10021
LOCATION - NEW MEXICO
VEHICLE - 2009 TOYOTA MATRIX S
CRASH DATE - March 2010

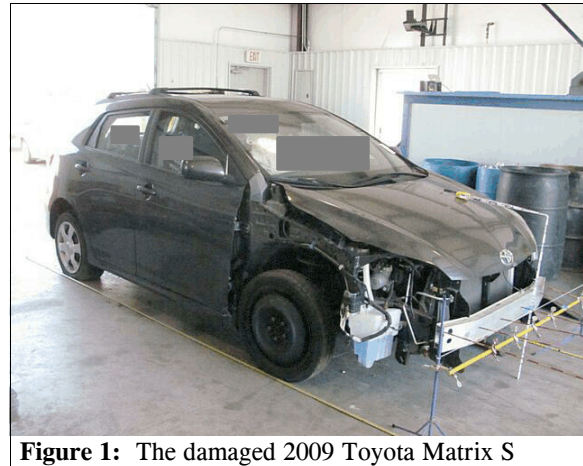
Figure 1: The damaged 2009 Toyota Matrix S

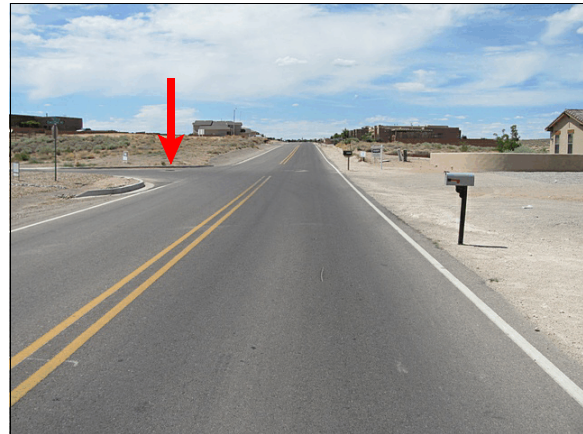
Figure 2: Approach of the Toyota to the intersection; arrow shows location of impact with 20 cm (7.9 in) high concrete curb

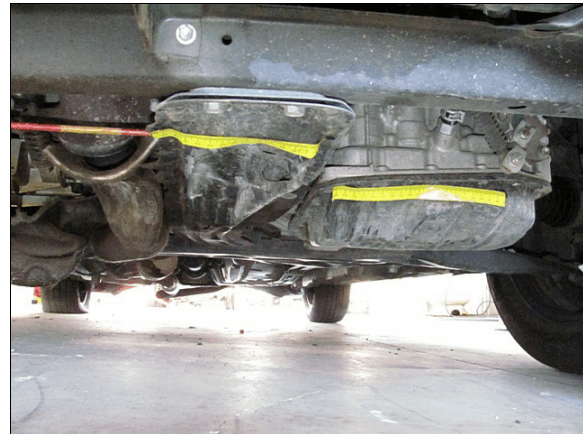
Figure 3: Yellow tape and colored rod show area of damage on the front undercarriage and bottom of the engine

Exterior Damage Event 1: The front plane impact with the curb involved the front undercarriage and the bottom of the engine. The bumper was not engaged during this impact. The direct damage on the undercarriage began 26 cm (10.2 in) left of the vehicle's centerline and extended to the right 102 cm (40.1 in). The impact on the undercarriage slightly buckled the right stub frame member and the induced damaged displaced the front right corner of the bumper bar 3 cm (1.2 in) rearward.

Damage Classification Event 1: The Collision Deformation Classification (CDC) for the undercarriage impact with the curb was 01UFDW1 (20 degrees). The WinSMASH program could not be used to calculate a Delta V for this impact since an impact on the undercarriage is out of scope for the program. The vehicle's EDR recorded the maximum velocity change as 8.8 mph (14.2 km/h) occurring at 80 ms following the impact trigger. Based on the damage on the undercarriage, the severity of the damage was moderate.

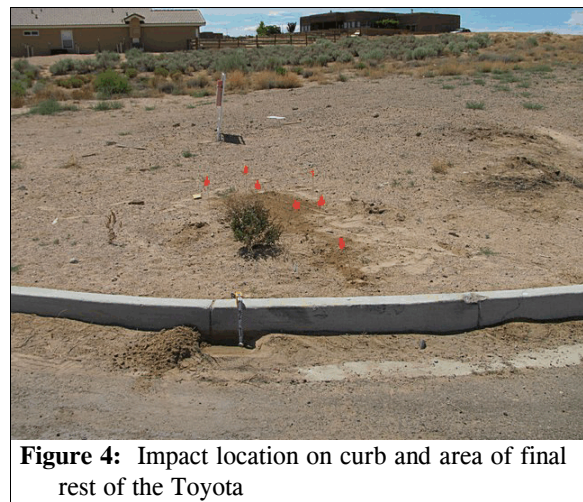
Crash: The undercarriage and bottom of the engine (Figure 3) located immediately behind the bottom of the radiator frame impacted the concrete curb (Figure 4, event 1). The vehicle was rotating counterclockwise at the moment of impact, which produced a force direction on the vehicle within the 1 o'clock sector. The impact force was sufficient to trigger deployment of the driver's and front right passenger's frontal air bags. The front wheels also impacted the curb as the vehicle traveled over the curb. The right front wheel rim was dented (Figure 5, event 2) and the wheel was displaced rearward 10 cm (3.9 in). The left front wheel was undamaged. The vehicle came to final rest heading southwest with the front half of the vehicle off the roadway.

Figure 4: Impact location on curb and area of final rest of the Toyota

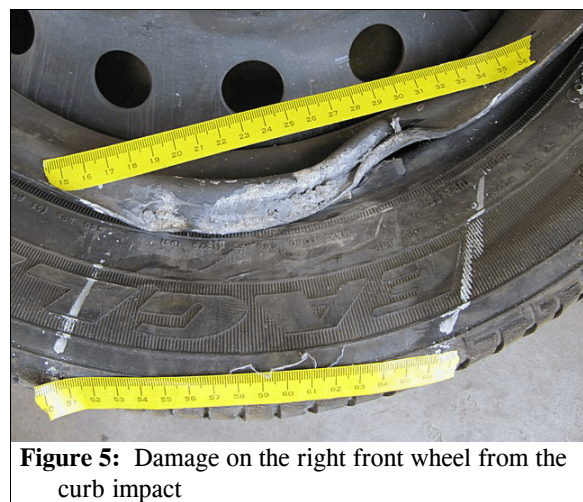
Figure 5: Damage on the right front wheel from the curb impact

Exterior Damage Event 2: The right front wheel impact with the curb created a dent on the outside of the rim 19 cm (7.5 in) in length. Concrete residue transfer was on the rim. The tire bead was also separated, which deflated the tire. The impact displaced the right front wheel rearward 10 cm (3.9 in).

Damage Classification Event 2: The CDC for the right front wheel impact with the curb was 01FRWN3 (20 degrees). The WinSMASH program could not be used on this impact since an impact with a wheel is out of scope for the program. Based on the displacement of the wheel, the severity of the damage was moderate.

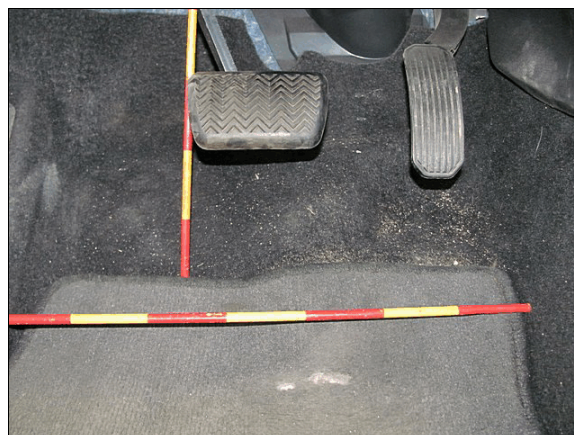
The initial status of the CTS accelerator pedal, brake pedal, and Toyota OEM floor mat at the time of the SCI inspection is shown in **Figure 6**. The driver's floor mat was secured by the two floor mounted attachments located immediately in front of the driver's seat tracks. The product codes on the back of the driver's floor mat (**Figure 7**) were PT206-02090-XX, PT206-12090-XX, 58510-YY250-XX, 58510-YY190-XX, PT206-02091-XX, PT206-12091-XX, 58510-YY010-XX. The distance from the front of the floor mat to the bottom end of the accelerator pedal was 7 cm (2.8 in). The lateral distance between the accelerator pedal and the brake pedal was 6 cm (2.4 in). The accelerator pedal was 4 cm (1.6 in) in width and 13 cm (5.1 in) in length. The brake pedal was 10 cm (3.9 in) in width at the top, 8.5 cm (3.3 in) in width at the bottom, and 6 cm (2.4 in) in length. The lateral distance between the centerline of the driver's seat and the right edge of the brake pedal was 7 cm (2.8 in). The longitudinal distance (i.e., offset) from the face of the brake pedal to the face of the accelerator pedal was 2.5 cm (1.0 in). The accelerator pedal functioned smoothly and did not bind. **Figure 8** shows the CTS accelerator mechanism housing. The product numbers on the accelerator housing were 78110-07011, 08149A1A X, and 49501032080 LHD.

Figure 6: The initial status of the brake pedal, accelerator pedal, and Toyota floor mat at the SCI inspection; please note that the vertical scale does not represent the centerline of the driver's seat

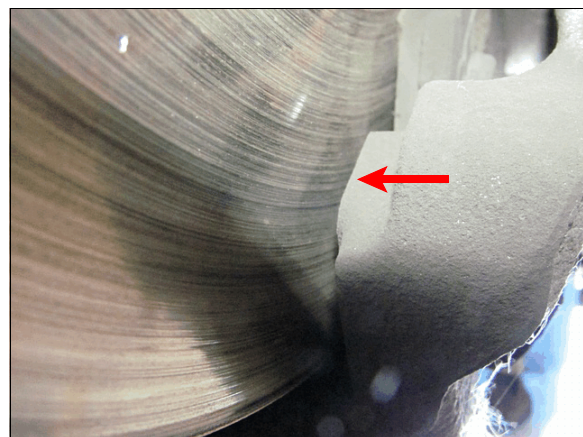
The right front and right rear wheels were removed and the brake rotors and brake pads were inspected. The right front and right rear brake rotors and brake pads showed no discernable evidence of overheating (**Figures 9 and 10**). The right rear brake rotor was slightly rusted. The emergency brake was found in the fully applied position at the SCI inspection. The photographs of the brake pads and brake rotors were taken with the emergency brake in the fully applied position.

Figure 9: The outside bottom surface of the right front brake rotor and the bottom portion of the brake pad (arrow); the photo was taken with the emergency brake in the fully applied position

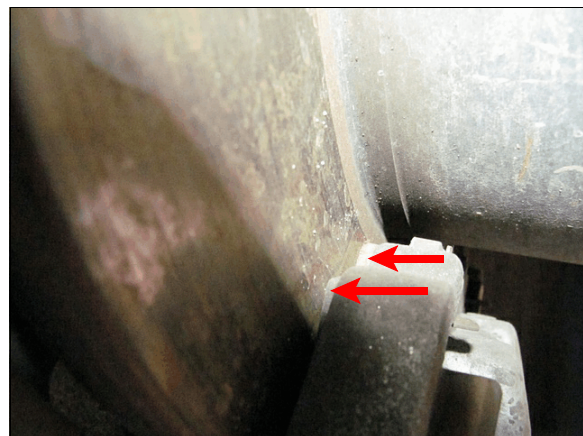
Figure 10: The outside bottom surface of the right rear brake rotor; arrows show the bottom portion of the brake pad; the photo was taken with the emergency brake in the fully applied position
