TRANSPORTATION RESEARCH CENTER

ON-SITE LOW SPEED VEHICLE INVESTIGATION

CASE NUMBER - IN10026
LOCATION - Michigan
VEHICLE - 2002 FORD TH!NK NEIGHBOR
CRASH DATE - April 2010

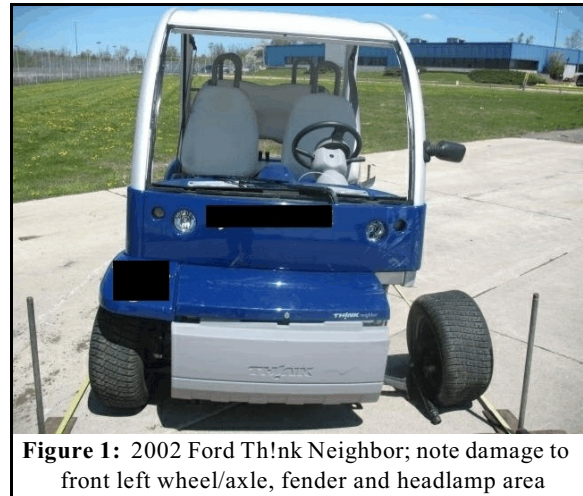
Figure 1: 2002 Ford Th!nk Neighbor; note damage to front left wheel/axle, fender and headlamp area

Exterior Damage: The Ford sustained direct contact at the front left area (**Figures 1, 4 and 5**) measured as 24 cm (9.4 in) wide, beginning at the front left corner. The impact caused the left front fender to break away completely (**Figures 6 and 8**). The front left axle and suspension were broken, the wheel rim was deformed and the entire wheel/tire assembly broke off (**Figures 6 and 7**). The wheelbase was shortened by 2 cm (0.8 inches) on the left. The pole engaged the headlight/turn

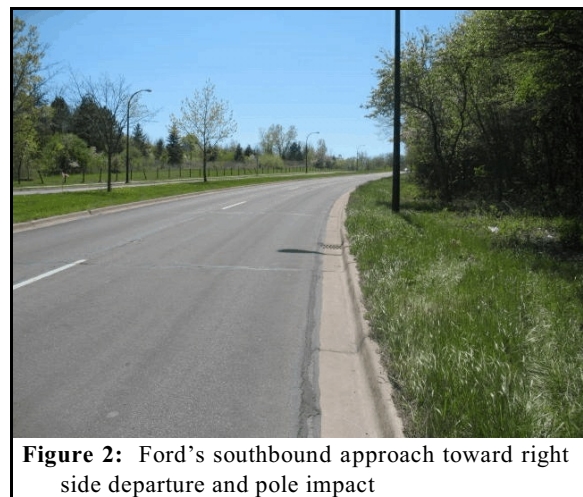
Figure 2: Ford's southbound approach toward right side departure and pole impact

Pre-Crash: The Ford was traveling southward in the outside southbound lane (Figure 2) and was negotiating the curve to the right. The Ford's driver became distracted by her dog, which was in the back seat. As a result of the driver's distraction, the Ford departed the roadway to the right (west). The driver did not attempt any avoidance maneuvers.

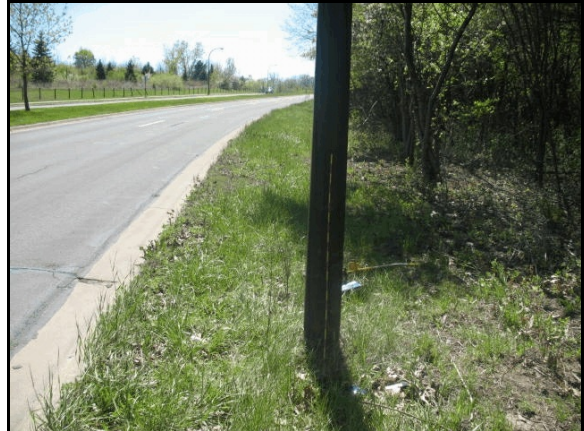
Crash: The Ford mounted the curb, traveled along the roadside a short distance and its front left corner area impacted a non-breakaway luminaire support pole that was located approximately 1 meter (3.3 feet) west of the curb (Figure 3). The Ford rotated approximately 5 degrees counterclockwise and came to rest against the pole.

Figure 3: Steel luminaire support pole; hexagonal cross-section, approx. 18 cm (7 inches) diameter

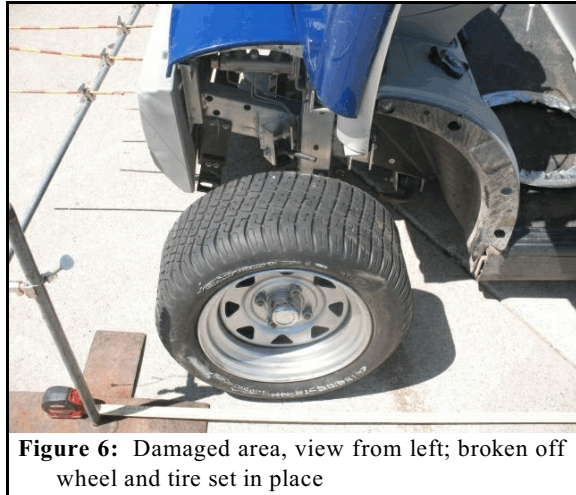
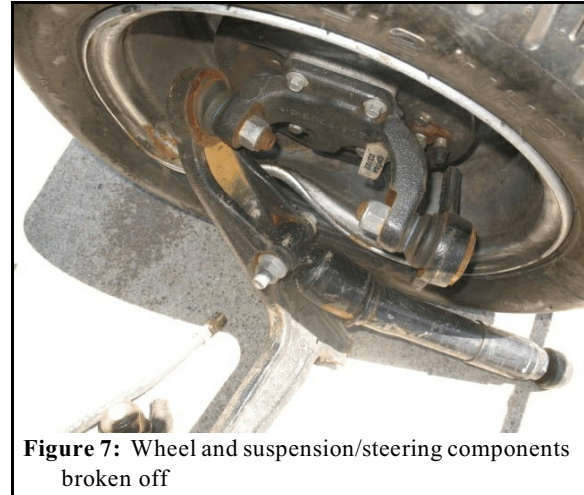
signal area. According to the driver, the windshield had a few linear cracks on the left side (the windshield glazing was removed prior to the vehicle inspection). The windshield was the only glazing panel installed in this vehicle. A crush profile was measured but it is not useable because the plastic fender components broke away entirely.

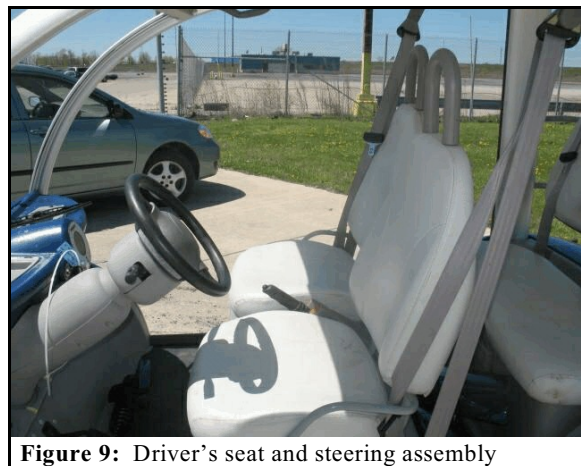
Figure 9: Driver's seat and steering assembly

The Ford's driver (53-year-old female, 152 cm [60 inches], 52 kg [115 pounds]) was restrained by the lap-and-shoulder safety belt. Her seat track was adjusted between the middle and forward most position and her seat back was not adjustable (**Figure 9**). She was turned to her right, attending to her dog in the back seat.
