ON-SITE CHILD RESTRAINT SYSTEM INVESTIGATION

CASE NUMBER - IN10027
LOCATION - MICHIGAN
VEHICLE - 1997 DODGE INTREPID
CRASH DATE - July 2010

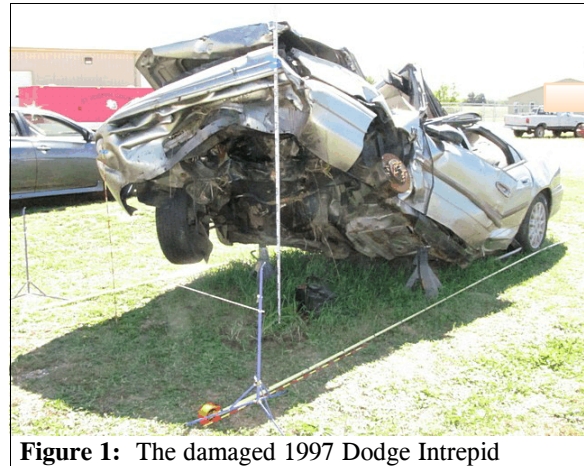
Figure 1: The damaged 1997 Dodge Intrepid

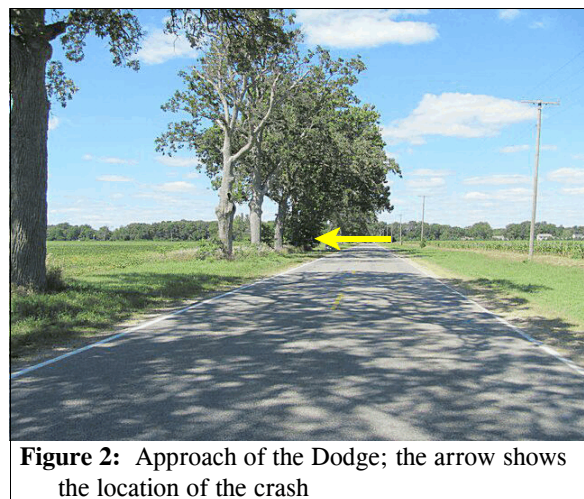
Figure 2: Approach of the Dodge; the arrow shows the location of the crash

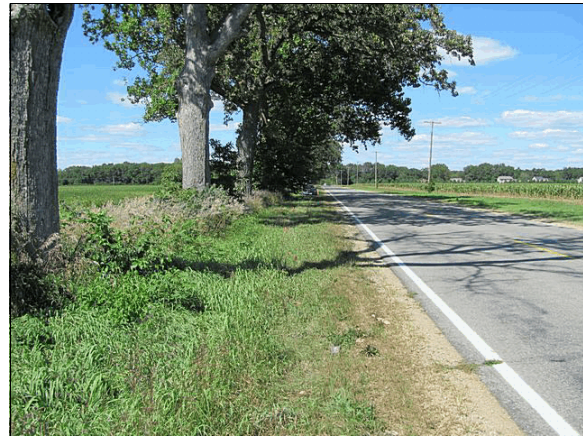
Crash: The vehicle departed the west side of the roadway (**Figure 3**) and traveled approximately 39 m (127.9 ft) through the grass where the left portion of the front plane impacted and broke a 6 cm (2.4 in) diameter sapling (event 1). The vehicle traveled an additional 5.8 m (19 ft) and the front plane (**Figure 4**) impacted a 130 cm (51.2 in) diameter Sycamore tree (**Figure 5**). During this impact, the vehicle rode up the base of the tree and there was significant front undercarriage engagement with tree, which shifted the front end structure upward (**Figure 5**). The vehicle deflected off the tree and rolled over right side leading three quarter turns. During the rollover, the second row left passenger was partially ejected out of the partially open left rear window glazing. His head and right arm were entrapped between the ground and the glazing causing a fatal head injury. The second row right passenger was completely displaced out of his CRS during the crash. The vehicle came to final rest on the left side plane heading north located 4.9 m (16.1 ft) north and 5.3 m (17.4 ft) east of the tree.

Figure 3: Approach of the Dodge to impact

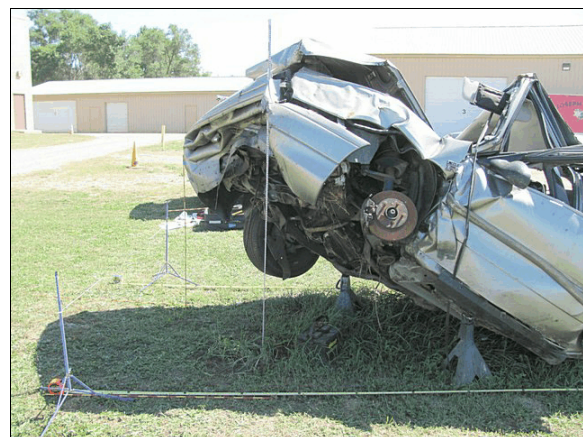
Figure 4: Left side view of the damage to the front plane of the Dodge from the impact with the 130 cm (51.2 in) diameter tree

The rollover of the Dodge was initiated by the impact with the 130 cm (51.2 in) diameter tree. As the left front wheel rode up the base of the tree, the front plane and front undercarriage engaged the tree and the vehicle was deflected upward and to the right, which initiated a right side leading rollover. The vehicle deflected off the tree becoming airborne in a northeast direction and rolled over three quarter turns touching down to final rest on its left side. The vehicle traversed a distance of approximately 10 m (32.8 ft) during the rollover.

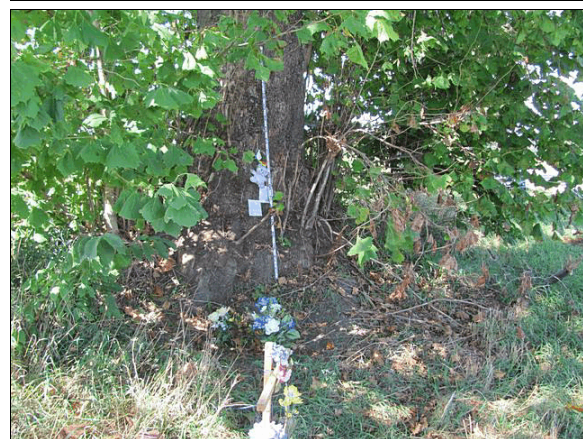
Figure 5: The impacted Sycamore tree

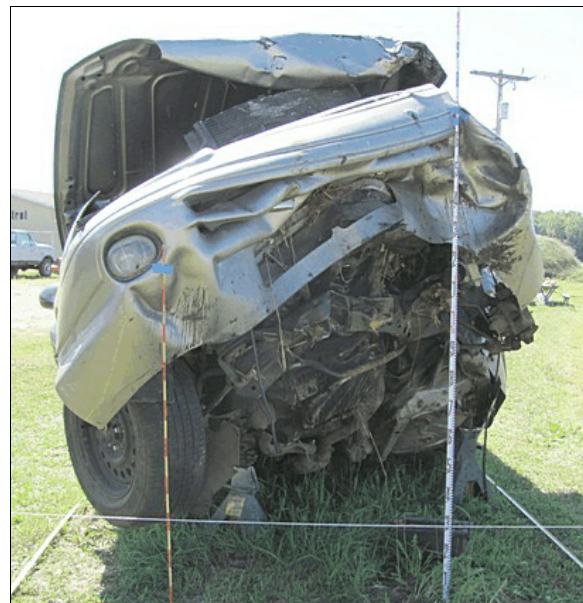
Exterior Damage Event 2: The Dodge sustained damage on the front bumper, hood, and the front undercarriage (**Figure 6**) from the impact with the 130 cm (51.1 in) diameter tree. The damage on the bumper began at the front left bumper corner and extended 93 cm (36.6 in) across the bumper. Crush measurements were taken on the front bumper and the maximum residual crush was 94 cm (37 in) occurring at C₁. The damage on the undercarriage began on the bottom of the bumper at the front left corner and extended 132 cm (52 in) to the right. The tree directly engaged the bottom of the engine and front frame members and deposits of tree bark and wood extended rearward

Figure 6: Damage on the front plane and undercarriage of the Dodge from the impact with the 130 cm (51.2 in) tree; scale on right in 10ths of meter; each increment on left scale is 5 cm (2 in)

approximately 201 cm (79.1). The end structure of the vehicle was shifted vertically upward 107 cm (42.2 in). The table below presents the crush that was measured on the bumper.

Damage Classification Event 2: The CDC for the impact with the 130 cm (51.1 in) diameter tree was 20FYEW4. The non-horizontal direction of force was incremented for the vertical shift of the front end structure. The WinSMASH program could not be used on this impact since an impact resulting in a non-horizontal direction of force is out of scope for the program. Based on the extent of the damage on the front plane and undercarriage, the severity of the damage was severe.

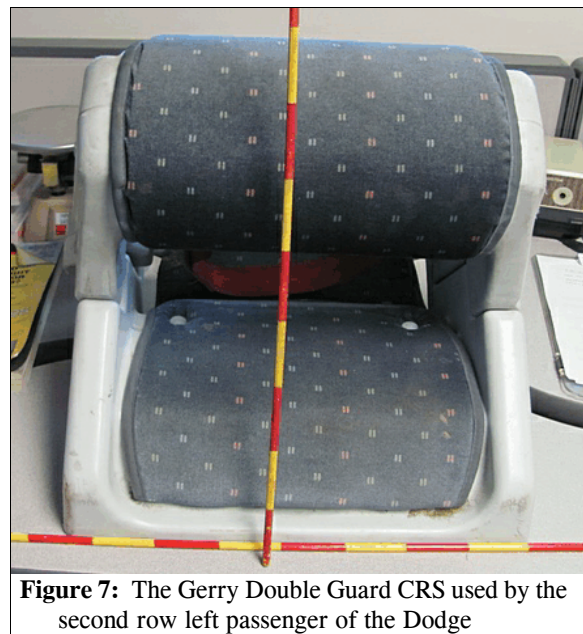
The second row left passenger of the Dodge [4-year-old male, 117 cm (46 in) and 21 kg (47 lbs)] was seated in a Gerry Double Guard booster CRS (**Figure 7**). The CRS had no label identifying the model number or year of manufacture. This model CRS was manufactured between 1990 and 1995. The CRS was equipped with a removable shield and had an integral lap belt within the shield assembly (**Figure 8**). A safety belt path was located on the seat bottom for securing the CRS with a vehicle's safety belt when the CRS was used with the shield. There was no label present that listed the height and weight restrictions for the CRS. A CRS of this type is typically intended for use by children over 1-year-old who weigh between 9 kg and 18 kg (20 and 40 lbs). The CRS was designed to convert to a belt-positioning booster by removing the shield. When used as a belt-positioning booster, the CRS is intended for children who weigh 18 kg (40 pounds) or more.

Figure 7: The Gerry Double Guard CRS used by the second row left passenger of the Dodge

Inspection of the CRS revealed no crash related damage. The shield and integral lap belt assembly functioned normally. The latch on the hinge side of the removable shield was jammed and the shield could not be removed from the CRS.

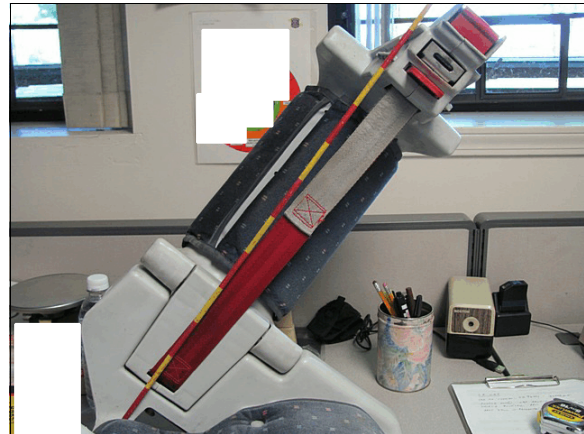
Figure 8: The shield and lap belt on the Gerry Double Guard CRS

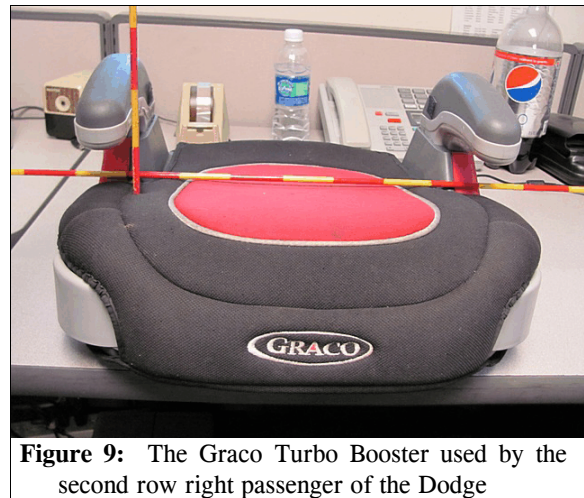
Figure 9: The Graco Turbo Booster used by the second row right passenger of the Dodge

The second row right passenger [5-year-old male, 122 cm (48 in) and 22 kg (49 lbs)] was seated in a Graco Turbo Booster belt-positioning booster CRS (**Figure 9**). The CRS was manufactured on June 22, 2007 and the model number was 8491QNY. The CRS was designed to be used with or without a back support. The back support was not in use at the time of the crash and was not with the CRS. When used without the back support, the CRS was designed for children whose height was 102 to 145 cm (40 to 57 in). When used with the back support, the CRS was designed for children whose height was 97 cm to 145 cm (38 to 57 in).

The CRS was constructed of plastic and was equipped with height adjustable arm rests. It had a 1 cm (0.4 in) thick cushion on the seat. The CRS sustained no damage during this crash. The second row right passenger was seated in the CRS at the time of the crash. While, the safety belt was in use, it is not known how it was positioned on the passenger.
