## ON-SITE HEAVY TRUCK UNDERRIDE INVESTIGATION

CASE NUMBER - IN10030

VEHICLE - 2009 WABASH NATIONAL SEMI-TRAILER

CRASH DATE - August 2010

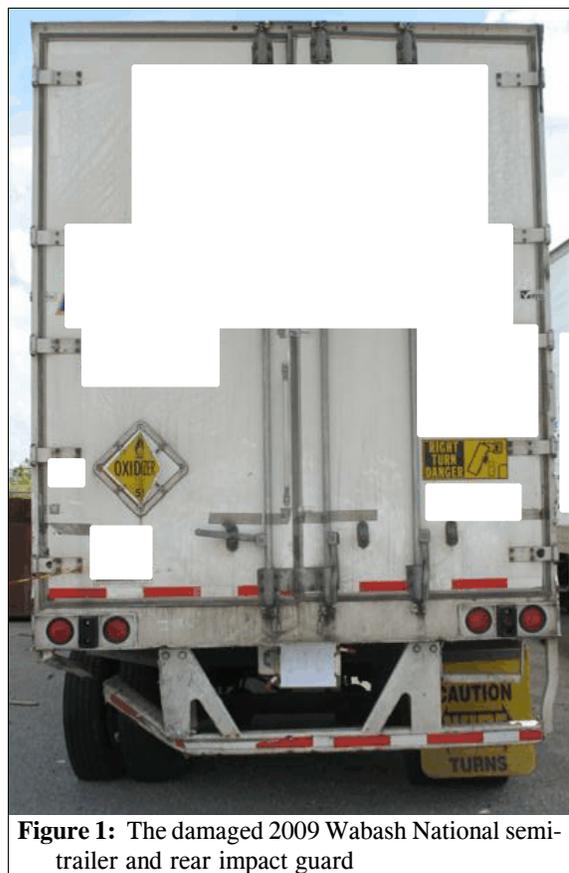
**Figure 1:** The damaged 2009 Wabash National semi-trailer and rear impact guard

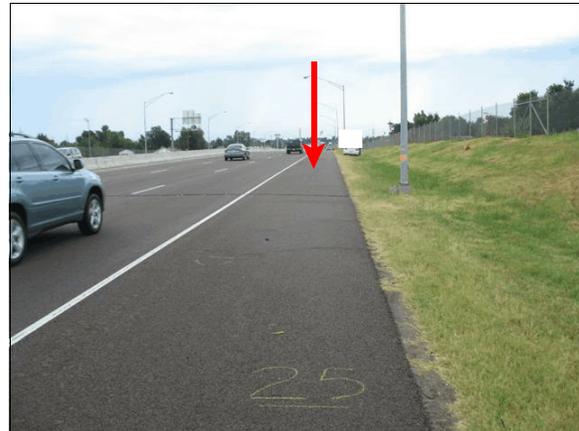
**Figure 2:** Approach to the area of impact (arrow)

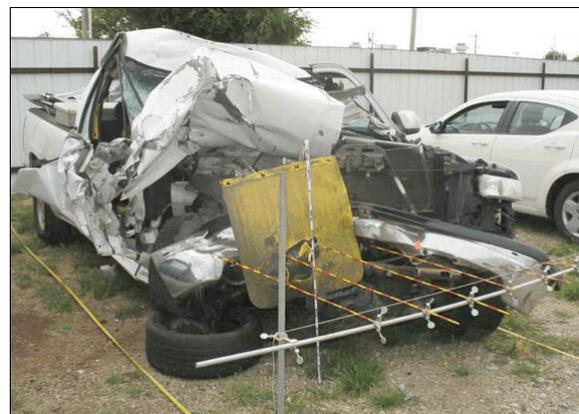
**Crash:** The front plane of the Chevrolet (**Figure 3**) impacted the impact guard (event 1, **Figure 4**) and underrode the back of the semi-trailer. The impact guard engagement on the Chevrolet began at the front right bumper corner and the direct damage extended 102 cm (40.2 in) across the bumper. The direct damage on the impact guard began at the left corner and extended 88 cm (62.9 in) to the right. The Chevrolet penetrated 112 cm (44 in) under the semi-trailer contacting the mud flap, mud flap bracket, and left rear tires. The mud flap was entrapped on the front right portion of the Chevrolet's bumper (**Figure 3**). The Chevrolet rotated clockwise approximately 45 degrees to final rest and remained under the semi-trailer heading southeast.

**Figure 3:** The damage on the front plane of the Chevrolet from the impact with the back plane of the semi-trailer

**Exterior Damage:** The direct damage on the front plane of the Chevrolet involved the front bumper, right head lamp/turn signal assembly, hood, right fender, and right front wheel. The direct damage began at the front right bumper corner and extended 102 cm (40.2 in) along the bumper. Crush measurements were taken at the bumper level and the maximum residual crush was 87 cm (34.3 in) occurring at C<sub>6</sub> (**Figure 6**). The right side wheelbase was reduced 58 cm (22.8 in), while the left side wheelbase was extended 17 cm (6.7 in). The induced damage involved the left portion of the front bumper, roof, windshield, both A-pillars, and right side doors.

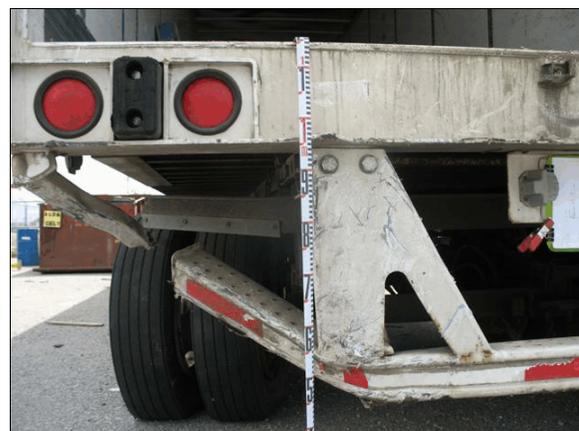
**Figure 4:** Direct damage on the impact guard and Wabash semi-trailer from the impact by the Chevrolet

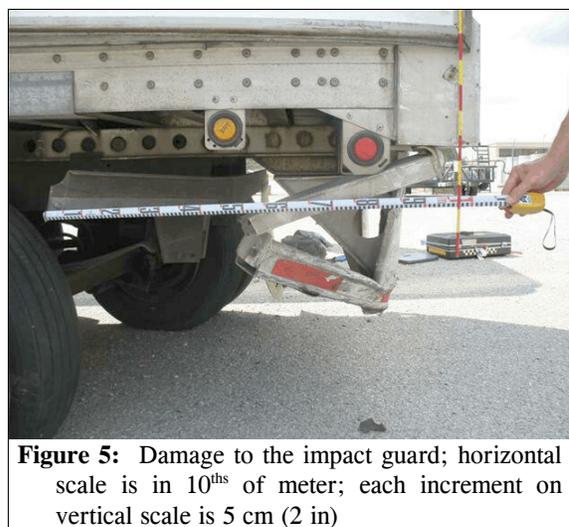
The remains of a possible identification placard was present on the impact guard. Only the dates 2004 and 2005 were readable. The impact guard was constructed of 64 mm (0.25 in) thick welded steel plate. The two primary vertical supports were bolted onto the center frame rails on the floor of the semi-trailer. The two outer vertical supports of the impact guard were bolted onto the back cross-member of the semi-trailer. The crash displaced the left corner of the impact

guard's horizontal member (**Figure 5**) forward 44 cm (17.3 in). The left outer vertical support of the impact guard was displaced forward 52 cm (20.5 in) and was broken off the horizontal member. The undeformed width of the horizontal member was 240 cm (94.5 in), which excluded the 5 cm (2 in) width of the vertical supports welded on each end of the horizontal member. The width of the semi-trailer was 259 cm (102 in). The lateral distance from the projected side of the semitrailer to the undeformed right end of the horizontal member, which excluded the 5 cm (2 in) width of the vertical support was 9.5 cm (3.7 in). The distance from the bottom of the horizontal member to the ground was 42 cm (16.5 in). The left rear tires of the semi-trailer were displaced forward 44 cm (17.3 in) by the impact. The distance from the back of the semi-trailer to the rear tires in their undamaged position was 68 cm (26.8 in). **Figure 7** on page 5 of this report presents the measurements of the underride guard and positions of the damaged rear wheels of the semi-trailer.

**Figure 5:** Damage to the impact guard; horizontal scale is in 10<sup>th</sup>s of meter; each increment on vertical scale is 5 cm (2 in)

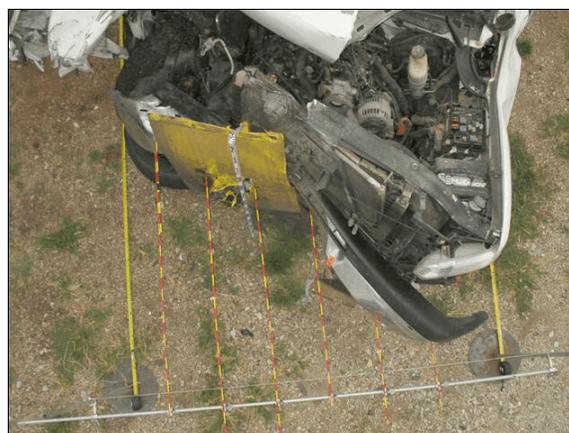
Units	Event	Direct Damage		Field L	C <sub>1</sub>	C <sub>2</sub>	C <sub>3</sub>	C <sub>4</sub>	C <sub>5</sub>	C <sub>6</sub>	Direct	Field L
		Width CDC	Max Crush								±D	±D
cm	1	102	87	120	0	10	67	80	85	87	24	0
in		40.2	34.3	47.2	0.0	3.9	26.4	31.5	33.5	34.3	9.4	0.0

**Damage Classification:** The Collision Deformation Classification for the Chevrolet was 12FZEW4 (0 degrees). The WinSMASH program was used to calculate a Barrier Equivalent Speed (BES) based on the frontal crush. The calculated BES was 68.1 km/h (42.3 mph). The WinSMASH program could not be used to calculate a Delta V for the Chevrolet since an impact with a heavy truck is out of scope for the program. The vehicle’s EDR reported a maximum velocity change (Delta V) of -55.9 km/h (-34.74 mph) occurring at 110 ms after AE.

**Figure 6:** The crush on the front of the Chevrolet; the baseline was set 11 cm (4.3 in) longer than the vehicle’s overall length to clear the displaced front left bumper corner
