**CALSPAN ON-SITE MOTORCOACH FIRE INVESTIGATION**

**SCI CASE NO.: CA10030**

**VEHICLE: 1998 PREVOST MODEL H3-45 MOTORCOACH**

**INCIDENT DATE: JULY 2010**

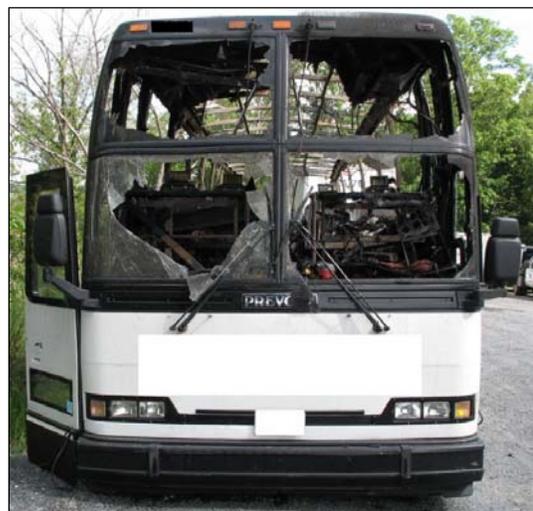
The front of the motorcoach sustained minor damage (**Figure 6**). All components below the level of the beltline, including the bumper, bumper fascia, headlight and turn signal assemblies, and body paneling were intact and undamaged. The windshield was divided into four quadrants. All four windshield glazing panels had been removed during firefighting activities in an effort to ventilate the interior of the motorcoach and aid in the extinguishment of the fire. Glass and laminate lined the intact gaskets along all four frame edges. There were four wiper blade assemblies for the upper and lower windshields. Both lower wipers were undamaged and remained in the stowed positions. The upper wipers were coated in soot and partially melted from the radiant heat. The left half of the windshield header was soot stained and charred, undamaged.

**Figure 6:** Minor frontal damage to motorcoach.

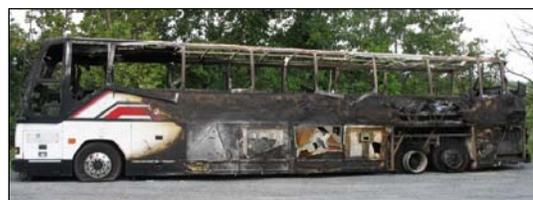
Damage to the left side of the motorcoach was extensive and extended full-height from the D-pillar rearward. The left side damage is depicted in **Figure 7**. All of the left side glazing was out of the vehicle. The perimeter of the three glazing panels between the A- and B-pillars remained intact within the gaskets on all frame edges. The lower aspect of the glazing panel between the B- and C- pillars was in

**Figure 7:** Left side damage to the motorcoach.

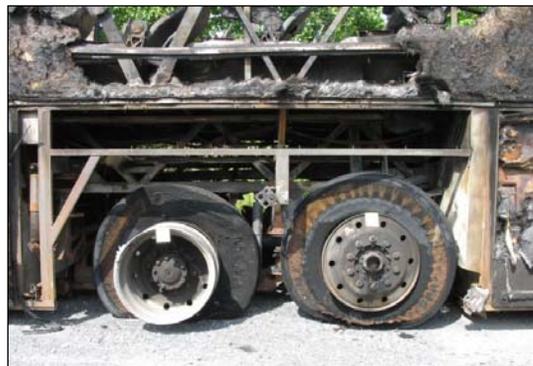
Fiberglass, plastic, and aluminum components of the body paneling, fascia, and splashguard surrounding the rear axles were fully consumed by the fire. All body paneling above the rear axles was burned full-thickness, with the frame of the motorcoach exposed. Oxidation on the frame evidenced the high heat of the fire in this area. As depicted in **Figure 8**, there were no remnants of the outboard drive axle tire. The corresponding alloy wheel was slightly melted on its outer bead from the 9-6 o'clock positions, with blackening and smoke damage around surrounding the lugs. The inboard drive axle tire was burned full-thickness on 180 degrees of its sidewall, with exposure of the steel cord. A small area of tire tread that had remained in contact with the road surface during the fire was intact and undamaged. This area was rotated 180 degrees from its original 6 o'clock position at the time of SCI inspection, and was attributed to towing and recovery efforts. The tag axle tire was burned to full-thickness on the full circumference of its sidewalls on both sides, with exposure of the steel cord. Combustible rubber and polymer components of the air ride suspension and shock absorbers were consumed by the fire.

**Figure 8:** Left rear axle area of the motorcoach.

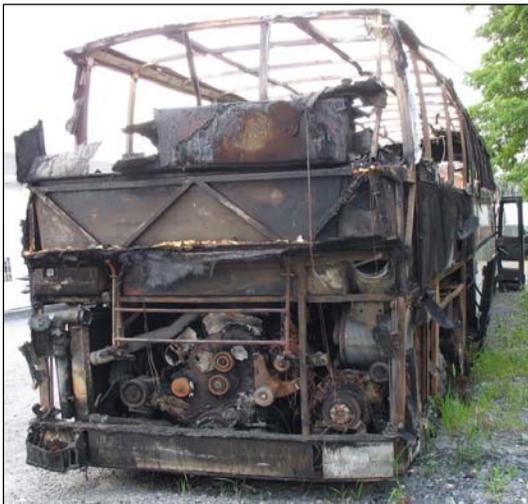
Fire damage to the rear plane of the motorcoach was extensive, as all combustible exterior surfaces were burned. The majority of the polymer bumper fascia and internal support structure were consumed by the fire, with only a small melted portion remaining in the left corner as seen in **Figure 9**. The taillight assemblies were fully consumed. Fiberglass and aluminum components of the engine compartment door and upper paneling were also fully consumed, causing exposure of underlying frame rails and vehicle components.

**Figure 9:** Fire damage to the rear of the motorcoach.

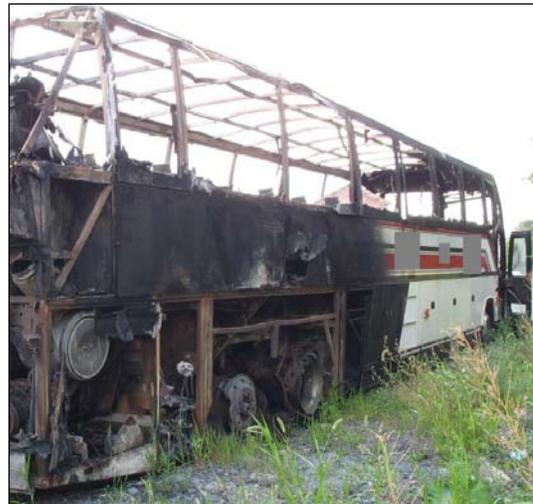
The right side of the motorcoach was burned in a fashion similar to that of the left side, as seen in **Figure 10**. Evidence of heat and fire damage was present from the rear corner forward to the approximate midpoint of the motorcoach at the level of the beltline and frame. The engine and battery storage compartment access doors aft of the rear axles were nearly entirely consumed by the fire, with only small sections of melted fiberglass strands remaining at the mounting brackets on the hinges. The batteries and associated components originally located within the compartment immediately aft of the tag axle had been consumed by the fire and were reduced to a cluster of oxidized wire and non-combustible components. Fiberglass and aluminum body paneling above the engine compartment access door at the rear corner were completely consumed, which had created full-exposure of the underlying frame and remnants of vehicle components.

**Figure 10:** Right side damage to the motorcoach.

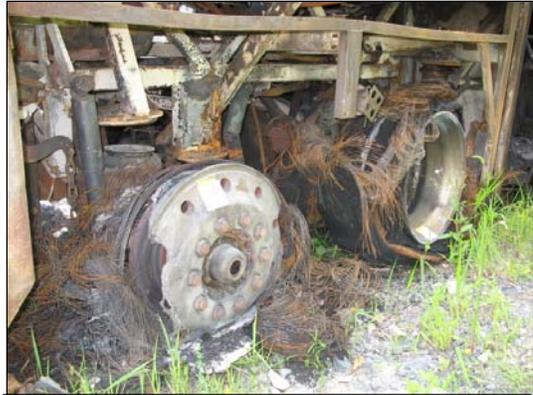
The fiberglass, plastic, and aluminum components of the body paneling, fascia, and splashguard surrounding the rear axle wheel well were completely consumed by the fire. The rubber of the tag axle tire was consumed. The steel cord from the sidewall and bead was the only remnants of the tire. The tag axle alloy wheel was melted clockwise from the 3-11 o'clock positions, with a hardened pool of melted aluminum at the 6 o'clock position. The rubber sidewalls of both drive axle tires were completely consumed by the fire, which resulted in the separation of the melted tread and collapse of their steel cord structures. The outer alloy wheel was intact with evidence of high heat from the 7-12 o'clock positions. Damage to the right rear axle area is depicted in **Figure 11**. Fire involvement of the tires had incinerated the polymer splash shield within the wheel well and consumed all other combustible materials in close proximity to the flames. Air ride suspension assemblies were reduced to only heat-oxidized metal components. Fire involvement surrounding the vertical frame-mounted shock absorbers had consumed the rubber and polymer components in a manner such that the integrity of their compression chambers was compromised, leading to the subsequent collapse of the right rear suspension.

**Figure 11:** Fire damage to the right rear axle area of the motorcoach.

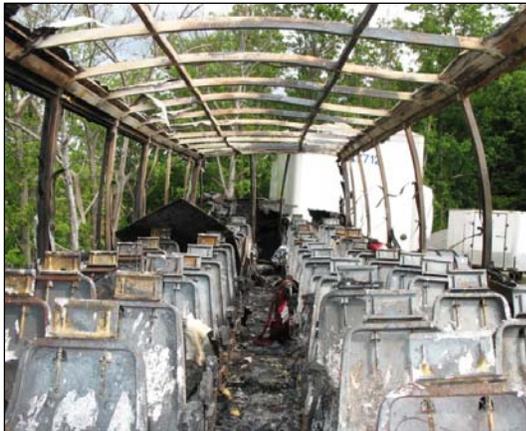
The interior of the motorcoach sustained extensive damage as the fire spread into the passenger compartment above the rear axles. A large amount of debris, which had fallen from the ceiling or displaced by firefighters, littered the soot and smoke covered stainless steel forward entrance staircase to the motorcoach. The entire instrument panel and driver's compartment was melted, distorted, and discolored by direct heat and fire involvement. Wiring harnesses of the gauge cluster were exposed by the consumption of the polymer paneling above the instrument panel. The vinyl coating of the steering wheel was completely melted from the wheel, with a small disfigured portion remaining at the center of the hub. Only the oxidized metal frames of the seats remained, as all of the fabric and cushions of all seats, including the passenger seats and driver's seat, were completely consumed. The onboard restroom was also consumed by the fire. A view of the rear of the passenger compartment is provided in **Figure 12**.

**Figure 12:** Rear of the interior of the motorcoach.

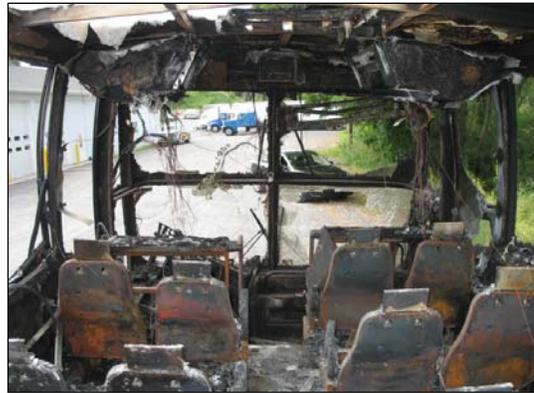
The aircraft-style overhead storage compartments with top-hinged doors were completely consumed by the fire aft of the C-pillar. The structure of the forward-most overhead compartment remained on either side of the passenger seating area, still mounted to the small section of the remaining roof panels (**Figure 13**).

**Figure 13:** Forward area of the interior of the motorcoach.

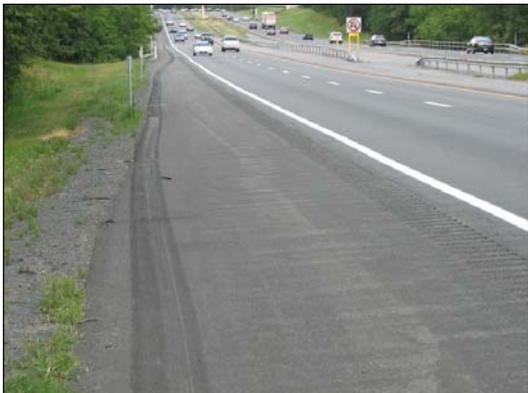
Physical evidence at the scene consisted of a long dragging tire mark on the right shoulder of the roadway that extended from the outboard travel lane and ended at the burn pattern. This tire mark is documented in **Figure 14**, which depicts the look-back view of the motorcoach's trajectory. Based on its location with respect to the trajectory and position of the motorcoach, the tire mark was associated to an outboard tire on a right rear axle.

**Figure 14:** Tire mark visible in look-back of motorcoach's approach.

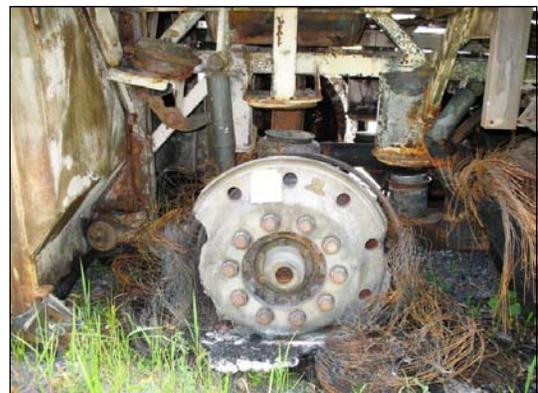
**Figure 15:** Location of fire origin at right tag axle.

Fire pattern analysis and knowledge of the tendency of fire to progress vertically and horizontally toward sources of fuel, heat, and oxygen were used in identifying the origin of the fire. Based on the overall burn pattern of the fire's progression, the SCI team focused on the right rear area of the motorcoach as the source of the fire's evolution. The SCI team noted evidence of high heat and extensive fire-related damage concentrated within the right rear axle area.

The SCI team recognized the degree of incineration of the tag axle tire, corresponding alloy wheel, and proximal vehicular components relative to the remaining axle positions on the motorcoach. As the fire's fuel sources in this area were exhausted, the fire proliferated vertically and horizontally through the undercarriage towards supplemental fuel sources within the engine compartment, left axle area, and ultimately the passenger compartment. Accordingly, the SCI team identified the right rear tag axle as the location of the fire's origin (**Figure 15**). The specific cause of the fire could not be determined as the wheel ends were not disassembled; therefore brake and wheel bearing issues could not be ruled out as the source of the dragging tire.

***Determination of Cause:*** Comparing the amount of relative damage to the two right rear wheels on this vehicle, and the damage to the structure around the rear axles, indicates that this fire is consistent with a right side tag axle tire fire. The root cause of the tire fire cannot be determined as the wheel end was not disassembled and the brakes, wheel seals, and bearings were not inspected.
