CALSPAN ON-SITE MOTORCOACH FIRE INVESTIGATION

SCI CASE NO.: CA10032

VEHICLE: 2001 MOTOR COACH INDUSTRIES MODEL G4500

INCIDENT DATE: JULY 2010

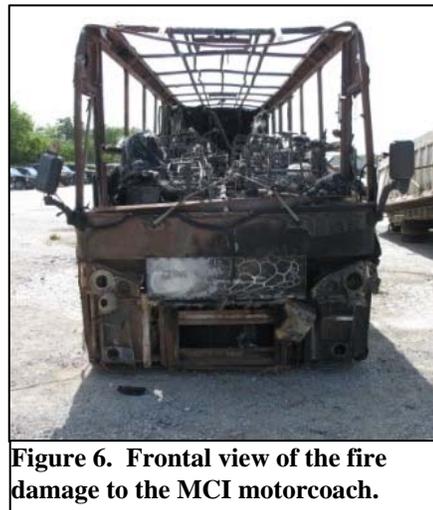
Most of the combustible materials on the frontal area of the motorcoach were consumed by the fire. This included the bumper fascia, the headlamp assemblies, and the windshields. The bumper beam was separated from the vehicle and was missing at the time of the inspection. A portion of a fiberglass body panel that was located above the bumper remained at the center and left areas of the vehicle. The exterior surface of a sheet metal panel that was located between the headlamp assemblies was charred with high heat oxidation present on the right side. The high heat oxidation was also present in the area above and below the right headlamp area. This suggested the fire spread through the interior and undercarriage areas and vented through the front right location. The lower windshield gasket was charred and melted, but it retained its shape and position. The remaining gaskets were completely consumed. **Figure 6** is an overall view of the fire damage to the front of the motorcoach.

Figure 6. Frontal view of the fire damage to the MCI motorcoach.

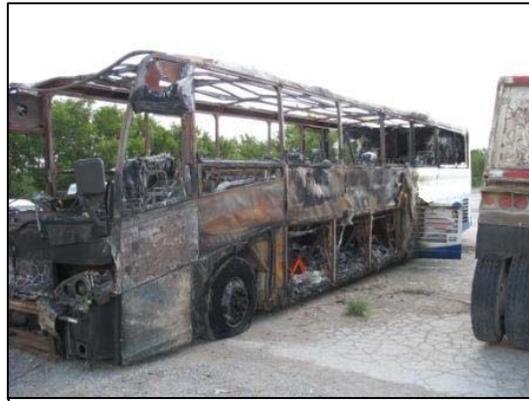
The fire damage to the left side began at the G-pillar and spread forward. The painted surface of the body panel between the G- and the F-pillar was charred and blistered. The sheet metal and fiberglass body panel at the F-pillar was burned at this pillar location. The panels from this point forward were completely consumed to the B-pillar. The underlying sheet metal panels were warped by heat. The three luggage compartment doors were completely consumed. The louvered door for the AC condenser cooling fans was smoke and soot stained at the upper surface and melted at the leading edge along the hinge location. The side panels below the driver compartment were charred, with blistering of the paint. **Figure 7** is a left side view of the fire damage to the motorcoach.

Figure 7. Left side view of the fire damage to the MCI motorcoach.

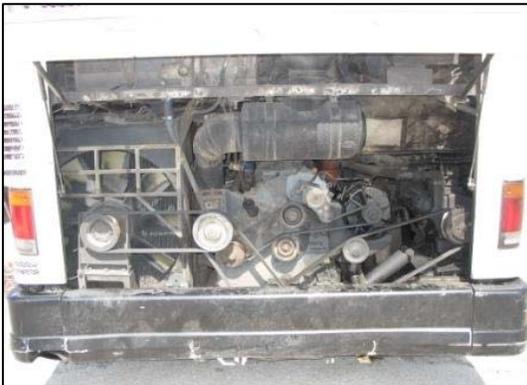
The back plane of the motorcoach was not involved in the fire. The fiberglass engine compartment door was closed and operational post-incident. The taillights were intact and all painted surfaces were without damage by fire or smoke. There was no fire damage to the engine or the engine compartment (**Figure 8**).

Figure 8. Undamaged back plane and the engine compartment area.

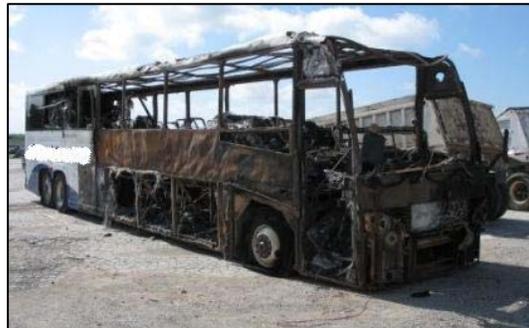
Figure 9. Right side view of the fire damage to the motorcoach.

The right side fire damage began at the F-pillar and extended forward (**Figure 9**). The wheelchair lift was located at the F- to G-pillar locations. The leading edge of the sliding

door to the passenger compartment was burned and the painted surface of the lift door was charred. The body panels from the F-pillar forward were completely consumed by the fire. The right loading door was fiberglass and was totally consumed as were the luggage bay doors on the underbody. The underlying sheet metal panels on the side body structure were warped from the F- to the B-pillar.

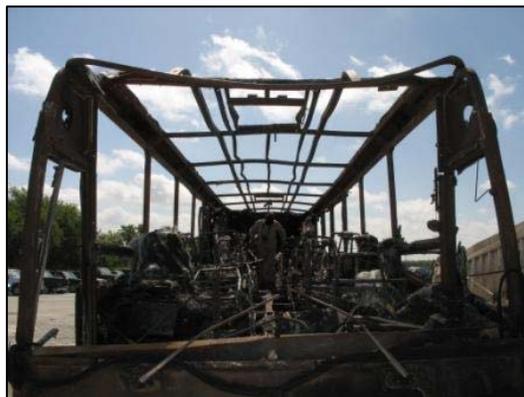
The roof was surfaced with overlapping aluminum panels that spanned the width of the motorcoach. These roof panels were completely burned from the back of the motorcoach forward. The right roof side rails retained a portion of the aluminum, protected by the structure of the vehicle. The longitudinal roof rails were deformed by heat. The lateral roof bows between the pillars sagged at the B- through D-pillar locations. The forward aspect of the roof structure over the windshield areas displayed the greatest amount of sag to both the lateral and longitudinal structures. **Figure 10** is a view of the roof damage to the motorcoach.

Figure 10. Rearward view of the roof of the motorcoach.

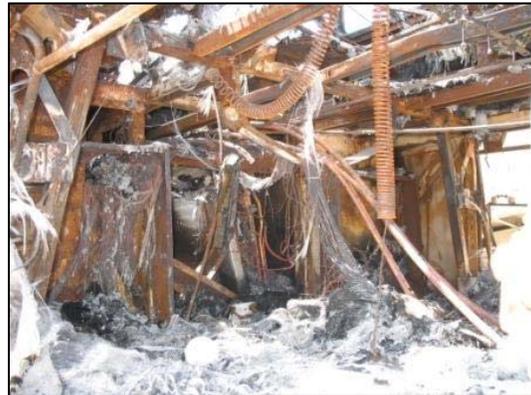
The undercarriage area of the motorcoach that was inspected for this fire investigation involved the luggage compartments and the electrical boxes and AC system that were located immediately rearward of the luggage bays (**Figure 11**). The undercarriage area of the rear drive and tag axles, in addition to the engine compartment were not involved or damaged by this fire.

Figure 11. View from the right rear luggage bay looking rearward at the electrical boxes and the AC system components.

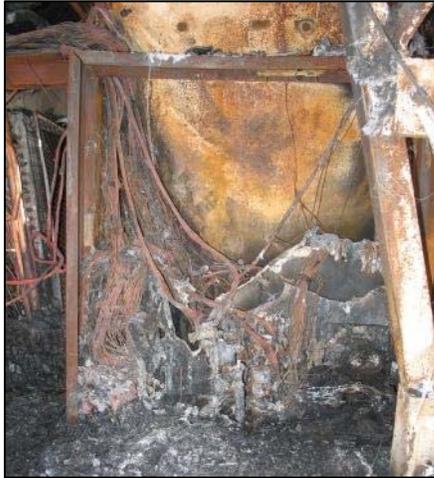
The investigation then focused on the electrical panel box that was mounted on the left side of the undercarriage, aft of the luggage bays. This panel box consisted of a sheet metal formed box. The cover and back plate was missing and was presumed to have been constructed of a combustible material such as plywood, as wood fragments were found in the debris. The box could have been covered by a plastic or aluminum cover that melted in the fire.

Figure 12. Left side panel box, wiring, and heat evidence.

This panel box contained a bundle of small gauge wires with a mix of a several 8-10 gauge wires. All of the wire insulation was burned and the remaining copper wire was clustered together. These wires extended through the top of the panel box and over the centerline of the motorcoach to a wire bundle that extended forward on the centerline and to the right side mounted box. These wires appeared to be intact with no evidence of arcing, separation, or welding of the braided wire. The sheet metal wall at the rearward aspect of the panel box displayed a burn pattern of high heat oxidation that extended upward to the floor of the passenger compartment (**Figure 12**).

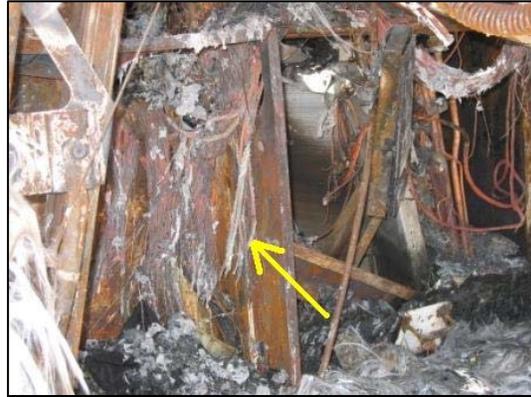
Figure 13. Right side panel box and the cable damage (arrow).

The matching right side-mounted panel box contained three distinct bundles of small gauge wire and five larger gauge wires and cables that extended to the center mounted AC system. Several of these larger gauge cables were routed rearward to the electric wheelchair lift. The cables at the lift unit were intact and not involved in the fire. Three of the large diameter cables within the box were burned through with welding of the braided copper wire. Two of the cables exhibited 10 cm (4 in) of wire welding while the third cable was welded over a 20 cm (8 in) length (**Figure 13**). The welded patterns extended upward. Melted aluminum was present on top of the panel box and fused to the copper wire. All of the combustible wire insulation was burned from the wires. The box was not enclosed at the front or back aspects as the covers were consumed by the fire.

Determination of Cause: Within the area of origin, there were two electrical power distribution boxes and the mid-mounted A/C system. Heavy gauge cables in the right side panel were found to be burned completely through and welded. Additional heavy damage was observed at the right side A/C evaporator. Because of the amount of damage sustained to the electrical and A/C systems, this fire is consistent with an electrical fire of undetermined cause.

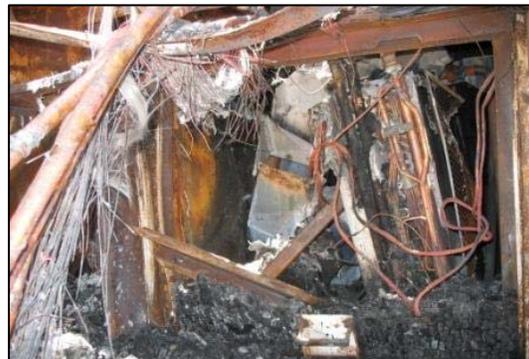
The AC evaporator and associated plenum/duct work/shielding were located on the vehicle's centerline, rearward of the above referenced panel boxes (**Figure 14**). The AC compartment was enclosed by sheet metal side walls and a plywood front access panel. The sheet metal walls were blackened by the fire with an area of high heat oxidation present on the forward aspect of the right wall. Charred remnants of the plywood access panel were present at the bottom of the opening.

Figure 14. AC evaporators and related fire damage located aft of the luggage compartments.

Aluminum duct work or shielding was present at the forward aspect of the right evaporator. This formed component was melted at the upper forward corner. It also appeared that the formed duct work was displaced, possibly by efforts of the fire department. The evaporators consisted of copper coils with aluminum fins. The evaporators were intact and blackened by smoke and fire. The forward upper area of the right evaporator was clean as if exposed to high heat. This area was located under the melted aluminum duct.

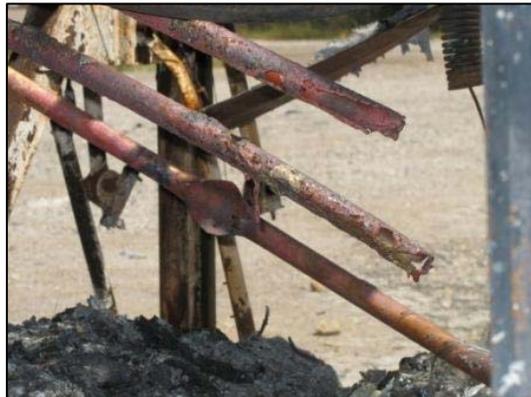
The rear mounted passenger compartment evaporator was exposed due to the severity of the fire to the interior of the motorcoach. The forward mounted evaporator was concealed by the remaining floor forward of the B-pillars. Four copper supply and return lines were routed along the centerline of the motorcoach from the mid-mounted evaporator system to the forward evaporator. These copper lines sustained significant damage forward of the evaporator consisting of burn through, complete melting of the copper, and burst fractures of the lines (**Figure 15**). The lines were completely burned through at the level of the D- to E-pillars and had fallen from the under floor mounting points to the floor of the luggage bays. A burst fracture was noted to one of the (3/4 in) copper lines at the midpoint of the second luggage bay. This occurred from heat build-up within the refrigerant line during the fire.

Figure 15. Example of the fire damage to the copper refrigerant supply and return lines.

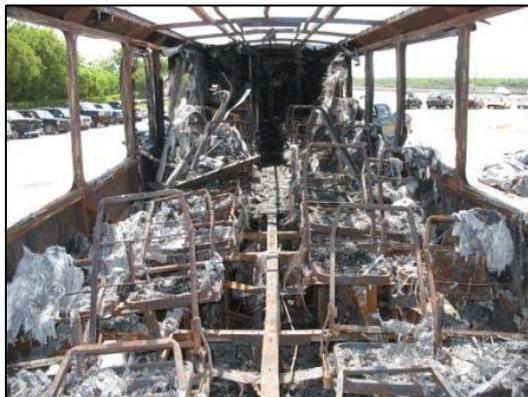
The interior of the motorcoach was completely burned by the fire (**Figure 16**). All combustible materials within the seats, overhead storage compartments, side wall, and ceiling were consumed. The plywood partitions for the back right mounted restroom were partially intact, but heavily burned. The plywood floor was completely burned from the B-pillar location the F-pillar area. The floor immediately forward of the drive axle to the back of the passenger compartment was charred, but intact. The longitudinal and lateral cross members of the floor were warped by the heat of the fire. An

Figure 16. Rearward view of the interior fire damage to the motorcoach.

area of high heat was present on the floor structure between the second and third luggage bays. The center rail was warped at the midline of the third luggage bay (E-pillar area). The fiberglass matting that was used in the construction of the overhead compartments was not completely burned and had fallen onto the outboard seat frames. The driver compartment and the instrument panel were completely consumed.
