ON-SITE ROLLOVER INVESTIGATION

CASE NUMBER - IN10033

VEHICLE - 2008 TOYOTA FJ CRUISER

CRASH DATE - August 2010

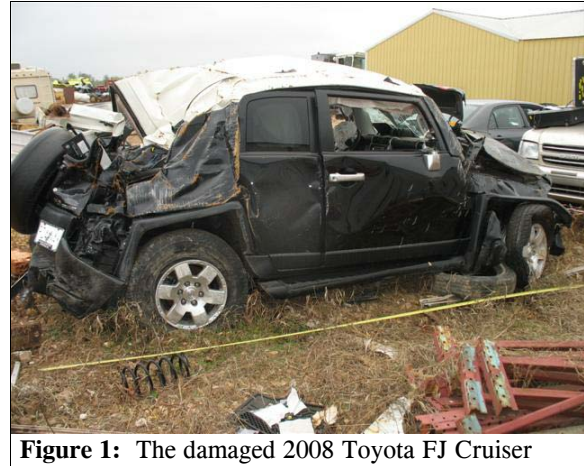
Figure 1: The damaged 2008 Toyota FJ Cruiser

Direct damage on the right side plane began at the front corner of the fender, 330 cm (129.9 in) forward of the right rear axle, and extended the length of the vehicle on the fender, A-pillar, roof side rail, doors, C-pillar, and quarter panel (Figure 1).

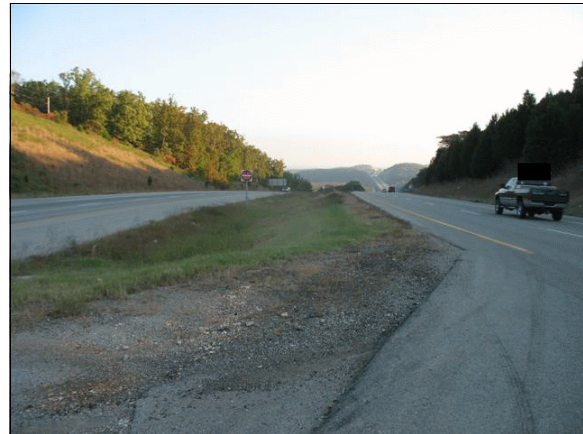
Crash: The Toyota traveled into the median (**Figure 2**) and down a negative 5% grade, for approximately 275 m (902 ft) where it tripped and rolled over (event 1), left side leading, 12 quarter turns. The vehicle came to final rest on its wheels, in the inside southbound lane, heading northwest (**Figure 3**).

Figure 2: View south in the area where the Toyota departed the roadway

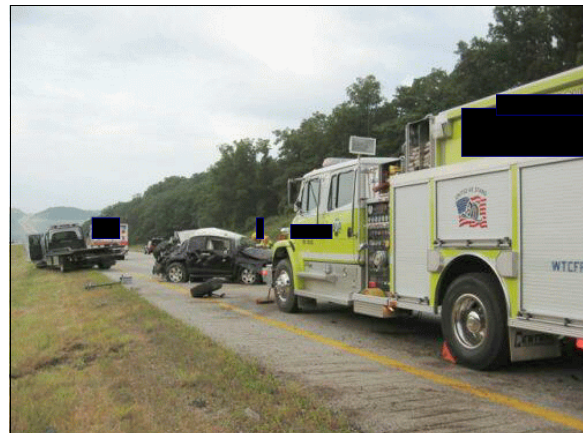
Figure 3: Police on-scene photo looking south to the final rest position of the Toyota

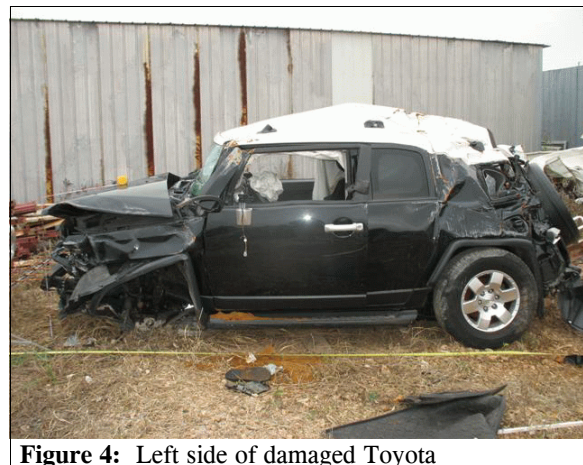
Exterior Damage Event 1: The rollover involved the left, right, and top planes of the vehicle. Direct damage on the left side plane began at the front of the left fender, 328 cm (129.1 in) forward of the left rear axle, and extended rearward 166 cm (65.3 in) on the fender, A-pillar, and roof side rail. The direct damage resumed at the door handle, 107 cm (42.1 in) forward of the left rear axle, and extended rearward 145 cm (57.1 in) on the doors, C-pillar, and left quarter panel (**Figure 4**).

Figure 4: Left side of damaged Toyota

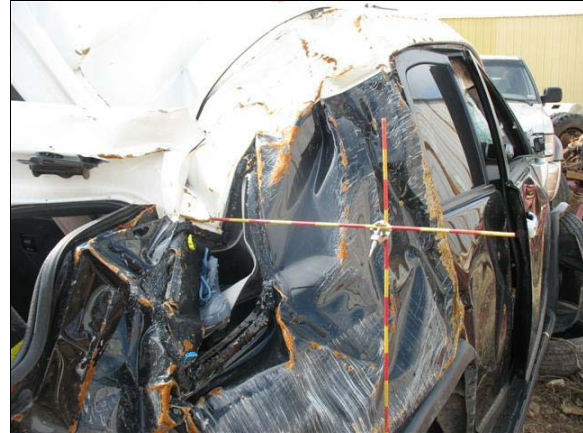
Direct damage to the top plane began at the front of the hood, 330 cm (129.9 in) forward of the right rear axle. Also directly damaged were both corners of the windshield header. Direct damage on the right side of the roof continued on the roof side rail, extending to the rear of the vehicle. Direct contact on the roof itself was limited to light scratching on the middle of the roof. The maximum lateral crush was located at the right roof side rail, 30 cm (11.8 in) rear of the right rear axle (Figure 5) and measured 25 cm (9.8 in). The maximum vertical crush was located at the right rear roof area, 30 cm (11.8 in) rear of the right rear axle (Figure 6) and measured 36 cm (14.1 in).

Figure 5: Lateral max crush on right roof rail

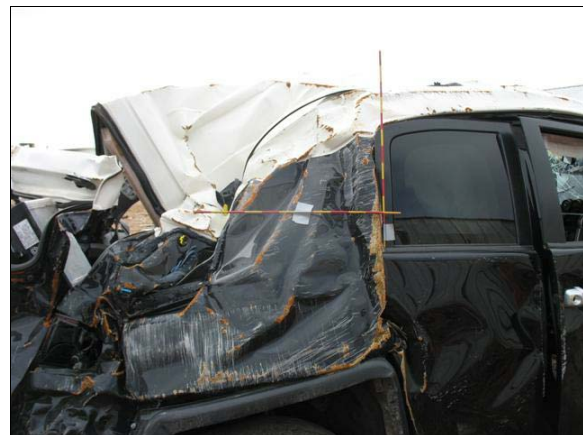
Figure 6: Max vertical crush to right rear roof area

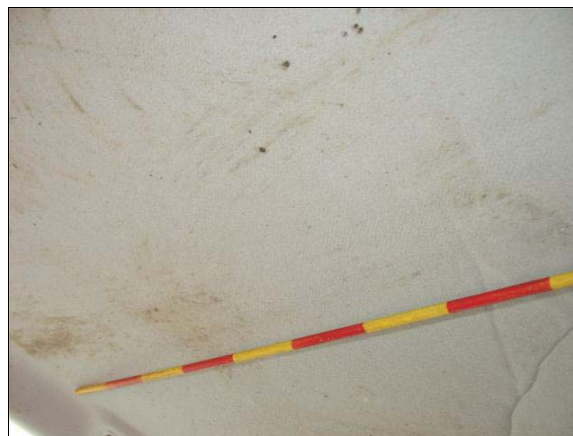
Vehicle Interior: The inspection of the Toyota's interior revealed a scuff on the roof above the driver's area (**Figure 7**), blood stains on the driver's frontal and seat-mounted side impact air bag, and a bent driver's head restraint (**Figure 8**). The roof and head restraint were contacted by the driver's head and the left side impact air bag and IC air bags were contacted by the driver's shoulder and head. There was no evidence of steering rim deformation or compression of the energy absorbing steering column.

Figure 7: Roof contact above driver area

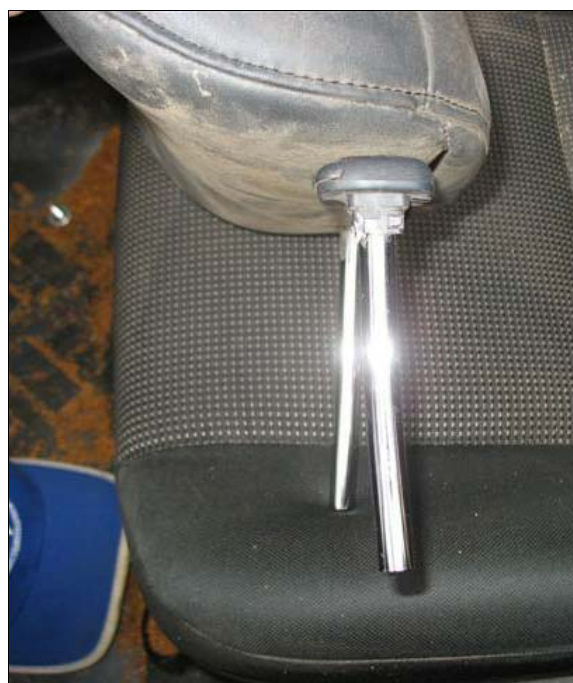
Figure 8: Driver's deformed head restraint posts
