ON-SITE SMALL OVERLAP/OBLIQUE INVESTIGATION

CASE NUMBER - IN10034

VEHICLE - 2010 TOYOTA CAMRY LE

CRASH DATE - September 2010

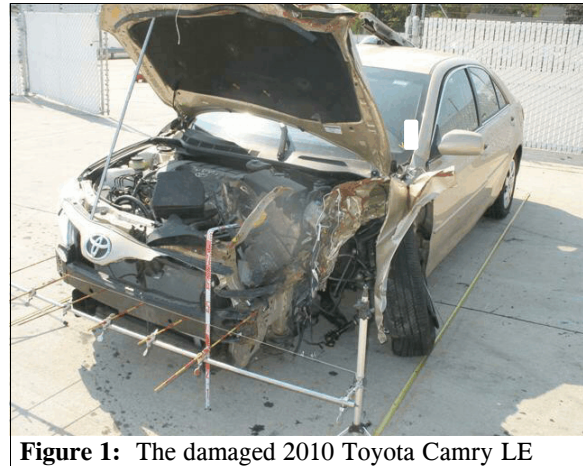
Figure 1: The damaged 2010 Toyota Camry LE

Exterior Damage: The Toyota sustained front plane damage during its impact with the Chevrolet. The front bumper, left headlamp/turn signal assembly, grille, hood, left fender, left front wheel, and left front door were directly damaged. The direct damage began at the front left bumper corner and extended 37 cm (15 in) across the bumper. The crush measurements were taken on the bumper bar. A second set of measurements was taken at the upper radiator support level. The maximum residual crush at the bumper level was 6 cm (2.4 in) occurring at C₁. The maximum crush at the radiator support level was 15 cm (5.9 in) at C₁. The vehicle’s left side wheelbase was reduced 31 cm (12.2 in), while the right side wheelbase was reduced 2 cm (0.8 in). The crush values at the bumper level and upper radiator support level did not meet the crush measurement averaging protocol and the table below presents the vehicle’s front crush profile at the bumper level.

Damage Classification: The Collision Deformation Classification was 12FLEE7 (350 degrees). The Missing Vehicle algorithm of the WinSMASH program calculated the Toyota’s total Delta V as 14 km/h (8.7 mph). The longitudinal and lateral velocity changes were -14 km/h (-8.7 mph) and 0.0 km/h, respectively. The results should be considered borderline since this was a narrow end engagement impact. The vehicle’s EDR reported the maximum velocity change as 44.6 km/h (27.7 mph).

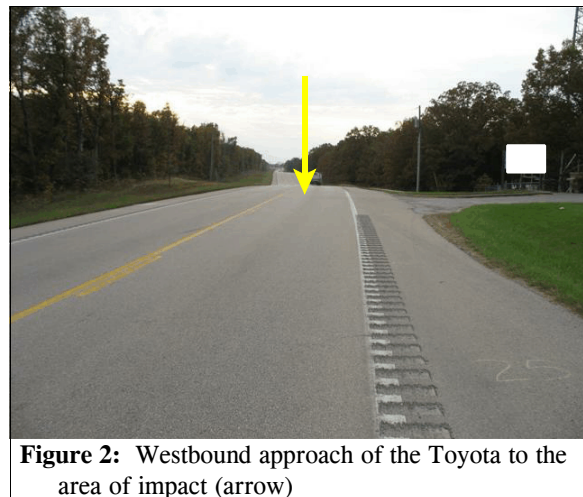
Figure 2: Westbound approach of the Toyota to the area of impact (arrow)

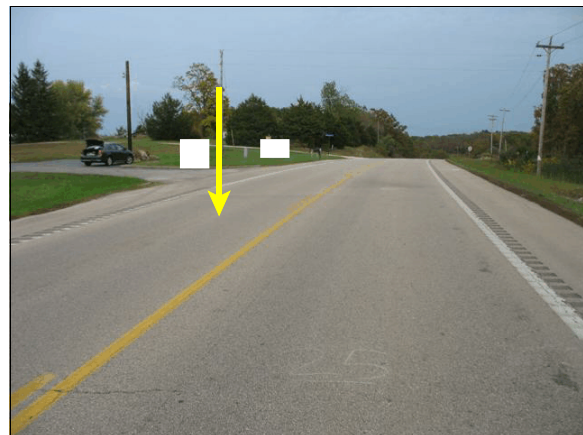
Figure 3: Eastbound approach of the Chevrolet to the area of impact

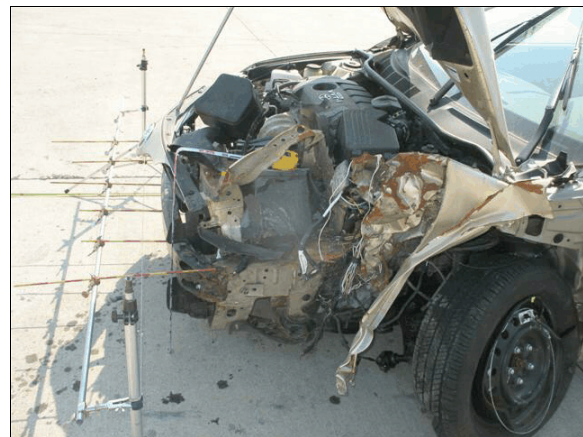
Crash: The Chevrolet entered the Toyota’s travel lane (**Figure 3**) and the front plane of the Chevrolet impacted the front plane of the Toyota (event 1). The impact on the Toyota occurred outside of the left frame rail on the corner of the front bumper. The Toyota’s fender, hood, and left front wheel were engaged and the left front wheel was displaced rearward 31 cm (12.2 in, **Figure 4**). The direction of force on the Toyota was within the 12 clock sector and the impact force triggered a stage 2 deployment of the driver’s frontal air bag. The driver’s knee air bag also deployed. Debris from the Toyota and Chevrolet impacted the Jeep (event 2).

Figure 4: The displacement of the Toyota’s left front wheel
