**CALSPAN ON-SITE ROLLOVER CRASH INVESTIGATION
SCI CASE NO.: CA10037**

VEHICLE: 2009 MITSUBISHI GALANT RALLIART

LOCATION: NORTH CAROLINA

CRASH DATE: OCTOBER 2010

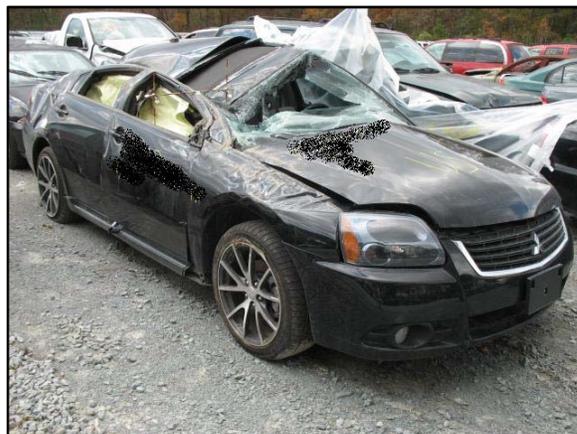
Figure 1: Front right oblique view of the 2009 Mitsubishi Galant.

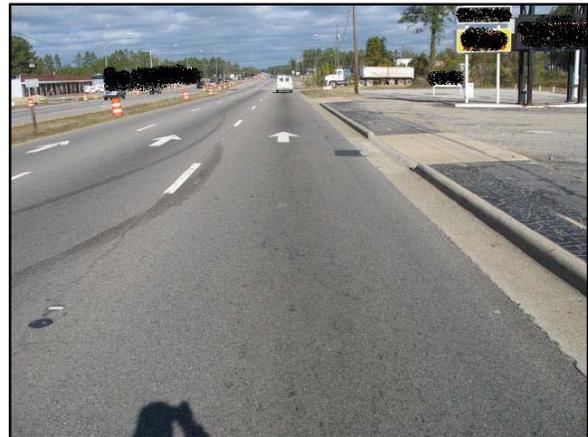
This crash occurred during early morning hours on a north/south three-lane urban roadway divided by a 5.9 m (19.5 ft) wide grass median. The environmental conditions were clear, dry and dark but lighted. **Figure 2** depicts the northbound approach to the crash site. The roadway was straight and had a level grade throughout the area in which the crash occurred. The right travel lane measured 4.0 m (13.1 ft) in width and the center and left travel lanes were 3.3 m (10.8 ft) in width. The east side of the roadway was bordered by a concrete barrier curb

Figure 2: Northbound approach to the crash site.

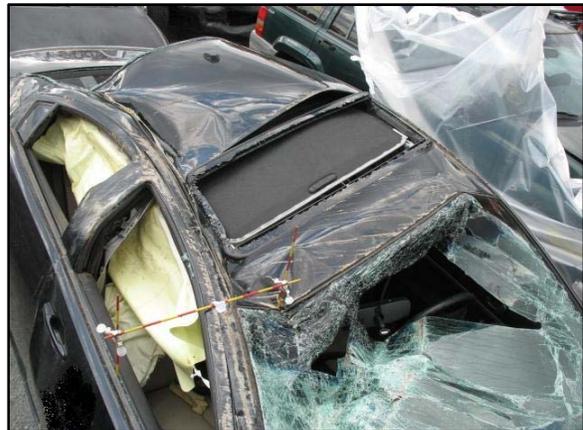
The Mitsubishi's top and right planes sustained severe damage as a result of this rollover (**Figure 3**). On the top plane, direct damage began at the front right edge of the hood and extended rearward 414 cm (162.9 in) to the rear right taillight area. Laterally, the direct damage extended 104 cm (40.9 in) across the full width of the roof. The longitudinal direct damage to the greenhouse extended 232 cm (91.3 in) from the base of the right A-pillar to the backlight header. The maximum vertical deformation was located on the right side of the windshield

Figure 3: View of the Mitsubishi's roof damage from above, right.

header, 17 cm (6.7 in) inboard of the right roof side rail. The residual vertical deformation measured 33 cm (13 in). The maximum lateral deformation was located at the right A-pillar area, 65 cm (25.6 in) forward of the upper rear corner of the door (using the B-pillar as a reference). The residual lateral deformation measured 13 cm (5.1 in). The Collision Deformation Classification (CDC) assigned for the rollover event was 00TDDO4.

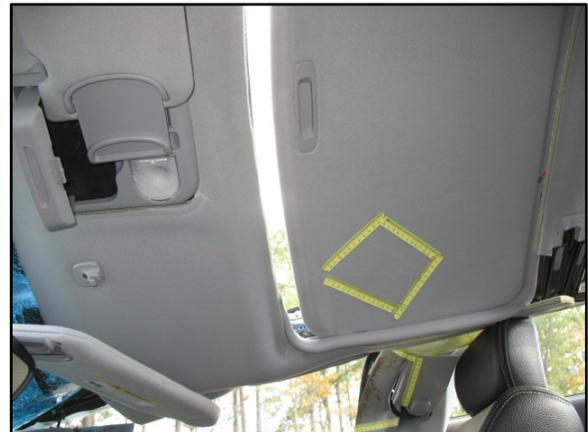
The Mitsubishi sustained moderate severity interior damage that was attributed to passenger compartment intrusion, occupant contact and air bag deployment. There was a scuff mark on the fabric sunroof cover located 4-20 cm (1.6-7.9 in) aft of the front edge of the cover and 5-20 cm (2-7.9 in) left of the cover’s right edge. This scuff mark was attributed to the driver’s head. There was a large blood transfer on the interior aspect of the right B-pillar that extended the full width of the pillar and extended from 9-31 cm (3.5-12.2 in) below the right roof side rail. This post-crash transfer was attributed to the front right passenger’s head injuries. **Figure 4** depicts contact evidence observed during the SCI inspection. The following table lists the passenger compartment intrusion:

Figure 4: Interior contact evidence in the Mitsubishi.

Figure 4 depicts contact evidence observed during the SCI inspection. The following table lists the passenger compartment intrusion:

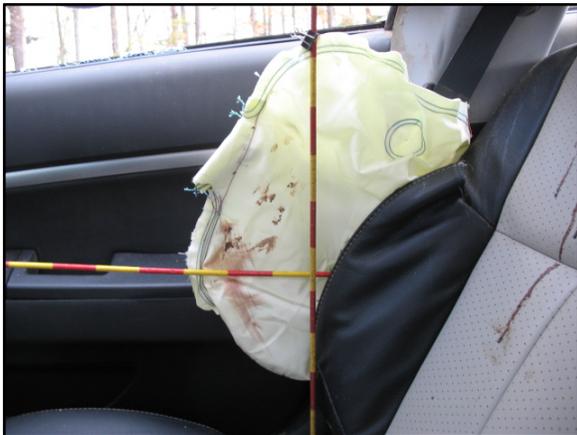
The side impact air bag deployed from a 30 cm (11.8 in) long seam in the outboard aspect of the front right seatback. The air bag measured 46 cm (18.1 in) in height and 18 cm (7.1 in) in width. There was smeared blood on the lower left aspect of the inboard side. The side impact air bag was vented by a single vent port at the forward 9 o'clock position. There were no tethers present in the side impact air bag. The right side impact air bag (**Figure 5**) was free from crash related damage.

Figure 5: Inboard side of the right side impact air bag.

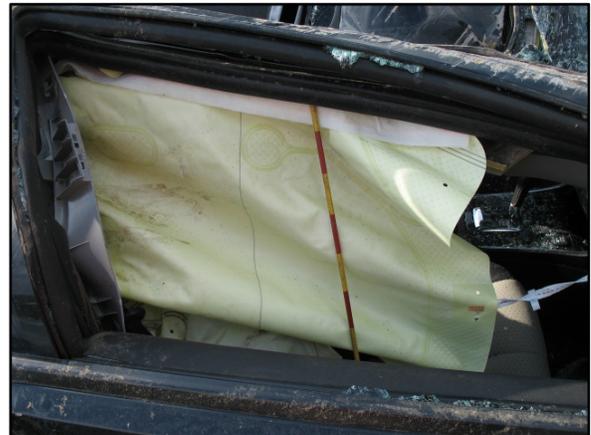
Figure 6: Blood evidence on the outboard side of the right IC air bag.

The right IC deployed from the right roof side rail. It was manufactured by Life Curtain Technology and identified by the following nomenclature: Pattern 775, Design 77511380. The IC measured 146 cm (57.5 in) in length and was 38 cm (15 in) in height at the front and rear right seating positions. Vertically, the curtain air bag extended below the belt line in each row. The right IC provided protection from a location that measured 42 cm (16.5 in) aft of the top of the right A-pillar rearward the right C-pillar. The open triangular area located forward of the IC measured 26 cm (10.2 in) in height at the IC, 14 cm (5.5 in) in height at the base of the A-pillar, and was 42 cm (16.5 in) in length. The right IC was tethered to the right A-pillar by a web strap 36 cm (14.2 in) in length. The right IC is depicted in **Figure 6**.

There was a smeared blood transfer on the outboard side of the right IC that extended across the full height of the IC. The blood transfer began 40 cm (15.7 in) aft of the forward aspect of the IC and extended rearward 24 cm (9.4 in). The transfer was located adjacent to the right B-pillar. This blood transfer was attributed to the front right passenger's head and right hand.

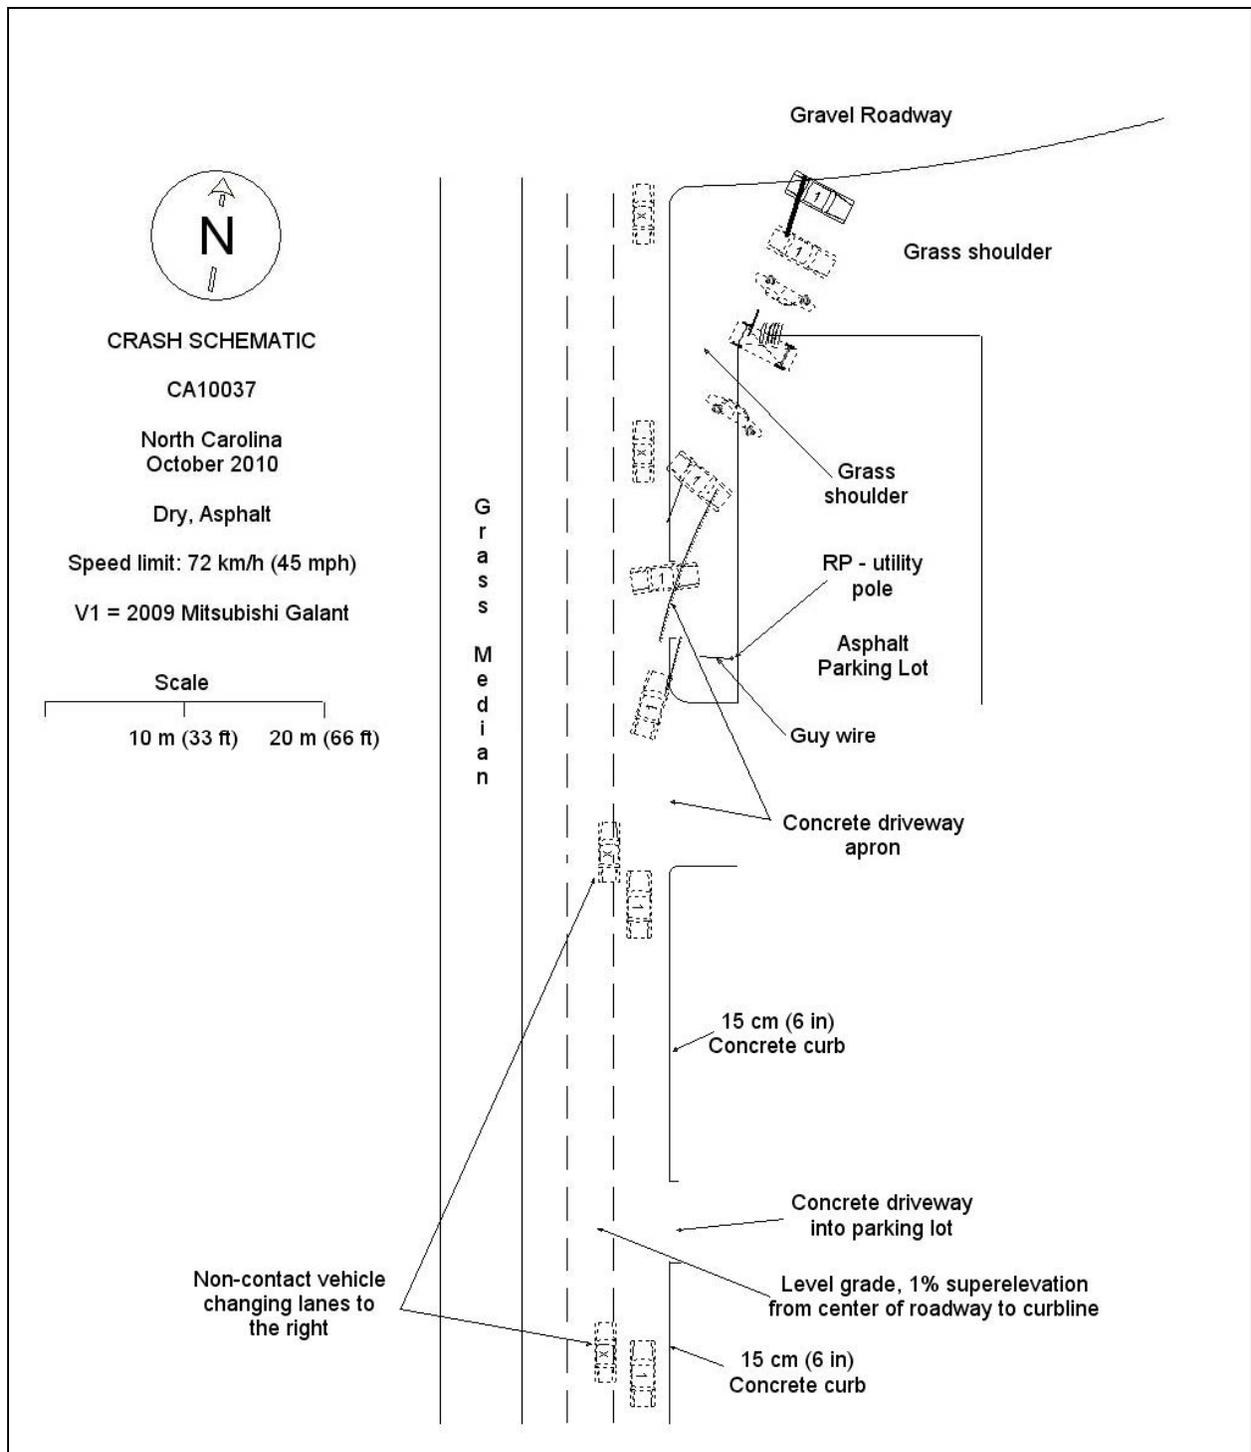
Figure 7: Crash Schematic

15 cm (6 in) in height. This barrier curb transitioned to a concrete driveway apron in several areas along a northbound path of travel. The driveway aprons provided access to the asphalt public parking lot that was located east of the roadway. The Mitsubishi departed the roadway at a driveway apron and entered a 5.0 m (16.4 ft) wide section of the grass roadside. Outboard this grass area, the roadside transitioned to the asphalt parking lot. North of the rollover area, an east/west gravel road intersected the primary road forming a three-leg intersection. The speed limit on the primary roadway was 72 km/h (45 mph). A schematic of the crash is included as **Figure 7** at the end of this report.
