# INDIANA UNIVERSITY

## ON-SITE CHILD RESTRAINT SYSTEM INVESTIGATION

CASE NUMBER - IN10038  
LOCATION - KANSAS  
VEHICLE - 2005 DODGE DURANGO SLT  
CRASH DATE - May,2010

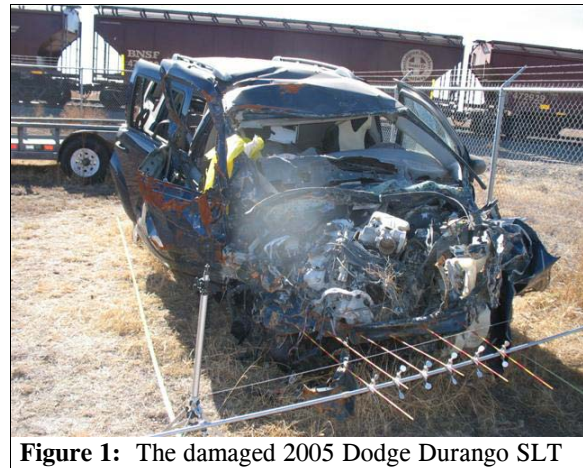
**Figure 1:** The damaged 2005 Dodge Durango SLT

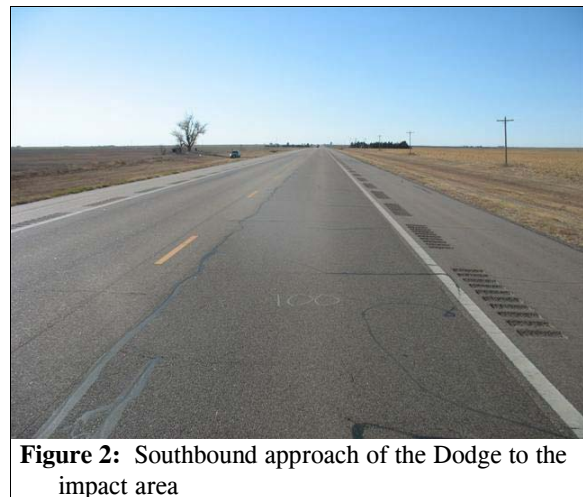
**Figure 2:** Southbound approach of the Dodge to the impact area

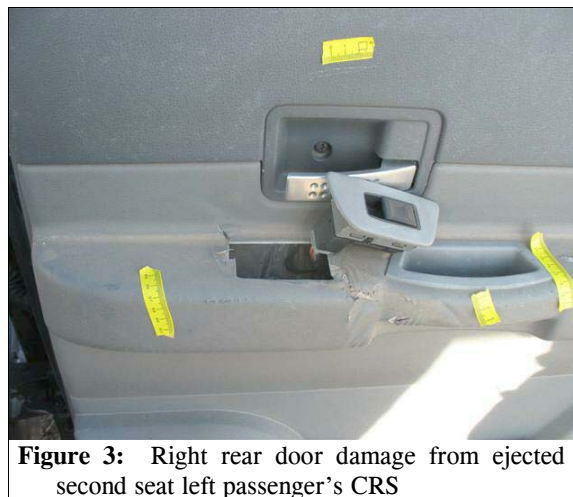
The front doors were jammed shut, with the right front door mechanically forced open by rescue personnel. The left rear door remained closed and operational. The right rear door panel was displaced and deformed (**Figure 3**) by impact from the displaced second row left CRS. The right rear door came open during the crash. This was probably caused by indirect damage to the door structure and door frame from the initial impact with the Peterbilt and the subsequent contact by the CRS.

**Figure 3:** Right rear door damage from ejected second seat left passenger's CRS

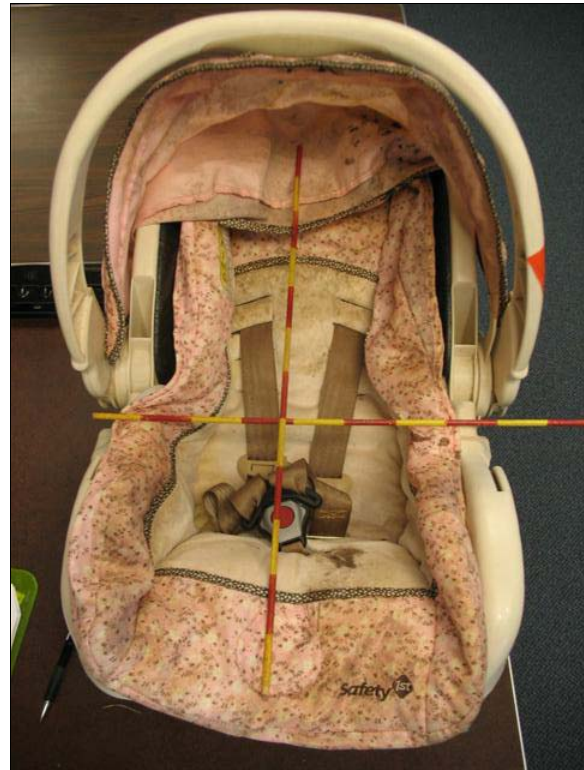
Figure 4: Second row left CRS

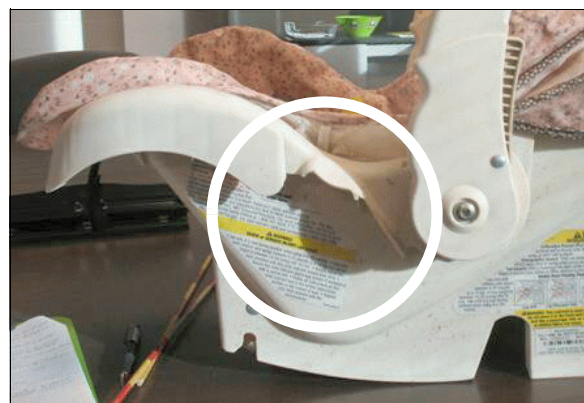
Figure 5: Second row left CRS with damaged left flange

Inspection of the CRS revealed minor scratch marks on the right side, likely caused during the ejection and some blood drops on the left armrest. On the bottom of the CRS, the right harness anchor was pulled through the seat bottom, causing a 10 cm (3.9 in) “S”-shaped crack (**Figure 6**). On the left side of the CRS, the plastic tab behind the belt guide was fractured (Figure 5).

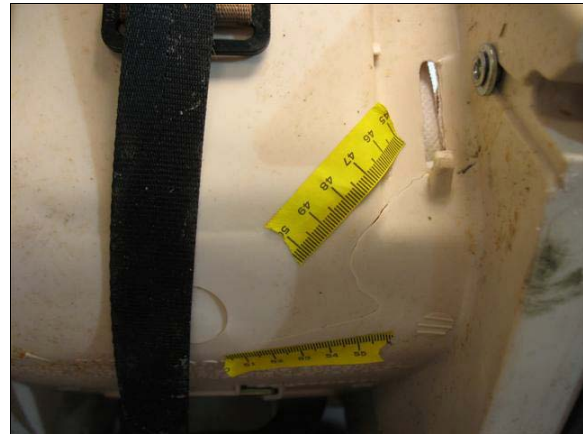
**Figure 6:** Cracked bottom of second row left CRS

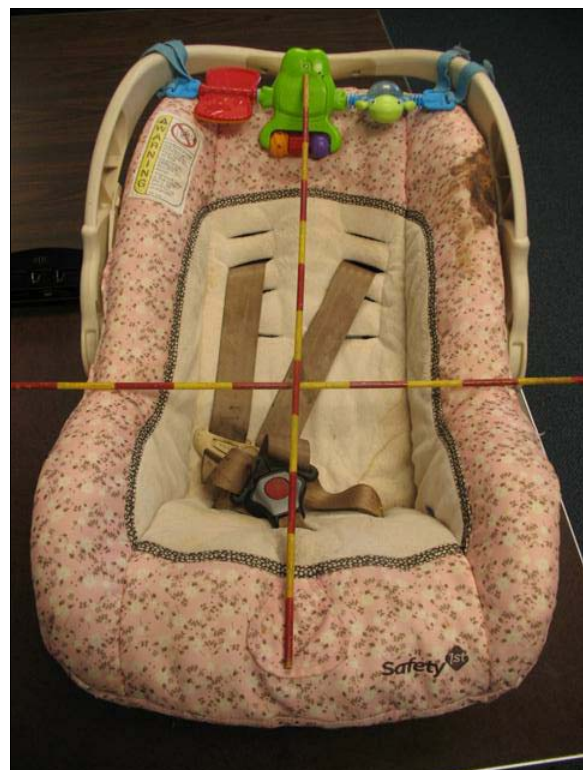
The second row right passenger [10-month-old, female; 51 cm and 8 kg (20 in, 17 lbs)] was seated in a Dorel Safety 1<sup>st</sup> Designer 22 (**Figure 7**) that was identical to the one in the second row left position. It was also manufactured on March 3, 2009 and the model number was 22303-ADA. The CRS was equipped with a 5-point harness and a harness retainer clip that was positioned above the armpit level. The CRS was designed for only rear facing use and was for children who weigh between 2.3 and 10 kg (5 and 22 lbs) and were between 48 and 74 cm (19 and 29 in) in height. The base for the CRS was not in use at the time of the crash. The shoulder straps were also threaded through the third highest set of slots.

**Figure 7:** Second row right passenger’s CRS

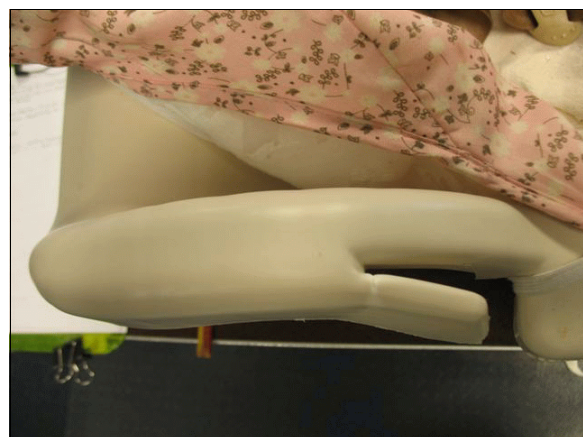
Inspection of this CRS revealed a moderate size blood stain at the top left and dried blood on the harness retainer clip. The left side belt guide path was deformed (**Figure 8**) due to loading by the vehicle’s safety belt during the initial impact. The remainder of the CRS was unremarkable.

**Figure 8:** Deformed left belt guide on second row right CRS
