ON-SITE ROLLOVER INVESTIGATION

CASE NUMBER - IN10040
LOCATION - INDIANA
VEHICLE - 2008 GMC ENVOY
CRASH DATE - October 2010

May 17, 2011

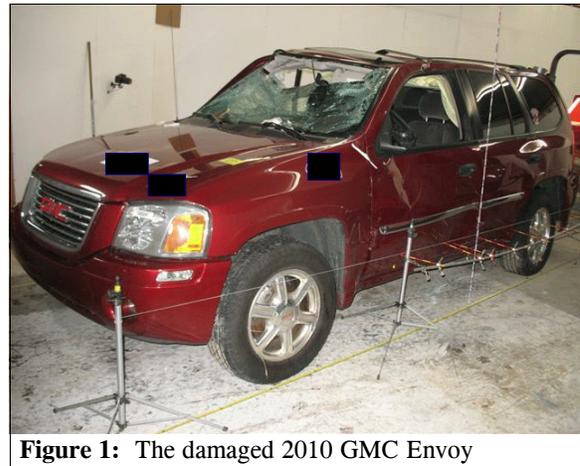
This on-site investigation focused on the rollover of a 2010 GMC Envoy (**Figure 1**). The vehicle was equipped with rollover/side impact Inflatable Curtain (IC) air bags that deployed as a result of the crash. This crash was brought to our attention by the National Highway Traffic Safety Administration (NHTSA) on October 22, 2010 by the sampling activities of the National Automotive Sampling System (NASS)-General Estimates System (GES). Final cooperation to inspect the vehicle was confirmed with the insurance company on December 16, 2010 and this investigation was assigned on December 17, 2010. The crash involved the GMC and a 2000 Saturn SL1. The crash occurred in October, 2010, at 0550 hours, in Indiana and was investigated by the local sheriff's department. The GMC was inspected on December 28, 2010. The Saturn and crash scene were inspected on December 29, 2010. An interview with the driver of the GMC was completed on January 3, 2010. This report is based on the police crash report, vehicle and crash scene inspections, exemplar vehicle inspections, driver interview, medical records, occupant kinematic principles, and evaluation of the evidence.

Figure 1: The damaged 2010 GMC Envoy

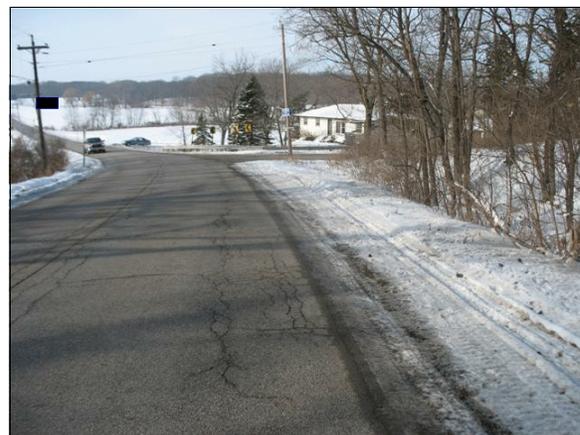
Pre-Crash: The GMC was occupied by an unrestrained 52-year-old male driver. The driver was westbound negotiating a left curve (**Figure 2**). The Saturn was occupied by an unrestrained 56-year-old male driver. He was traveling east approaching the curve and intended to continue eastbound. As the Saturn's driver negotiated the curve, his vehicle entered the GMC's travel lane. The GMC's driver steered to the right and braked in an attempt to avoid the crash. The GMC was

Figure 2: GMC's westbound approach to impact

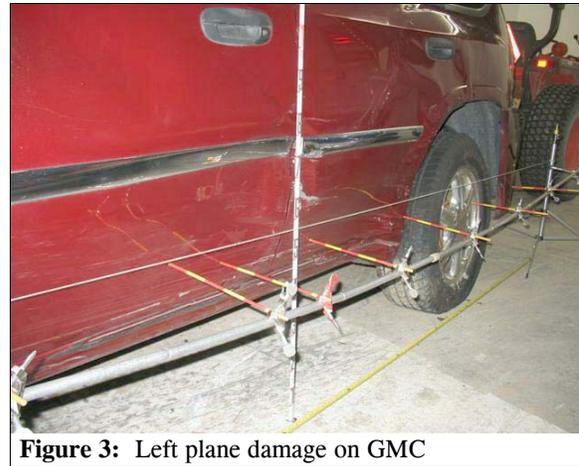
Exterior Damage Event 1: The GMC sustained damage on the left plane during the impact with the front plane of the Saturn. The left doors, quarter panel, and side of the rear bumper fascia were directly damaged. The direct damage began 95 cm (37.4 in) rear of the left front axle and extended 250 cm (98.4 in) rearward along the lower doors (**Figure 3**) and onto the side of the rear bumper fascia. Crush measurements were taken at the lower door level and the residual maximum crush was 4 cm (1.6 in) occurring at C₃. The left side wheelbase was unchanged and there was no induced damage. The sill height was 40 cm (15.7 in). The height of the maximum door crush was 50 cm (19.7 in) and the door sill differential was 0 cm.

Figure 3: Left plane damage on GMC

Damage Classification Event 1: The GMC’s Collision Deformation Classification (CDC) was 12LZES1 (350 degrees). The WinSMASH program could not be used to calculate Delta V on this impact since sideswipe type impacts are out of scope for the. The severity of the damage was minor.

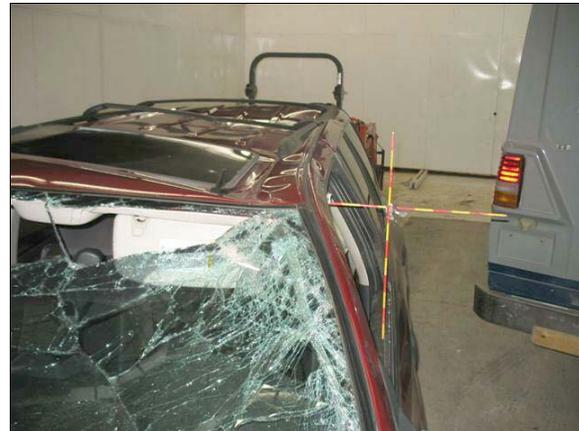
Direct damage on the top plane consisted of light scratches, 75 cm (29.5 in) rear of the left front axle, immediately forward of the sunroof glazing. Direct contact extended 262 cm (103 in) along the left side luggage rack rail which was bent inward. There were scratches on the right roof side rail near the right A-pillar and on the right rear portion of the roof. There was no discernable damage from the rollover on the hood. The maximum vertical crush was 10 cm (3.9 in) and occurred on the roof near the left front corner of the sunroof (**Figure 4**). The maximum lateral crush was 3 cm (1.2 in) and occurred at the left roof side rail over the center of the left front door (**Figure 5**).

Damage Classification Event 2: The CDC for the rollover was 00TZDO3 for the rollover. The WinSMASH program could not be used to calculate Delta V since rollovers are out of scope for the program. Based on the extent of the roof crush, the severity of the rollover damage was moderate.

Figure 4: Vertical maximum crush to roof of the GMC

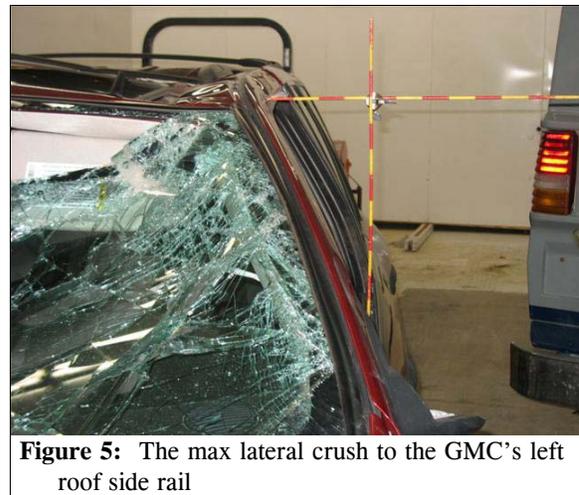
Figure 5: The max lateral crush to the GMC's left roof side rail

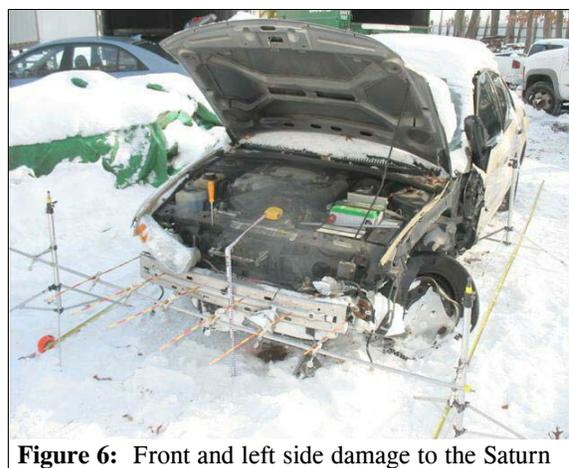
Exterior Damage Event 1: The Saturn sustained damage on the front and left planes during the impact with the left plane of the GMC. The Saturn’s front bumper, left fender, hood, left front wheel, and left front door were directly damaged. The direct damage began at the front left bumper corner and extended 2 cm (0.8 in) along the bumper (**Figure 6**). Crush measurements were taken on the bumper and the residual maximum crush was 1 cm (0.4 in) occurring at C₁. This impact was a narrow end engagement and the damage extended down the left side onto the left front wheel and left front door. The left wheelbase was reduced 12 cm (4.7 in) and the right wheelbase was extended 2 cm (0.8 in).

Figure 6: Front and left side damage to the Saturn

Damage Classification Event 1: The CDC for the Saturn’s impact with the GMC was 12FLES6 (10 degrees). The WinSMASH program could not be used to calculate Delta V on this impact since sideswipe type impacts are out of scope for the program. The severity of the damage was minor.
