TRANSPORTATION RESEARCH CENTER
School of Public and Environmental Affairs

ON-SITE SIDE IMPACT INFLATABLE OCCUPANT PROTECTION INVESTIGATION

CASE NUMBER - IN11002
LOCATION - MISSOURI
VEHICLE - 2008 HYUNDAI ELANTRA SE
CRASH DATE - November 2010

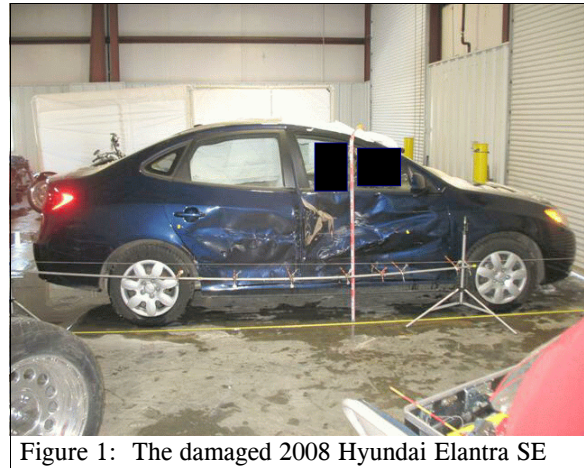
Figure 1: The damaged 2008 Hyundai Elantra SE

The Hyundai sustained right plane damage during the impact with the Ford. The right side doors and quarter panel were directly damaged. The direct damage began 78 cm (30.7 in) rear of the right front axle and extended 163 cm (64.2 in) rearward along the right plane. Crush measurements were taken at the lower door level and the maximum residual crush was 14 cm (5.5 in) occurring 23 cm (9.1 in) forward of C₄. The height of the maximum door crush was 44 cm (17.3 in) and occurred on the lower center portion of the right front door. The door sill differential was 8 cm (3.1 in). The height of the sill was 31 cm (12.2 in). The vehicle's wheelbase was unchanged by the impact.

The Collision Deformation Classification (CDC) was 02RPEW2 (60 degrees). The Damage algorithm of the WinSMASH program calculated the total Delta V as 19 km/h (11.8 mph). The longitudinal and lateral velocity changes were -10 km/h (-6.2 mph) and -16 km/h (-9.9 mph), respectively. Based on the damage to both vehicles, the results appeared reasonable.

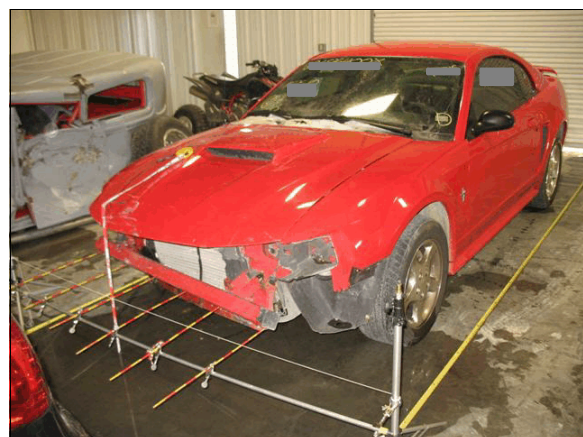
Figure 4: Damage to the front plane of the Ford from the impact to the right side plane of the Hyundai

The Ford sustained front plane damage during the impact with the Hyundai. The direct damage began at the front right bumper corner and extended across the full width of the front plane, 152 cm (59.8 in) across the frontal plane. The crush measurements were taken at the bumper level and the residual maximum crush was 26 cm (10.2 in) occurring at C₆.

The CDC was 11FDEW1 (340 degrees). The Damage algorithm of the WinSMASH program calculated the total Delta V as 19 km/h (11.8 mph). The longitudinal and lateral velocity changes were -18 km/h (-11.2 mph) and 6 km/h (3.7 mph), respectively.

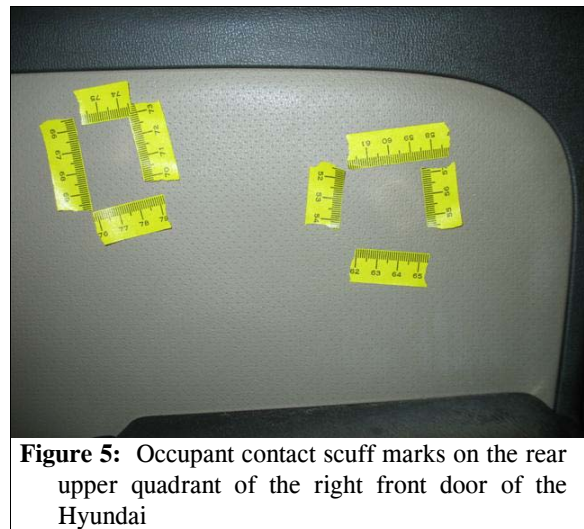
The front right passenger loaded through the seat-mounted side impact air bag and contacted the rear upper quadrant of the right front door (**Figure 5**). No other occupant contacts were observed.

Figure 5: Occupant contact scuff marks on the rear upper quadrant of the right front door of the Hyundai

Injury Number	Injury Description	AIS 2005/08	Injury Source	Confidence Level
1	Fracture right 7 th rib, laterally	450201.1,1	Right front door panel, rear upper quadrant	Certain
2	Contusion (hematoma), 15.2 cm (6 in) long, right forearm, not further specified	710402.1,1	Right front door panel, rear upper quadrant	Certain

The frontal impact by the Ford on the right plane of the Hyundai displaced the front right passenger to the right and forward, opposite the 2 o'clock direction of force. She loaded through the deployed seat-mounted side impact air bag and contacted the rear upper quadrant of the right front door, which caused a fracture of the 7th right rib and a contusion on the right forearm.

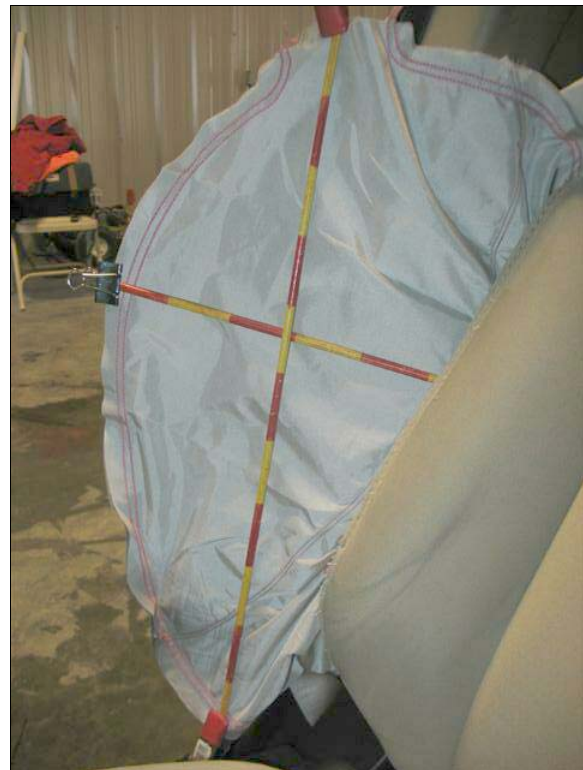
The deployed front right seat-mounted side impact air bag was oblong in shape and was 27 cm (10.6 in) in width and 50 cm (19.7 in) in height (**Figure 6**). There was one 8 cm (3.1 in) wide vent port at the top of the air bag. The air bag deployed through a tear seam on the outboard side of the seat back. Inspection of the air bag revealed no discernable evidence of occupant contact and no damage.

Figure 6: The Hyundai's front right seat-mounted side air bag

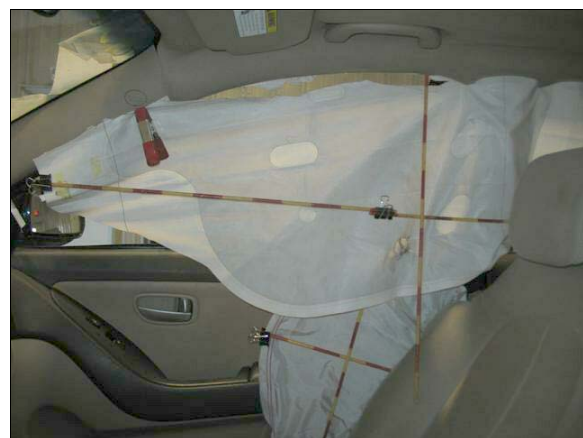
The deployed right IC air bag extended from the A-pillar to the C-pillar (**Figure 7**). There were no external vent ports. The IC was 170 cm (55.1 in) in width and 32 cm (12.6 in) in height,

Figure 7: The Hyundai's right IC air bag

and was attached to the A-pillar by a 15 cm (5.9 in) nylon tether. The IC did not extend below the beltline. Inspection of the IC revealed no discernable evidence of occupant contact and no damage.
