CALSPAN ON-SITE ROLLOVER CRASH INVESTIGATION

SCI CASE NO.: CA11003

VEHICLE: 2007 BMW 328i COUPE

LOCATION: NORTH CAROLINA

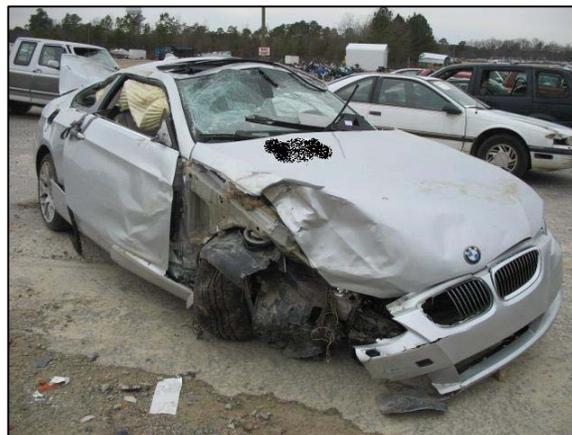
Figure 1: Front right oblique view of the 2007 BMW.

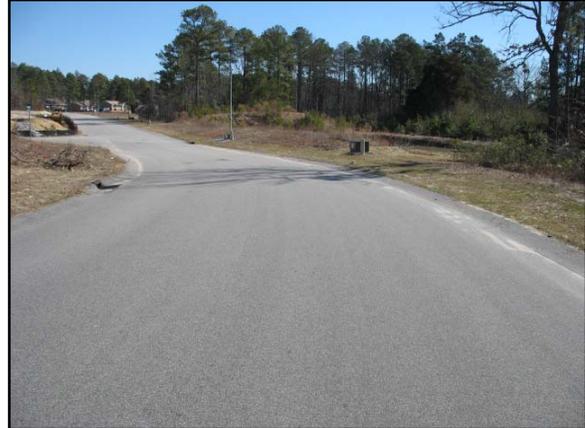
This crash occurred during early morning hours of December 2010 on a two-lane residential roadway with a posted 40 km/h (25 mph) speed limit. **Figure 2** depicts the approach to the crash site. At the time of the crash, the police-reported environmental conditions were cloudy, dry and dark but lighted. The roadway extended north/south in the area in which the crash occurred and included a left curve with a radius of curvature of 95 m (311 ft). There was a negative grade of 1 percent in the northbound approach to the crash site. The roadway was not marked and was 9 m (29.5 ft) in width.

Figure 2: Northbound trajectory view of the BMW prior to the roadside departure.

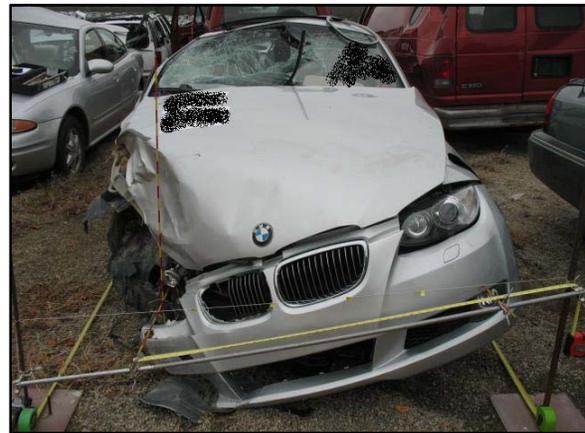
The front plane of the BMW sustained moderate severity damage as a result of the embankment impact (Event 1). Event 1 damage is depicted in **Figure 3**. The direct damage began 20 cm (7.9 in) right of the vehicle centerline, and extended right 50 cm (19.7 in). The maximum crush was located at C6, the front right bumper corner, and measured 29 cm (11.4 in). The combined direct and induced damage (Field L) extended across the full width of the front bumper. A residual crush profile was documented along the front

Figure 3: Front right corner damage to the BMW.

bumper and was as follows: C1 = 0 cm, C2 = 0 cm, C3 = 3 cm (1.2 in), C4 = 16 cm (6.3 in), C5 = 22 cm (8.7 in), C6 = 29 cm (11.4 in). The right front wheel was deformed and displaced rearward. The right wheelbase was shortened by 47 cm (18.5 in). The yielding nature of the embankment invalidated the full use of the WinSMASH program to calculate the severity of the crash. A Barrier Equivalent Speed (BES) of 21 km/h (13 mph) was calculated using the Barrier Algorithm. The Collision Deformation Classification (CDC) assigned for the damage pattern was 01FZEW2.

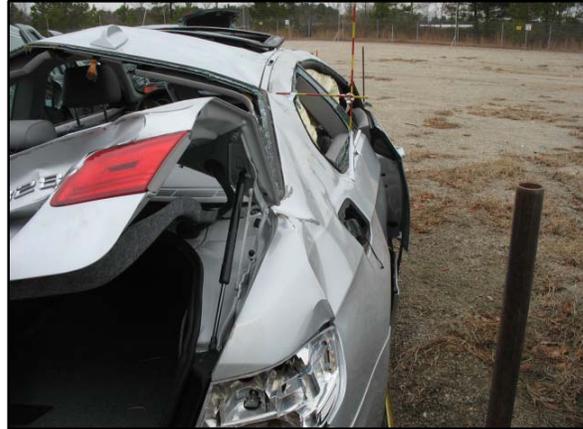
The BMW's right, left and top planes sustained moderate severity damage as a result of the rollover (**Figure 4**). On the right side, the direct contact damage began at the right front bumper corner and extended rearward 390 cm (153.5 in) to the trunk lid/taillight area. The direct contact damage to the roof extended 105 cm (41.3 in) laterally from the side rail to side rail. The maximum vertical and lateral deformations were located at the right C-pillar, 9 cm (3.5 in) forward of the junction of the right roof side rail and the backlight header. The maximum residual deformation measured 11 cm (4.3 in) laterally and 10 cm (3.9 in) vertically. The CDC assigned for the rollover event was 00RDAO3.

Figure 4: Rollover damage to the right side of the BMW.

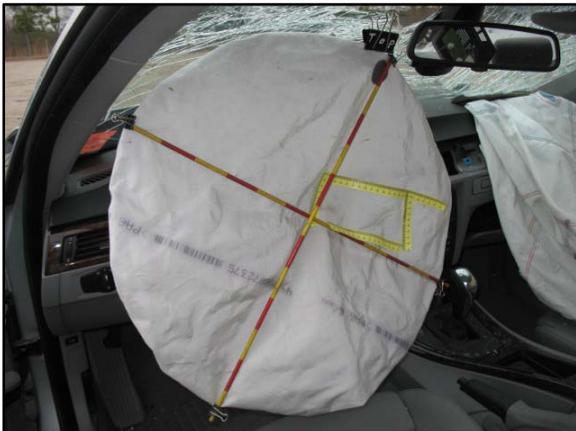
Figure 5: Driver's frontal air bag.

o'clock positions. There were no tethers present. Examination of the driver's air bag showed two deployment transfers and one occupant contact. The first deployment transfer was centered on the front of the air bag and measured 6 cm (2.4 in) in width and 8 cm (3.1 in) in height. The second deployment transfer was located on the lower rear aspect of the air bag and measured 8 cm (3.1 in) in height and 22 cm (8.7 in) in width. The contact was a scuff that was attributed to

the driver's face, located 5-18 cm (2-7.1 in) right of the vertical centerline of the air bag and 1-5 cm (0.4-2 in) above the horizontal centerline of the air bag. **Figure 5** depicts the deployed driver's air bag. The driver's air bag was labeled with the ID number 448906072375.

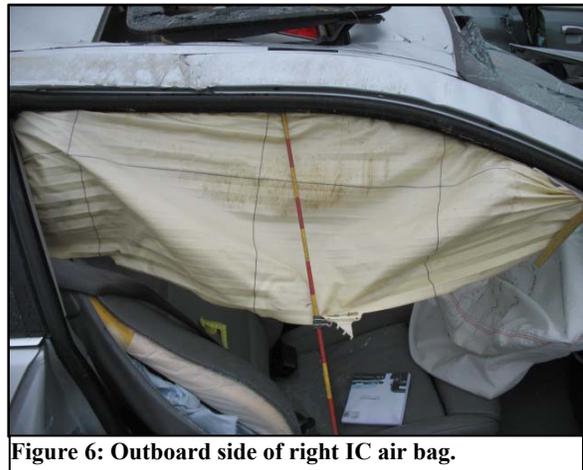
The right IC air bag deployed from the right roof side rail. The IC measured 195 cm (76.8 in) in length. It was 34 cm (13.4 in) in height at the front row and 18 cm (7.1 in) in height at the second row. Vertically, the IC air bag extended below the belt line at both seating positions. The right IC provided full coverage across the right greenhouse area of the BMW. At the forward aspect of the right IC was a non-inflated sail panel. The panel measured 20 cm (7.9 in) in height and 14 cm (5.5 in) in width at the upper aspect, curving to 26 cm (10.2 in) in width at the lower aspect. There was dirt present on the lower aspect of the inboard side of the right IC, and a scuff mark with mud on the outboard side of the right IC that resulted from contact with the ground. The mark on the outboard side was 6-17 cm (2.4-6.7 in) below the right roof side rail and 15-60 cm (5.9-23.6 in) forward of the right B-pillar. **Figure 6** depicts the outboard side of the right IC.

Figure 6: Outboard side of right IC air bag.

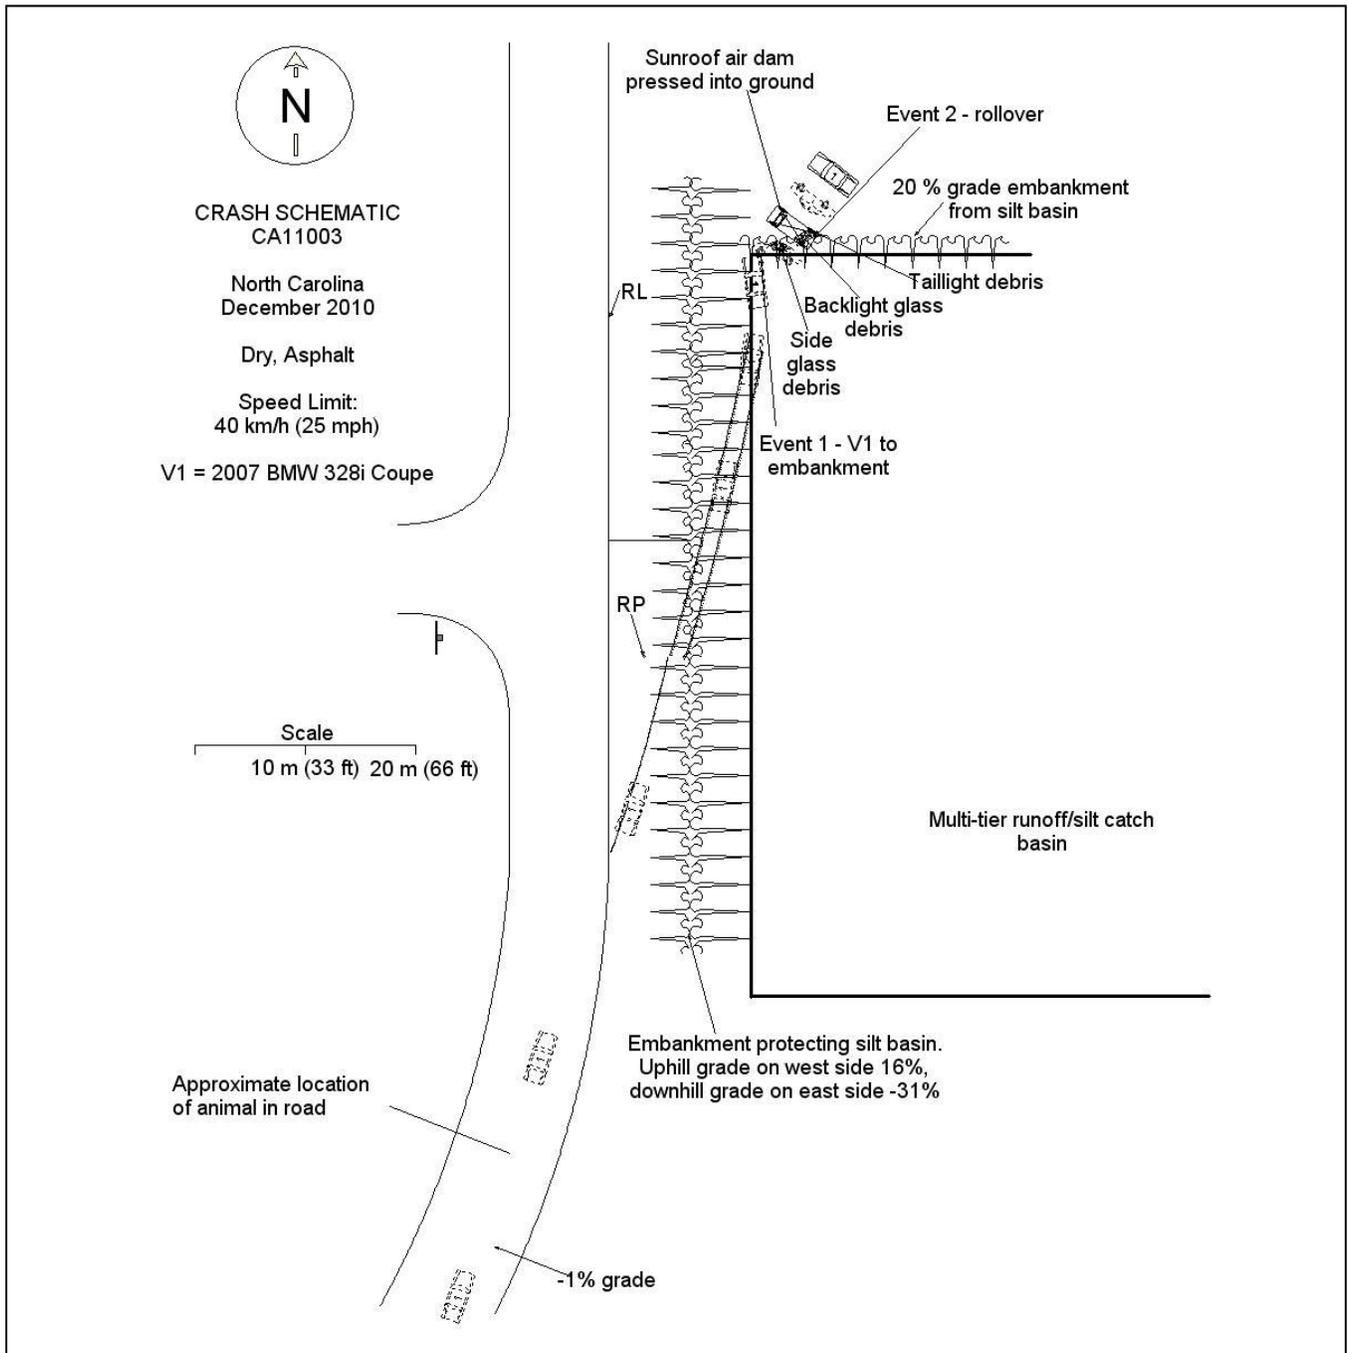
SCENE DIAGRAM

Outboard of the roadway was a grass roadside and a catch basin protected by earth embankments. The roadside had a positive grade of 1 percent for 4 m (13.1 ft) before sloping uphill with a positive grade of 16 percent for 3.6 m (11.8 ft) to the top of the embankment. From the top of this embankment, the grade then transitioned to a downhill grade of -31 percent for 5.4 m (17.7 ft) to the catch basin. The catch basin was partially filled with water. At the north end of this catch basin was a second embankment that extended perpendicular to the east. This embankment had an uphill 20 percent grade and was the point of impact. A Scene Diagram is included at the end of this report.
