**CALSPAN ON-SITE ROLLOVER CRASH INVESTIGATION**

**SCI CASE NO.: CA11009**

**VEHICLE: 2011 MERCEDES-BENZ ML350**

**CRASH DATE: FEBRUARY 2011**

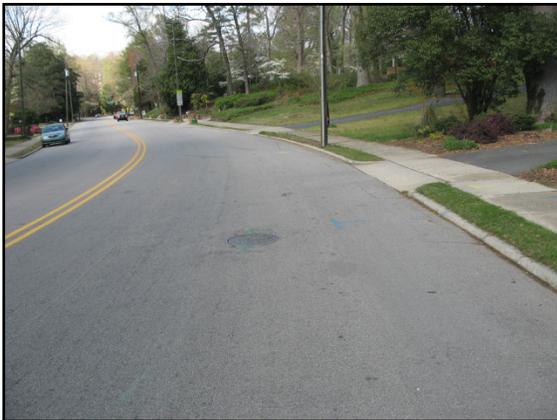
**Figure 2: Eastbound trajectory view of the Mercedes approaching the road departure and the initial utility pole impact.**

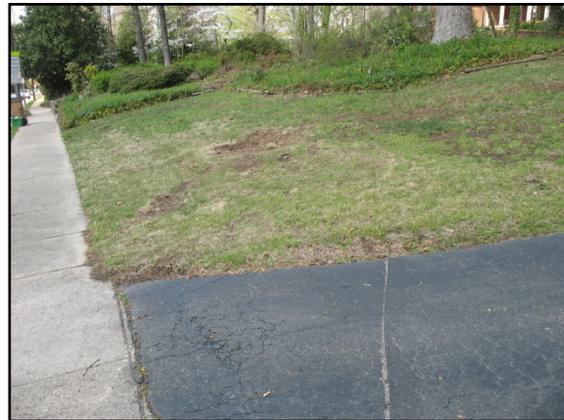
**Figure 3: Eastbound trajectory view of the Mercedes at the initiation of the rollover.**

Adjacent to the east edge of the driveway was a narrow depression in the grass that measured 31 cm (12 in) in width and 8 cm (3 in) in depth. The left wheels of the Mercedes entered this depression, furrowed and tripped the vehicle into a left side leading rollover (Event 3). The rollover resulted in the deployment of the IC air bags on both sides of the Mercedes. The vehicle

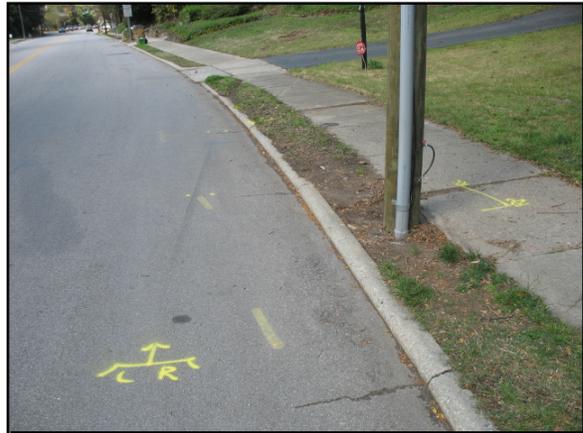
The driver of the Mercedes was operating the vehicle eastbound, negotiating the left curve, at a police-reported speed of 56 km/h (35 mph). The Mercedes departed the roadway to the right in a tracking attitude at a shallow angle of approximately 3 degrees. The front right corner of the Mercedes approached the utility pole on the south roadside. Based on the SCI scene inspection, there was no evidence of braking or steering avoidance maneuvers prior to the initial impact with the utility pole (**Figure 4**).

**Figure 4: Eastbound trajectory view of the Mercedes at the initial (Event 1) point of impact.**

The front right corner (front plane) of the Mercedes impacted the 36 cm (14 in) utility pole (Event 1). The pole was completely fractured by the impact and had been replaced at the time of the SCI scene inspection. The force of this impact caused the actuation of the first and second row outboard safety belt pretensioners and the deployment of the CAC driver and front right passenger's frontal air bags in the Mercedes. The impact with the utility pole induced a CW yaw to the vehicle. A yaw mark on the asphalt roadway was attributed to its rear left tire. The Mercedes was equipped with Electronic Stability Control (ESC); however, ESC was an ineffective countermeasure of the induced yaw due to the force of the impact. As the left front wheel crossed the curb, it produced a furrow in the grass area and a yaw mark across the concrete sidewalk. The total length of the yaw marks measured 17 m (55.8 ft) and 11.2 m (36.7 ft) for the left rear and left front tires, respectively.

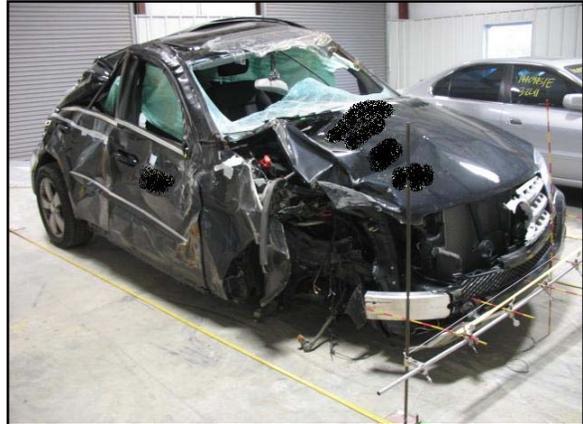
The front, left, and right planes of the Mercedes sustained moderate damage, and the top plane sustained severe damage in this multiple event crash sequence (**Figure 5**). The Event 1 impact damage with the utility pole was located at the front right corner of the Mercedes. The direct contact damage began at the corner and extended rearward along the right side of the vehicle a length of 84 cm (33.1 in) and ended aft of the right front wheel well. On the front plane, the direct damage began 55 cm (21.7 in) right of the vehicle centerline and extended right 14 cm (5.5 in) to the front right bumper corner. The combined direct and induced damage extended along the full width of the front bumper. The maximum crush to the front bumper was located at C6, the right bumper corner, and measured 16 cm (6.3 in). A residual crush profile was documented along the full width of the front bumper reinforcement and was as follows: C1 = 0 cm, C2 = 2 cm (0.8 in), C3 = 4 cm (1.6 in), C4 = 1 cm (0.4 in), C5 = 1 cm (0.4 in) and C6 = 16 cm (6.3 in). The front right wheel separated from the vehicle and was not available for inspection. Based on the location of the remaining right front suspension components, the right wheelbase was shortened by 40 cm (15.7 in). The corner configuration and yielding of the utility pole for this Event 1 impact invalidated a full reconstruction with the WinSMASH program; however a Barrier Equivalent Speed (BES) of 14 km/h (8.7 mph) was calculated by the Barrier Algorithm of the program. The BES under-estimated the severity of the impact and the results were considered to be low. The CDC assigned to the initial impact was 12FREE4.

**Figure 5: Front right oblique view of initial impact damage to the Mercedes.**

The initial impact with the utility pole caused the Mercedes to initiate a Clockwise (CW) yaw. The shearing of the pole allowed the vehicle to maintain its trajectory to the east. The front plane of the Mercedes impacted a mailbox (Event 2). This frontal damage from the Event 2 impact was overlapped by the initial impact and subsequent rollover damage, and was not measured.

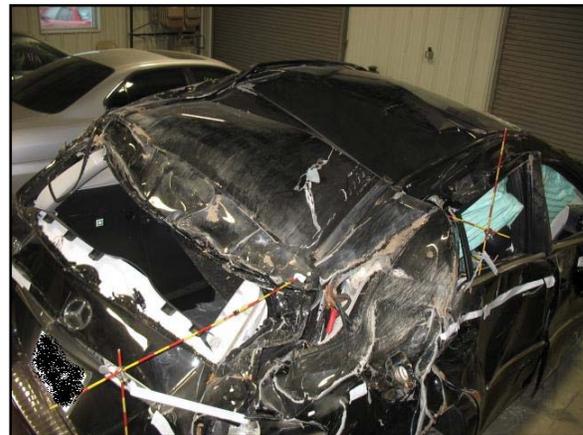
The top plane of the Mercedes sustained severe damage and the left and right planes sustained moderate damage as a result of the rollover (Event 3). This damage is depicted in **Figure 6**. On the top plane, the direct damage began at the

**Figure 6: Overhead view of the Mercedes from the right rear corner.**

leading edge of the hood and extended rearward 423 cm (166.5 in) to the backlight header encompassing the 132 cm (52 in) width of the roof from side rail to side rail. The greatest vertical deformation to the greenhouse area was located over the cargo area, at the junction of the right D-pillar and the backlight header. The residual vertical deformation measured 39 cm (15.4 in). Over the passenger compartment, the greatest vertical deformation was located on the right roof side rail 6 cm (2.4 in) aft of the right rear window quarter glass divider. The residual vertical deformation in this area measured 28 cm (11 in). The greatest lateral deformation was also located on the right roof side rail (C-pillar area) 6 cm (2.4 in) aft of the right rear window quarter glass divider. The residual lateral deformation was 5 cm (2 in). The CDC assigned for the rollover event was 00TDDO4.

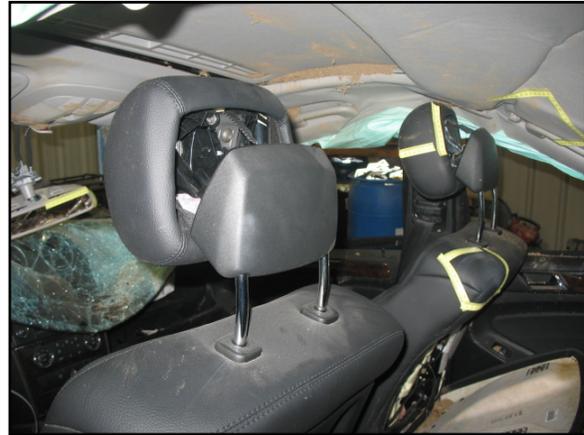
restraint, and the right roof slightly aft of the right B-pillar. The evidence on the back of the driver's seat was attributed to the second row passenger's left knee. This contact evidence was located 21-28 cm (8.3-11 in) below the top of the seat and 5-12 cm (2-4.7 in) inboard of the left edge of the seat. The scuff mark located on the upper left corner of the front right seatback measured 10 cm (3.9 in) in width and 12 cm (4.7 in) in height and was attributed to the passenger's chest. The scuff mark on the inboard aspect of the front right head restraint was located 0-8 cm (0-3.1 in) below the top of

**Figure 7: Left lateral view of the contacts within the Mercedes second row.**

the head restraint and 0-7 cm (0-2.8 in) aft of the front of the head restraint. This contact was attributed to the passenger's head. The scuff mark on the interior of the roof was located 17-36 cm (6.7-14.2 in) aft of the right B-pillar and 15-26 cm (5.9-10.2 in) inboard of the right roof side rail. This contact was also attributed to the second row passenger's head. **Figure 7** is an interior view depicting the contacts within the second row of the Mercedes.

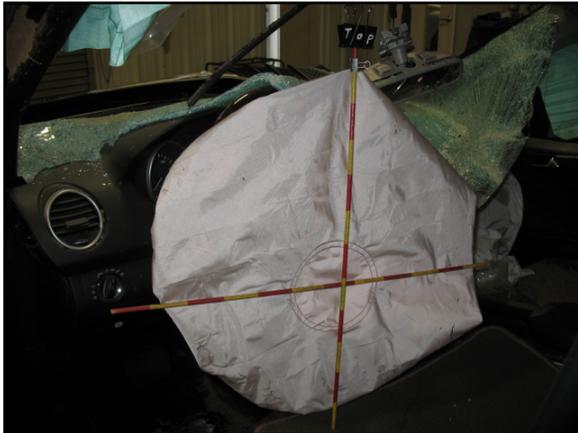
The driver's frontal air bag was mounted within the center hub of the four-spoke steering wheel by a five-flap design. The upper center cover flap measured 6 cm (2.4 in) in width and 8 cm (3.1 in) in height. The upper left and right flaps were triangular in shape and measured 3 cm (1.2 in) in width and height. The lower flaps measured 6 cm (2.4 in) in height and 8 cm (3.1 in) in width. There was no damage present to the cover flaps. The driver's air bag measured 68 cm (26.8 in) in diameter in its deflated state. It was vented by two ports in the upper rear aspect of the air bag that were located at the 11 and 1 o'clock positions. There were two internal tethers that attached to the 12 and 6 o'clock positions of a 14 cm (5.5 in) circular tether sewn to the center face of the air bag. The deployed-shape of the air bag was also controlled by two lines of tear threads on the front of the air bag. These threads were arranged in stitch pattern, 3 cm (1.2 in) apart, which extended from the 6 o'clock sector of the air bag to 3 and 9 o'clock positions, respectively. There was no crash-related damage to the driver's air bag. Two small areas of post-crash blood droplets were observed on the air bag. One was located in the front upper right quadrant of the

air bag and the other located in the upper left quadrant on the back side of the air bag. The deployed frontal air bag is depicted in **Figure 8**.

**Figure 8: Overall view of the driver's frontal air bag in the Mercedes.**

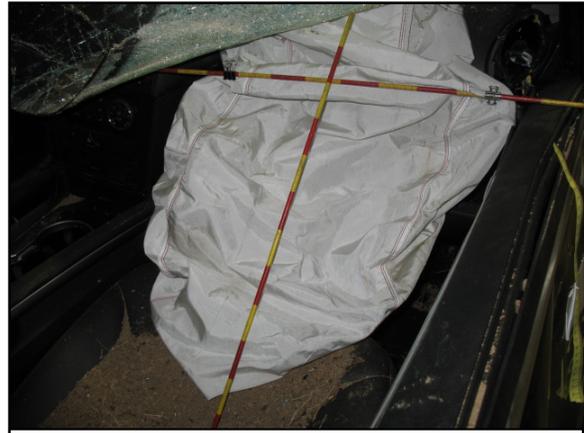
**Figure 9: Overall view of the Mercedes front right passenger's air bag.**

The front right passenger's frontal air bag (**Figure 9**) was mounted within the upper aspect of the right instrument panel by a single cover flap. This flap measured 25 cm (9.8 in) in width and 12 cm (4.7 in) in height. The deflated air bag was 60 cm (23.6 in) in height and 38 cm (15 in) in width. It was vented by a single vent port at the upper right side of the air bag, and had no internal tethers. There was no crash related damage to the front right air bag. There was an area of post-crash blood located at the lower right on the side of the air bag that measured 15 cm (5.9 in) in width and 28 cm (11 in) in height.

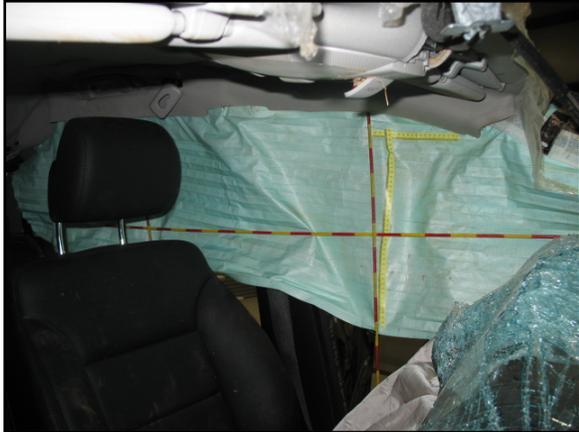
**Figures 10 and 11** depict the inboard sides of the left and right IC air bags, respectively. The inboard side of the left IC contained a scuff mark that was attributed to the left side of the driver's head in an area adjacent to the front left seating position. This scuff mark was located 6-41 cm (2.4-16.1 in) below the top of the left IC and 24-34 cm (9.4-13.4 in) aft of the front edge of the air bag. A scuff mark was also present on the inboard side of the right IC, adjacent to the front right seating position. This scuff mark was located 3-32 cm (1.2-12.6 in) below the top of the IC and 31-43 cm (12.2-16.9 in) aft of the front edge of the air bag and was attributed to the

**Figure 10: View of the Mercedes left IC, including the driver contact.**

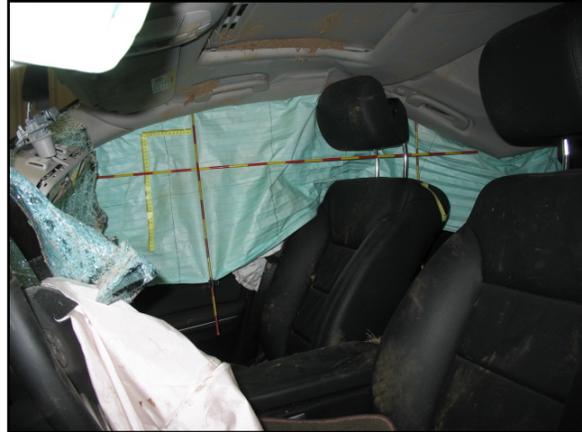
**Figure 11: View of the Mercedes right IC including the front right passenger contact.**

front right passenger's head. On the outboard side of the right IC, at the right front window, were two abrasions from contact with the ground. The first was in the upper left quadrant of the right front window, 6-16 cm (2.4-6.3 in) below the top of the IC and 2-17 cm (0.8-6.7 in) forward of the right B-pillar. The second ground contact abrasion was located 18-40 cm (7.1-15.7 in) below the top of the right IC and 19-41 cm (7.5-16.1 in) aft of the front edge of the right IC.

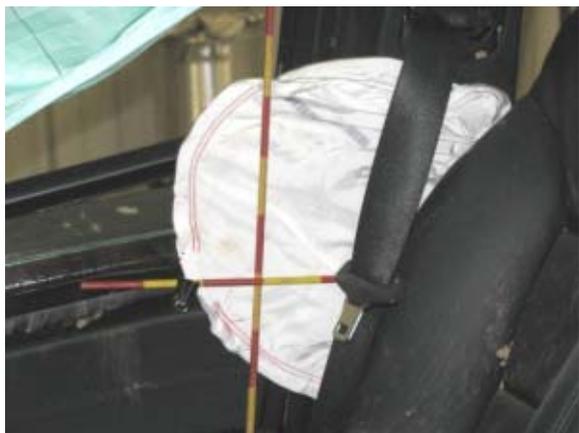
The two right side impact air bags of the Mercedes also deployed during this crash sequence (**Figures 12 and 13**). The front right side air bag deployed from a 32 cm (12.6 in) tear seam in the upper outboard aspect of the front right seatback. The deflated air bag measured 18 cm (7.1 in) in width and 26 cm (10.2 in) in height. It was vented by one port located slightly below the forward 3 o'clock position on the air bag. The right side air bag was not tethered. It was not damaged and did not contain any crash related evidence. The second row right side air bag deployed from a 36 cm (14.2 in) tear seam in the upper outboard aspect of the seatback.

**Figure 12: Lateral view of the front row right side impact air bag.**

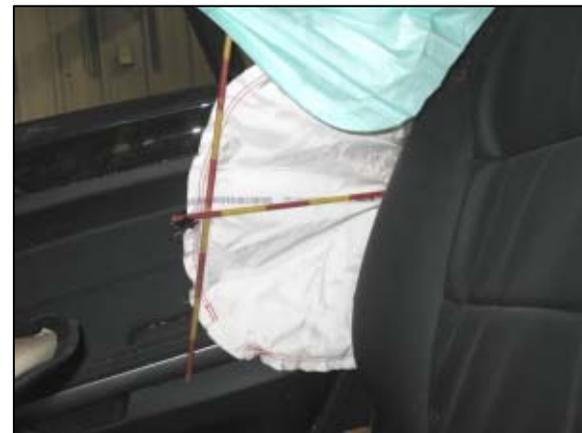
**Figure 13: Lateral view of the second row right side impact air bag.**

This air bag was 22 cm (8.7 in) wide and 32 cm (12.6 in) in height. It was vented by a single vent port at the forward 4 o'clock position. No crash related evidence was identified on this air bag during its inspection.

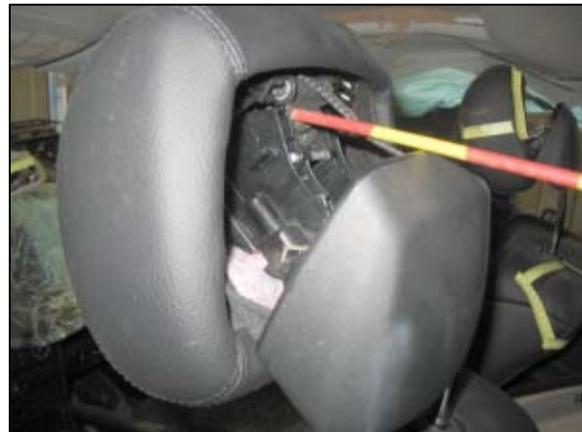
At the time of the SCI inspection, the front right seat was found in the full-rear position. Both front head restraints were in a raised position and had opened forward on a spring-loaded mechanical hinge (**Figure 14**). The SCI inspection revealed that the front windows were closed before disintegrating as a result of the crash due to the presence of glazing fragments in the tracks and seals of the window frames. The sunroof was closed post-crash. The driver stated that he had no recollection of the crash during his interview. He was unaware of the pre-crash position of the windows or sunroof.

**Figure 14: Front row head restraints raised and hinged forward.**
