NASS/SCI COMBINED AIR BAG DEPLOYMENT INVESTIGATION

CALSPAN CASE NO. 1997-06-140K

VEHICLE - 1997 GEO METRO

CRASH DATE - OCTOBER, 1997

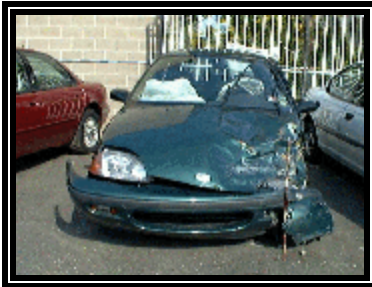
Figures 3 and 4 below are front and left front views of the Geo Metro respectively. The resultant direct contact damage to the Geo began at the left corner of the front bumper and extended 61 cm (24 in) to the right. The NASS researcher measured 34 cm (13 in) of bumper deformation at the left front corner. The Collision Deformation Classification (CDC) for the Geo was 11-FYEW-2. The measured crush profile for vehicle is specified in the table below.

Figure 3: Front view of the Geo Metro.

The Geo's damage at the bumper elevation extended upward and rearward onto the left front corner of the hood. The impact foreshortened the left side wheelbase 10 cm (4 in). The deformation restricted the rotation of the left front tire and the tire was deflated. The left front fender deformed rearward in the impact, jamming the left door and fracturing the left lower corner of the windshield. There was evidence along the leading edge of the door that the door was pried open during the rescue process. The left door window glazing was also shattered in the impact.

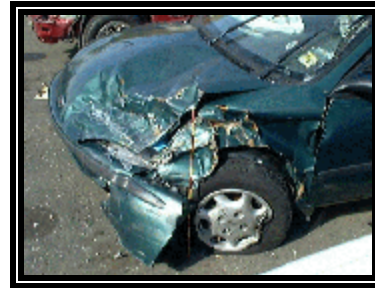
Figure 4: Left front view of the Geo.

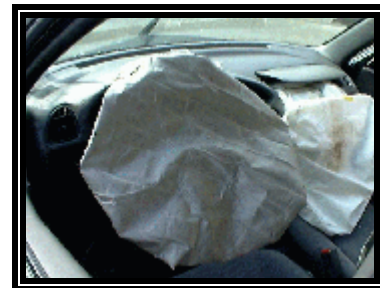
The Supplemental Restraint System in the Geo consisted of driver and front passenger air bags that had deployed as a result of the crash. The driver side air bag module was located in the typical configuration in the center of the steering wheel. The steering wheel was fixed and there was no steering wheel rim deformation. The air bag had deployed normally from the module (Figure 5). The H-configuration module cover flaps were symmetrical and measured 15.5 cm (6.1 in) in width. The height of the upper flap and lower flap measured 6.0 cm (2.4 in) and 8.0 cm (3.1 in) respectively. The driver side air bag measured 56 cm (22 in) in diameter in its deflated state and was tethered by 4 internal straps. The air bag was vented by two ports located on the back side of the bag in the 10 and 2 o'clock sectors. The air bag was spattered with blood in the 6 and 9 o'clock sectors. These spatters were unrelated to

Figure 5: Driver air bag.

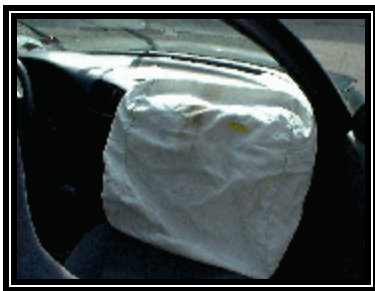
direct contact. The passenger side air bag module was a top mount configuration located on the right side of the instrument panel (Figure 6). The hinged module cover flap measured 35.5 cm (14.0 in) by 16.0 cm (6.3 in) width by height. There was no deformation or witness marks on the cover flap. The passenger side air bag was rectangular and measured 47.0 cm (18.5 in) by 50.0 cm (19.7 in), width by height, in its deflated state. There was a large blood smear on the top surface of the air bag

Figure 6: Front passenger air bag.

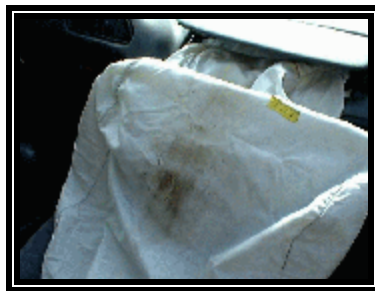
(Figure 7). This transfer was attributed to contact with the right front passenger’s head and neck. Directly forward of the cover flap on the windshield was an area of tissue/blood transfers. This area was in-line with the blood smear on the passenger air bag fabric and was transferred during the fabric’s contact with the windshield (Figure8). The center mirror was also displaced from passenger air bag contact.

Figure 7: Close-up view of blood transfers to the air bag.

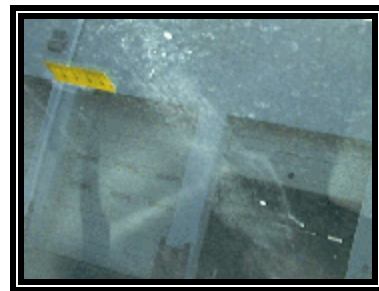
Figure 8: Close-up view of windshield transfers.
