Remote/Combo Investigation/Vehicle to Vehicle to Vehicle/ Front to Rear-Side to Rear

Dynamic Science, Inc. / Case Number: 1997-75-085J

1997 Ford Escort LX Station Wagon

1. Report No. 1997-75-085J		2. Government Accession No.		3. Recipient Catalog No.	
4. Title and Subtitle In-Depth Accident Investigation Lakewood, Colorado				5. Report Date August, 1997

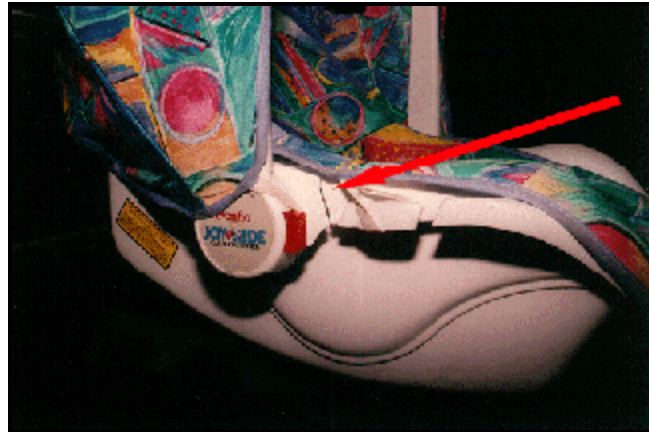
At impact, both right front seat occupants moved forward. The right front seat back was also being heavily loaded by a rear seat occupant. The infant seat impacted the instrument panel and glove box door. This impact occurred simultaneously with the air bag deployment.

The right side of child pitched forward and struck the right sidewall of the child seat—causing the right side head injuries. The deploying air bag pushed the child seat backwards (left side leading) where it came to a stop as a result of contact with the front right passenger who was now being loaded from the rear by the rear seat occupant. The child essentially then pitched rearward and struck the left interior sidewall of the infant seat. The child sustained numerous skull fractures bilaterally with associated subdural, subarachnoid, intraventricular hemorrhage and cerebral edema. There were no soft tissue injuries that would normally be associated with air bag interaction (i.e., facial abrasions). The combination of air bag forces in conjunction with instrument panel loading may account for the numerous injuries sustained to the right side of the child’s head. The left side (head) injuries are probably due to a rebound impact back into the infant seat.

Figure 2. View of cracked infant seat due to instrument panel and air bag contact

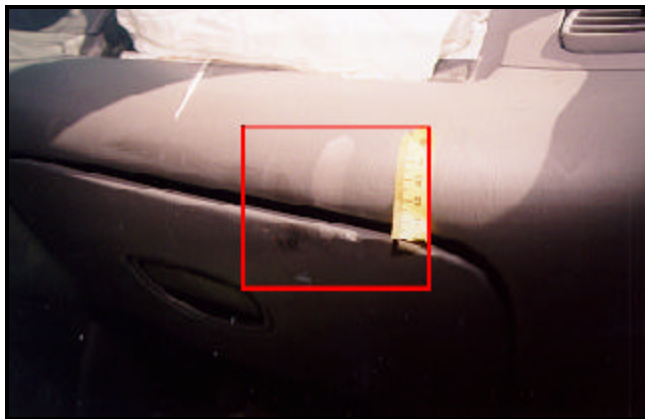
Figure 3. Closeup of instrument panel contact with infant seat (white mark)
