On-Scene / Vehicle to Vehicle / Front to Left Side
Dynamic Science, Inc. / Case Number: DS97001
1995 Dodge Caravan
Colorado
January, 1997

1. Report No. DS97001		2. Government Accession No.		3. Recipient Catalog No.	
4. Title and Subtitle In-Depth Accident Investigation				5. Report Date February/1998

**Dynamic Science, Inc.
Accident Investigation
Case Number: DS97001**

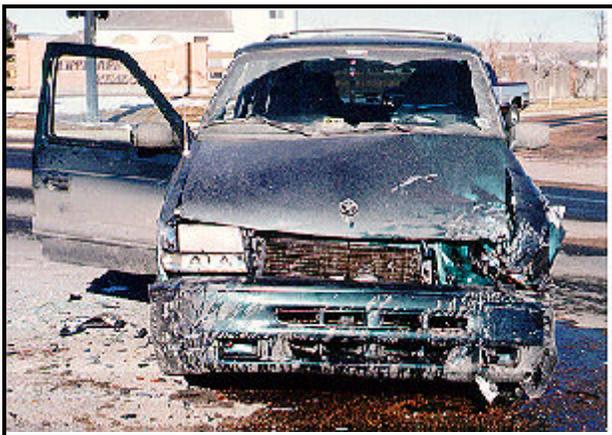
Description:	1995 Dodge Caravan van	
VIN:	2B4GH45RXXSRXXXXXX	
Odometer:	29,5888 km (18,386 mi)	
Engine:	3.3 L V6	
Reported Defects:	None	
Cargo:	None	
Damage Description:	Moderate damage across the front bumper, hood, grille area, left front quarter panel, and the windshield (see Figure 1).	
CDC:	12FDEW1	
Delta V: ¹	Total	16.7 km/h (10.4 mph)
	Longitudinal	-16.4 km/h (-10.2 mph)
	Latitudinal	-2.9 km/h (-1.8 mph)
	Energy	19,057 joules (14,065 ft-lbs)

Figure 1. Exterior damage to Vehicle 1.

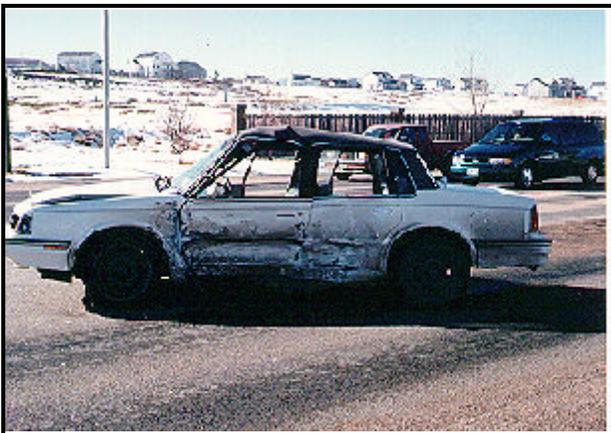
Description:	1986 Oldsmobile Cutlass Cierra LS	
VIN:	1G3AJ19X9GDXXXXXX	
Odometer:	Unknown	
Engine:	2.8 L V6	
Reported Defects:	None	
Cargo:	None	
Damage Description:	<p>Vehicle 2 was not inspected. CDC was estimated from photographs taken by police at the scene of the accident.</p> <p>Moderate damage to the left side, beginning just aft of the left front wheel well and ending just forward of the left rear wheel well. Maximum crush .</p> <p>Extent zone 3 (see Figure 2).</p>	
CDC:	11LYEW3	
Delta V: ²	Total	19.5 km/h (12.1 mph)
	Longitudinal	-14.9 km/h (-9.3 mph)
	Latitudinal	12.5 km/h (7.8 mph)
	Energy	19,193 joules (14,168 ft-lbs)

Figure 2. Exterior damage to Vehicle 2.

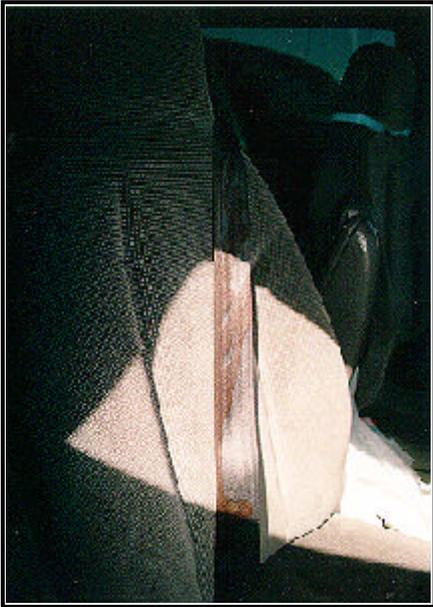
Figure 3. Blood on shoulder belt.

The right front seat was occupied by a 7-year-old male. He was seated in an upright position with the lap and shoulder restraints properly worn. A small laceration to the right side of his neck and the blood stains on the lap and shoulder belts are clear indications that the restraints were used and that he had come to rest slumped over the restraints in the center of the seat (see Figures 3 & 4). The driver asserts that the right front occupant was in a normal seated position and that he is very attentive to properly wearing the lap and shoulder restraints. The bucket seat was adjusted to the rear most seat track position.

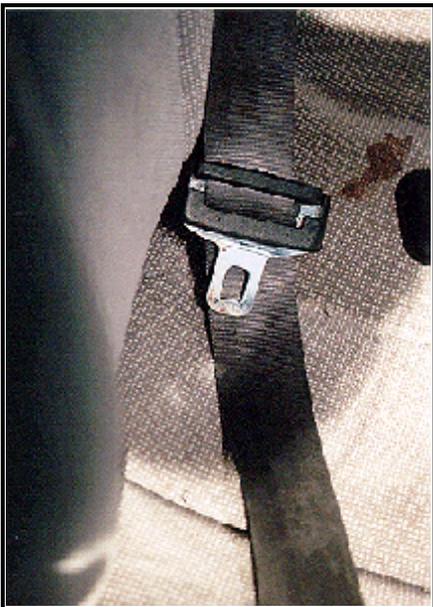
Figure 4. Blood on lap belt.
