On-Scene / Vehicle to Vehicle / Front to Back
Dynamic Science, Inc. / Case Number: DS97008
1995 Ford Crown Victoria LX
North Carolina
May/1997

1. Report No. DS97008		2. Government Accession No.		3. Recipient Catalog No.	
4. Title and Subtitle In-Depth Accident Investigation				5. Report Date September/1997

Description: This case was initiated in response to a report of a child fatality in a rear facing child seat in the right front seat position, and the interaction with the air bag.

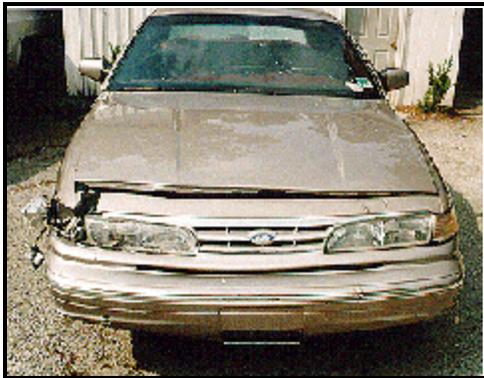
Description: 1995 Ford Crown Victoria LX
 VIN: 2FALP74W5SXxxxxxx
 Odometer: 63540 km (39483 miles)
 Engine: 4.6L 8 cyl
 Reported Defects: None
 Cargo: None
 Damage Description: Minor damage across the front bumper, and grille area.
 CDC: 12FDEW1

Figure 1. Exterior damage.

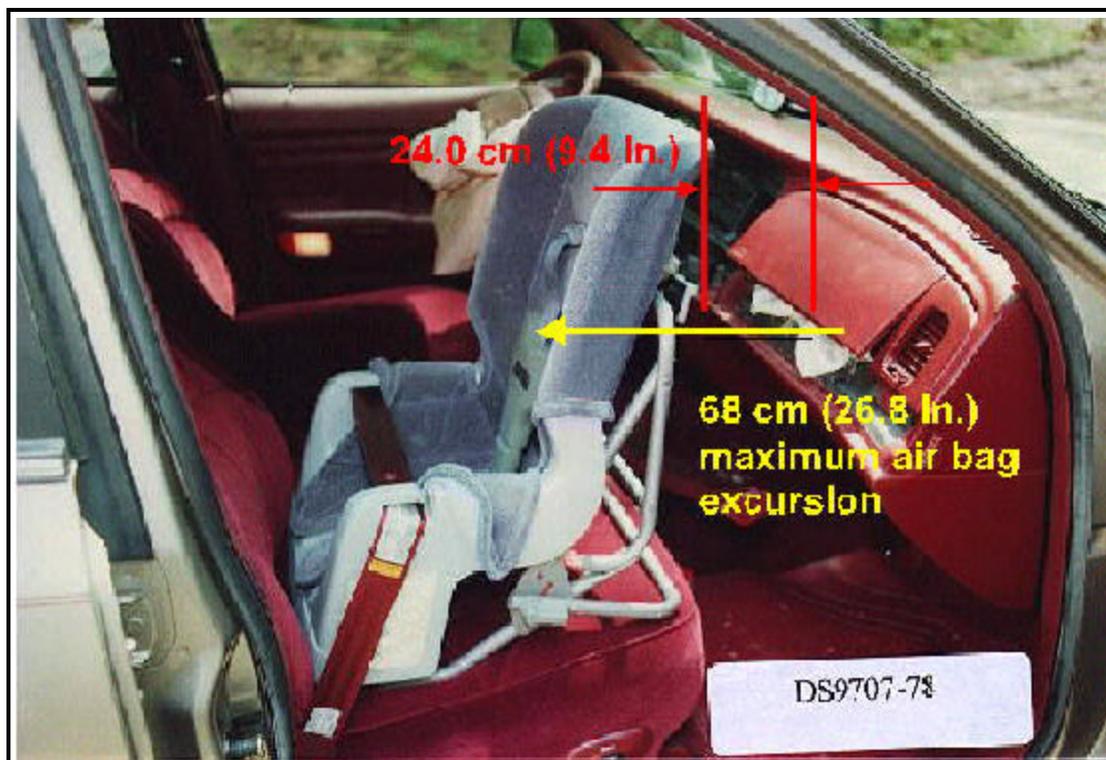
Pre-braking speed (travel speed) was 70.0 KPH (43.5 MPH). Both air bags in Vehicle 1 deployed at this time. The passenger air bag struck the back of the child seat which in turn struck the back of the child's head, and was the cause of severe closed head injuries.

Figure 1. Child seat Fisher-Price model 9100 in Vehicle 1.

was secured in the vehicle using the lap portion of the lap and shoulder belt. The lap belt was slotted through the child seat using the slots intended for the rear facing position, as is recommended. This vehicle has a switchable locking retractor type seat belt with a sliding latch. The driver was not aware of how to switch the retractor to an automatic locking retractor. She did not pull the seat belt completely out and therefore the retractor was in an emergency locking retractor mode. In this mode, the use of a locking clip is required and suggested both by the vehicle and child seat manufacturers (see photo #41). A locking clip was not in use at the time of the collision. The child was belted into the child seat using the T-shield arrangement, but the shoulder harnesses were routed through the top slots rather than the lower ones, as is recommended for a child in a rear facing position. At impact, the passenger side air bag deployed and because the retractor was in the emergency retractor mode it moved forward closer to the air bag. The deploying air bag struck the rear of the child seat, causing vertical and horizontal cracks to the rear right side of the child seat (see photos #86-87). The child seat was loaded rearward by the air bag forcing the child seatback into the back of the child's head. The majority of the child's injuries were caused by the back of the child seat.
