On-Scene / Vehicle to Vehicle / Front to Side
Dynamic Science, Inc. / Case Number: DS97009
1994 Mazda 626
California
August/1997

1. Report No. DS97009		2. Government Accession No.		3. Recipient Catalog No.	
4. Title and Subtitle In-Depth Accident Investigation			5. Report Date April/1997

Dynamic Science, Inc.
Accident Investigation
Case Number: DS97009

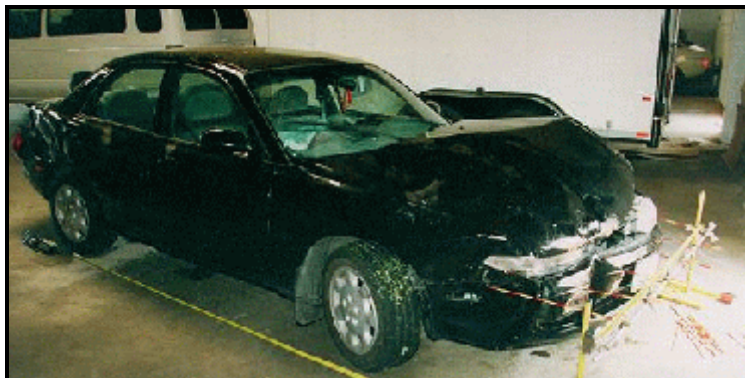
Figure 1. Exterior, Vehicle 1

Description:	1994 Mazda 626 Lx-6 4 door sedan	
VIN:	YVGE22D4R5XXXXXX	
Odometer:	86284 km (53616 miles)	
Engine:	2.4 L 4 cyl	
Reported Defects:	None	
Cargo:	Child seat	
Damage Description:	Moderate contact to the right front bumper corner; sideslap type damage to the right rear door and quarter panel.	
CDC:	01FREW1 (Impact #1) 03RZEW1 (Impact #2)	
Delta V: (Impact #1)	Total	21 km/h (13 MPH)
	Longitudinal	-16 km/h (-10 MPH)
	Latitudinal	-14 km/h (-9 MPH)
	Energy	43832 joules (23844 ft-lb)

This vehicle is equipped with two rows of seats. The front seats are both bucket seats. The seat tracks were just forward of the mid position and the seatbacks were slightly reclined. The driver's and passenger's airbags had no tethers and both had two vents. The passenger airbag had a maximum deployed excursion of 73 cm (28 in). There was a 48 cm (18.9 in) long scuff on the airbag from contact with the child seat. There was no intrusion nor any integrity loss.

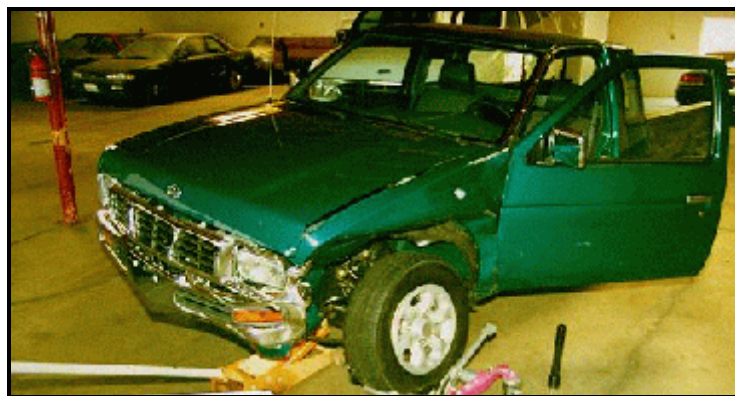
Figure 2. Exterior, Vehicle 2

Description:	1997 Nissan XE King Cab	
VIN:	1N6SD16S3VCXXXXXX	
Odometer:	513 miles	
Engine:	2.4 liter - 4 cyl	
Reported Defects:	None	
Cargo:	None	
Damage Description:	Moderate longitudinal and lateral crushing to the left front bumper and the left fender area. Sideslap type damage to left side along truck bed.	
CDC:	10LFEW2 (Impact #1) 09LZEW1 (Impact #2)	
Delta V: (Impact #1)	Total	17 km/h (11 MPH)
	Longitudinal	-11 km/h (7 MPH)
	Latitudinal	13 km/h (8 MPH)
	Energy	13135 joules (97687 ft-lb)

This vehicle is equipped with bucket seats in front and fold-down jump seats in the rear. The vehicle is equipped with a driver's airbag which did not deploy.

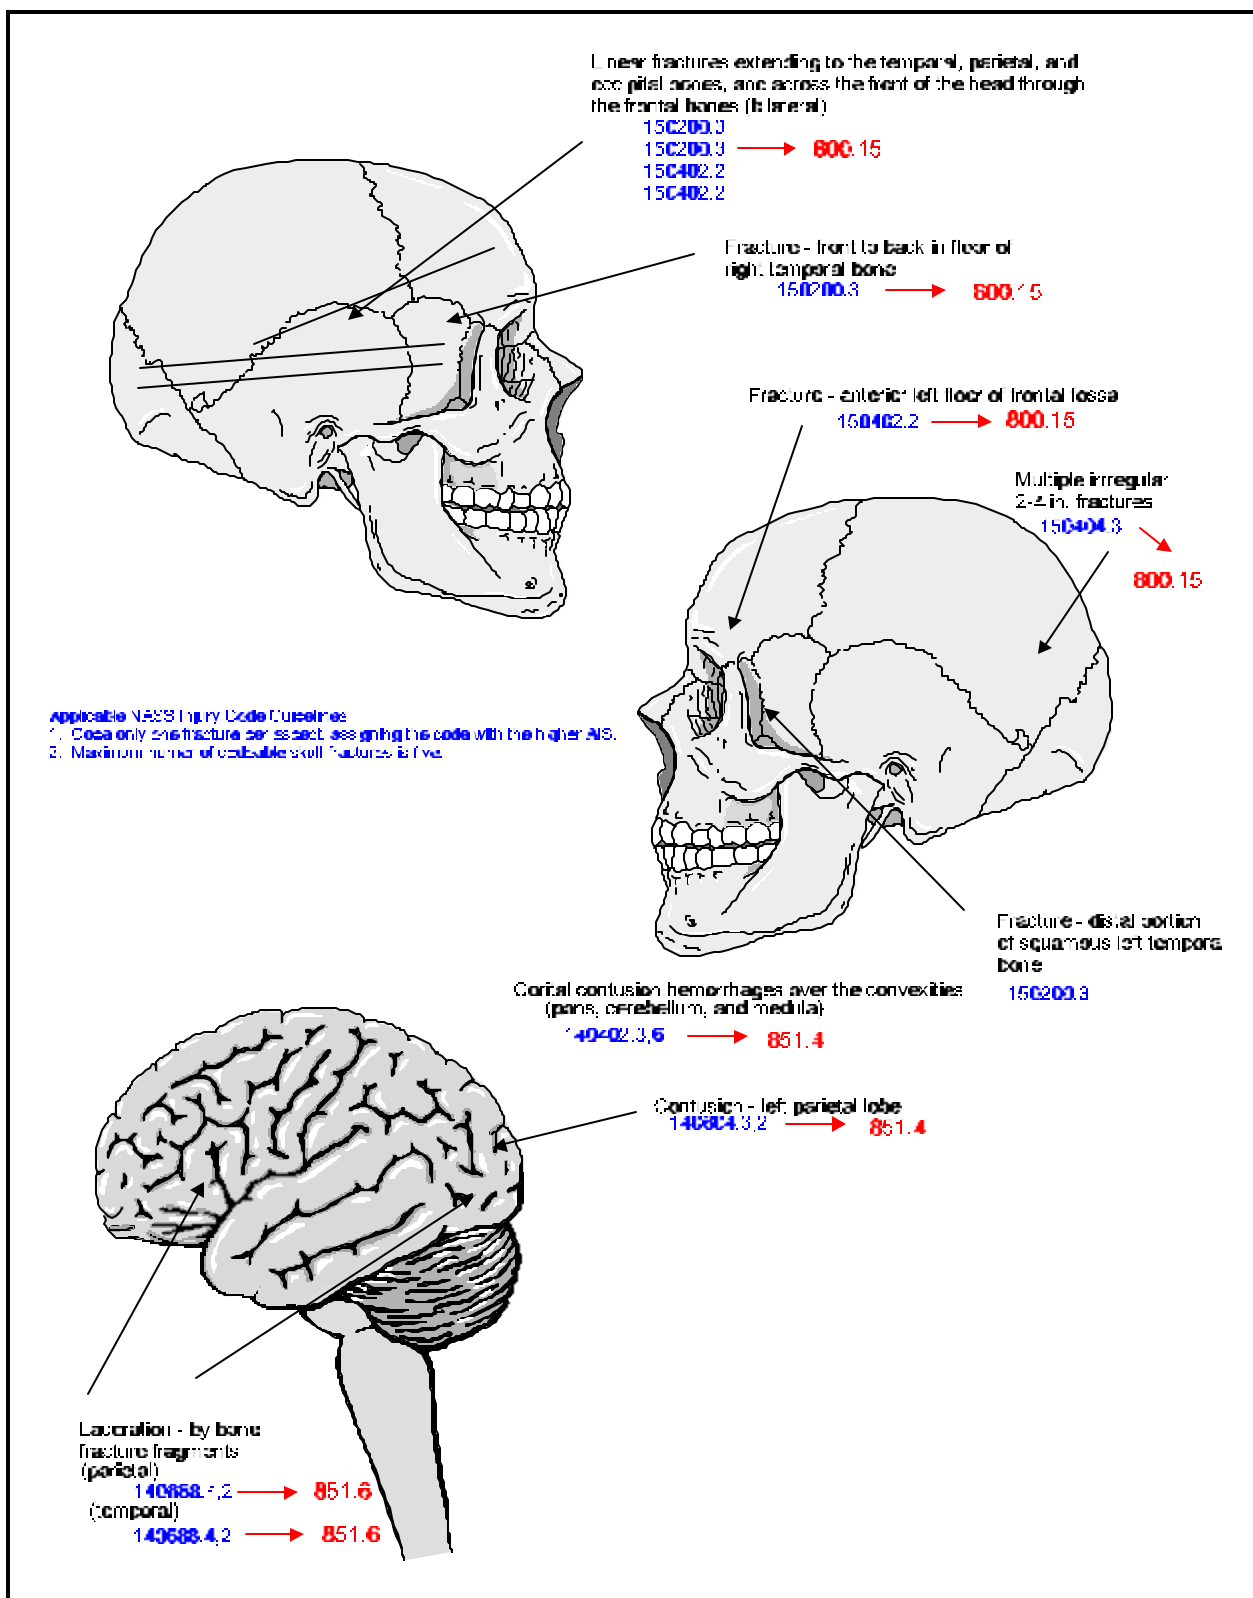
Figure 3. Head injuries, right front occupant

<u>INJURY</u>	<u>OIC CODE</u>	<u>ICD-9</u>	<u>SOURCE</u>
Driver:	Shoulder contusion	790402.1,2	923.10	Seat belt
	Chest contusion	490402.1,2	922.1	Seat belt
	Abdomen contusion	590402.1,2	922.2	Seat belt
Occupant 2:	Brain laceration, parietal	140688.4,2	851.6	Child seat back
	Brain laceration, temporal	140688.4,2	851.6	Child seat back
	Contusion, parietal lobe	140404.3,2	851.4	Child seat back
	Cortical contusions	140402.3,6	851.4	Child seat back
	Multiple irregular skull fractures	150404.3,2	800.15	Child seat back
	Fracture, anterior left floor of frontal fossa	150402.2,2	800.15	Child seat back
	Linear fractures (right side)	150200.3,1	800.15	Child seat back
	Fracture, front to back in floor of right temporal bone	150200.3,1	800.15	Child seat back
	Contusion, nose	290402.1,4	920	Unknown
	Contusion, left cheek	290402.1,2	920	Unknown
	Abrasion, near nose	290202.1,2	910	Unknown
	Abrasion, left side of neck	390202.1,2	910	Child seat restraint

Oblique abrasion, right cheek	290202.1,1	910	Unknown
	Dislocation, left wrist	751430.2,2	833.0	Child seat back

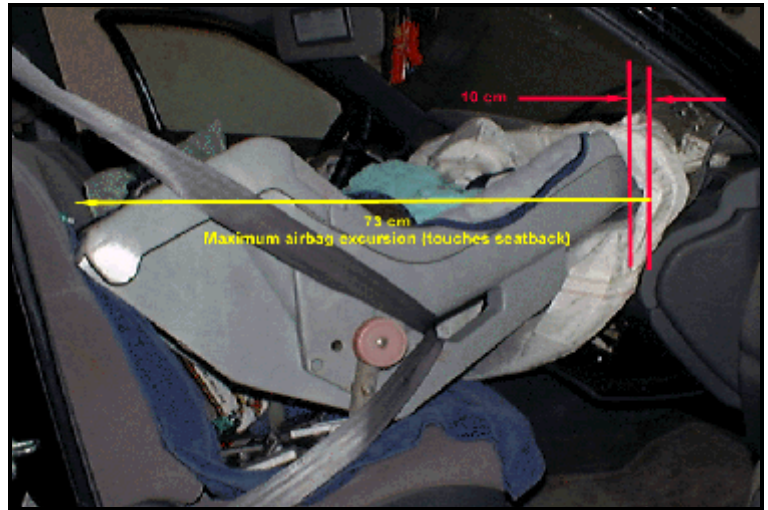
Figure 4. Century 2000 STE child seat, in case vehicle

The 4-month-old male occupant of the right front seat was improperly restrained in a Century 2000 STE convertible child seat. The child seat was in the rear-facing position. The seat was secured in the vehicle using the lap and shoulder belt. The lap and shoulder belt was routed through the child seat using the slots intended for the forward facing position. This is an emergency locking retractor type seatbelt with a sliding latch. It requires the use of a locking clip which was not used in this case. This child seat is designed for use with children from birth to 18 kg (40 lbs). The child was belted into the child seat using the T-shield arrangement, but the shoulder harnesses were routed through the top slots rather than the lower ones proper for a child of this age.

The right front seat was forward of the mid-track position. The child seat was situated near the module cover. At impact, the passenger side airbag deployed. The module cover and deploying airbag struck the rear of the child seat, breaking off a 15 cm (5.9 in) vertical plastic rib on the left side - facing the back of the child seat. The child seat was loaded rearward by the cover and the airbag forcing the seatback into the back of the child's head. This child's injuries were caused by the back of the child seat.
