**TRANSPORTATION SCIENCES
CRASH DATA RESEARCH CENTER**

**VERIDIAN ON-SITE ALLEGED INADVERTENT AIR BAG
DEPLOYMENT/CLOTHING FIRE INVESTIGATION
CASE NO. CA97-010
VEHICLE: 1995 HYUNDAI ACCENT
LOCATION: VIRGINIA
CRASH DATE: MARCH, 1997**

Contract No. DTNH22-94-D-07058

U.S. Department of Transportation
National Highway Traffic Safety Administration
Washington, D.C. 20590

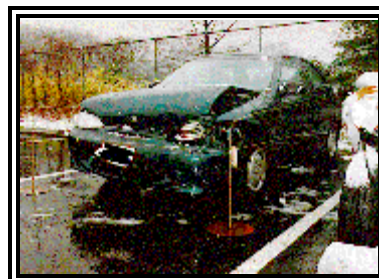
Figure 1. Frontal damage to the 1995 Hyundai Accent

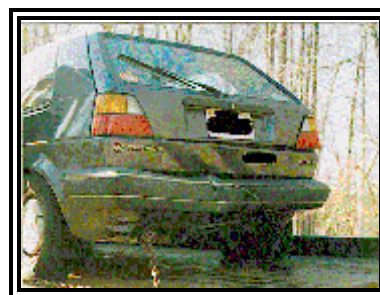
Figure 2. Rear damage to the struck Volkswagen Golf

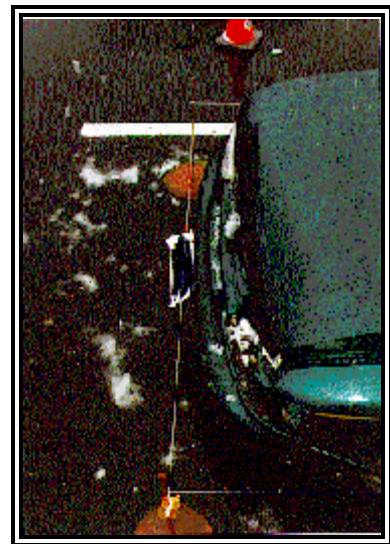
The frontal area of the Hyundai Accent impacted the rear of the stopped 1986 Volkswagen Golf resulting in a 12 o'clock/6 o'clock impact configuration. The direct contact damage on the Hyundai began on the bumper face 23.2 cm (9.1") right of center and extended 88.3 cm (34.75") to the left front corner. Maximum crush at bumper level was 4.1 cm (1.625") located at the left corner (**Figure 3**). Following initial contact, the bumper of the Hyundai underrode the bumper face of the Volkswagen which allowed the grille and hood face to engage against the bumper of the Volkswagen. Maximum crush at the left corner of the hood face of Hyundai was 7.9 cm (3.1"). The struck Volkswagen sustained an estimated 7.6 cm (3.0") of rear bumper crush that was located approximately 10.2 cm (4.0") left of center. These values were estimated from the on-scene police photographs that were obtained from the investigating officer. The Collision Deformation Classifications (CDC) were 12-FDEW-1 for the Hyundai and 06-BZEW-1 for the Golf. Velocity changes of 13.4 km/h (8.3 mph) for the Hyundai and 13.3 km/h (8.3 mph) for the

Figure 3. Overhead view of the frontal deformation

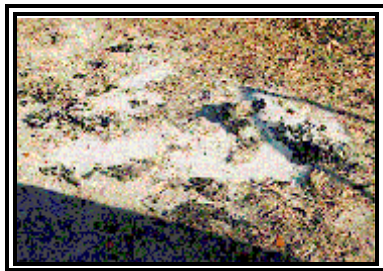
Figure 4. Remains of the burned jacket and shirt worn by the driver of the Hyundai

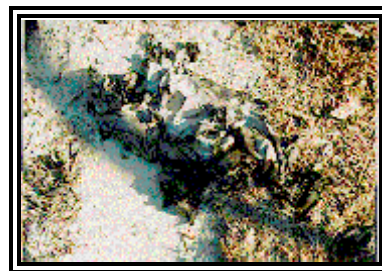
Figure 5. Close-up view of the remains of the burned jacket

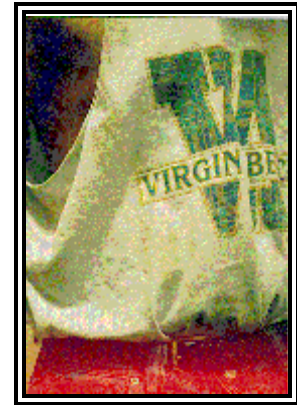
The driver of the Hyundai stated that the jacket was burning in the area of the lower right quadrant over the abdominal area. He further stated that as he removed the jacket, his shirt appeared to be more engulfed in fire, with flames extending across the right abdominal area diagonally upward onto the left chest area. He noted that his right eyebrow was singed by the flames, however, the investigating police officer who observed him at the hospital noted singeing to both eyebrows and to his beard. In addition to the loss of his jacket and shirt, the driver's blue denim jeans sustained superficial charring in the area of the right pocket. His tank-type, T shirt also had superficial charring over the right abdominal area (**Figure 6**). The T-shirt probably protected the driver from sustaining burns to his abdominal and thoracic areas. As a result of the alleged inadvertent air bag deployment, the driver of the Hyundai stated that he experienced an irritation of the throat and a ringing sensation in his ears. Both of these symptoms dissipated within one hour of the crash. He also complained of cervical pain that was attributed to the impact force of the crash.

Figure 6. T-shirt worn by the driver of the Hyundai with faint charring of the right side

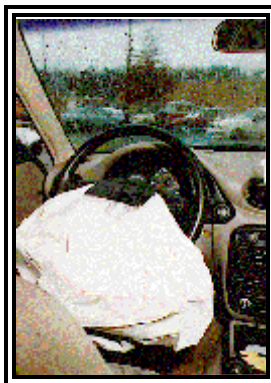
Figure 7. Deployed driver air bag

and 2 o'clock positions. There was a trace amount of deployment

The driver and passenger air bag system deployed from the respective module assemblies in a normal mode (**Figures 7 and 8**). The driver air bag deployed from symmetrical cover flaps within the four-spoke steering wheel assembly. The driver air bag was tethered by two internal tether straps and was vented with two 2.5 cm (1.0") ports located at the 10

residue surrounding the right (2 o'clock) vent port. There were no deposits on the interior surfaces forward of the vent port locations.

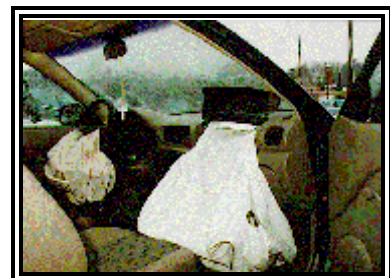
Figure 8. Deployed front right passenger air bag system

The passenger air bag deployed from a top mount air bag module assembly located in the right upper instrument panel. The single top hinged cover flap was 35.3 cm (13.9") in width and 19.7 cm (7.75") in height. The passenger air bag was tethered by two wide band internal tethers that were sewn to the face of the bag. The bag was vented directly into the passenger compartment by two 5.7 cm (2.25") located on the side panels of the bag at the 3 and 9 o'clock positions. The inboard vent port was centered 32.4 cm (12.75") rearward of the mid instrument panel. There was no damage to the air bag fabric or external burns. The interior of the passenger air bag was viewed through the inboard vent port (**Figure 9**). Numerous small fragments of a blackened substance (similar to carbon) were visible within the bag. The majority of these fragments had settled on the bottom surface of the bag as it deflated. In addition to these fragments, the remnants of a label were noted within the bag. Several large fragments which were approximately 13.0 mm (0.5") in diameter had settled to the bottom of the bag. Numerous smaller fragments of the label were also visible within the bag (**Figures 10 and 11**). These fragments appeared to have been subjected to heat and were brittle and curled. Samples of the fragments were recovered and transferred to the ODI representatives. Further inspection of the air bag assembly focused on the inflator manifold. This alloy manifold was a cylindrical tube that contained four ports which provided transfer of the gas from the generator to the air bag. The ports were positioned near the bottom of the manifold which was surrounded by a fabric heat shield. A carbon-like substance surrounded the most inboard manifold port primarily on the thickness of the manifold and immediately outboard of the port. The two adjacent ports appeared free of deposits while the outboard ports had faint carbon-like transfers. The internal surface of the bag and heat shield in the area of the manifold was covered with a light carbon-like film that easily transferred onto the fingers of the field investigator during the inspection process.

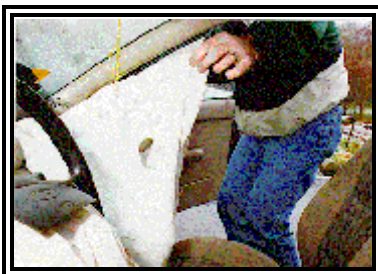
Figure 9. Left (inboard) vent port of the front right passenger air bag

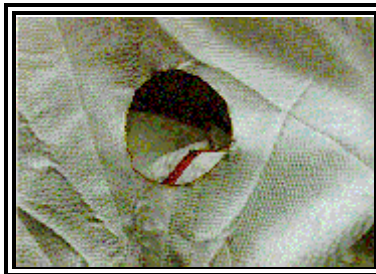
Figure 10. Close-up view of the left vent port of front right passenger air bag

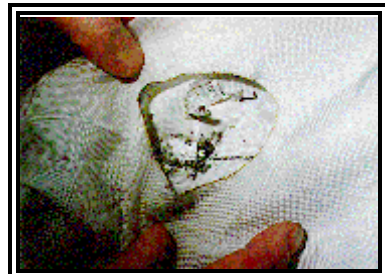
Figure 11. Label fragments and particulate on inside of air bag
