CALSPAN REMOTE SIDE IMPACT AIR BAG DEPLOYMENT INVESTIGATION

CALSPAN CASE NO. CA97-011

VEHICLE - 1997 BMW 528I

LOCATION - NEBRASKA

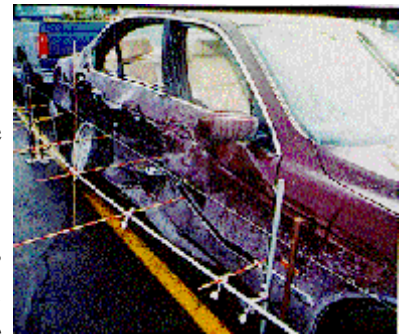
Figure 1. Right side damage to the BMW 528i.

Exterior: The BMW was initially struck on the right passenger compartment area by the full frontal area of the GMC pickup truck. The direct contact damage on the mid aspect of the right front door and extended 203 cm

(80") rearward to the mid aspect of the right rear quarter panel. Contact damage from the hood of the pickup truck extended above the beltline of the BMW onto the right upper B-pillar. Maximum crush was documented at 33 cm (13") located at the mid aspect of the right rear door. The combined induced and direct contact damage length was 318 cm (125") which extended from the leading edge of the right front door to the rear bumper corner. The crush profile at mid door level was as follows: C1 = 0 cm, C2 = 11 cm (4.3"), C3 = 27 cm (10.6"), C4 = 33 cm (13"), C5 = 6 cm (2.4"), C6 = 0 cm. The Collision Deformation Classification (CDC) for this impact sequence was 02-RZAW-3.

Maximum intrusion involved 17.0 cm (6.7") of lateral displacement of the lower right B-pillar into the right rear seated position. Additional intrusions included 10 cm (4") of lateral displacement of the right front door panel, 4.0 cm (1.6") of sill displacement into the right front position, 14.0 cm (5.5") of lateral displacement of the right rear door panel and sill.

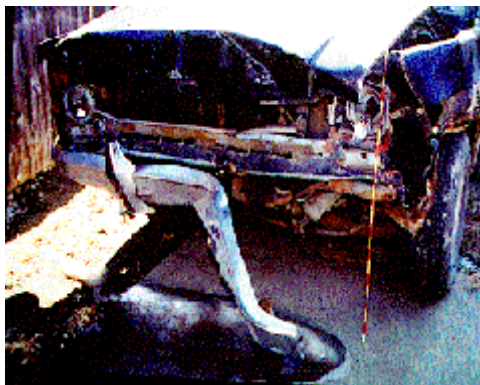
o'clock for the pickup truck. The damage algorithm of the SMASH program computed total velocity changes of 26 km/h (16 mph) and 15 km/h (9 mph) for the BMW and GMC pickup truck respectively. Specific longitudinal and lateral components for the BMW were -13 km/h (-8 mph) and -22 km/h (-14 mph) which were sufficient to deploy both the frontal driver and passenger air bag system and the right front door mounted side impact air bag. **Figures 3 and 4** identify the frontal damage to the GMC pickup truck.

Figure 3. Frontal damage to the GMC pickup truck.

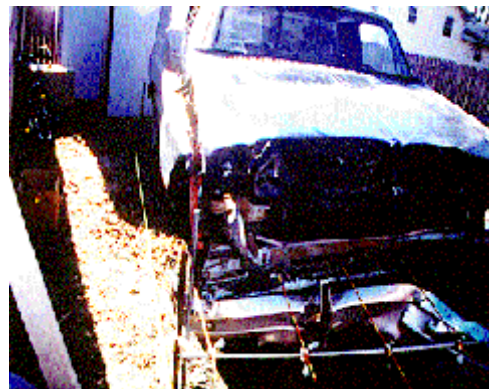
Figure 4. Right front three-quarter view of the GMC pickup truck.

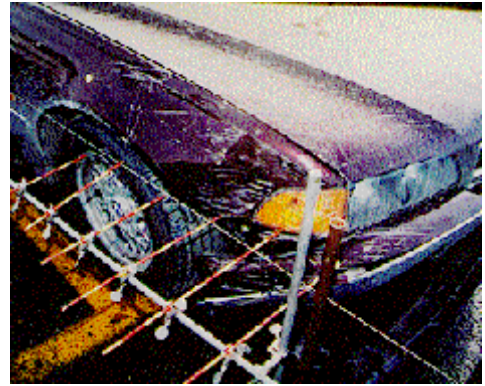
The secondary impact damage to the right frontal area of the BMW was minor in severity. The longitudinal abrasions extended across the front right bumper fascia and onto the forward aspect of the right front fender. Maximum crush was estimated at 5 cm (2") located on the fender immediately rearward of the turn signal assembly (refer to **Figure 5**).

Figure 5. Secondary damage to the right front fender area.

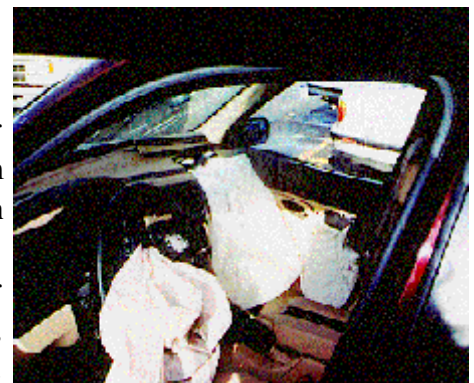
Interior: The interior damage to the BMW resulted from air bag deployment and intrusion of the right side components. The frontal and side impact air bag systems deployed as designed from the respective module covers. The front passenger air bag module cover flap opened at the designated tear points and impacted and fractured the laminated windshield adjacent to the right windshield header area. The expanding front passenger air bag membrane contacted the interior rear view mirror. The contact separated the mirror from the swivel mounting stalk.

Figure 6. Overall interior view of the deployed frontal and side impact air bags.

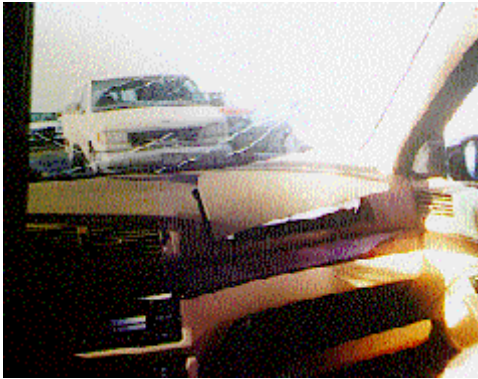
Figure 7. Front right mid mount air bag module cover.

The front passenger air bag deployed from a top mount module assembly (refer to **Figure 7**) that was concealed within the right upper instrument panel. The cover flap was 33 cm (13") in width (horizontally) and 20 cm (8") in height. Based on the NASS photographs, the front right module cover flap was tethered at the top edge which allowed the perimeter of the flap to totally disengage from the upper instrument panel. As the system deployed, the cover flap impacted and fractured the laminated windshield adjacent to the header area.

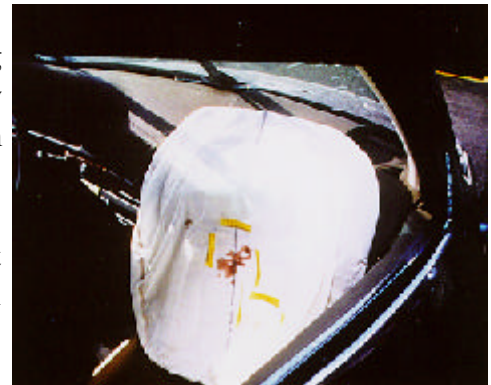
The front passenger air bag membrane was measured by the NASS researcher at 53 cm (21") horizontally and 62 cm (24") vertically. Although not documented, there were no vent ports visible in the provided photographs. The photographs did suggest that the front right passenger air bag was not tethered by internal straps or bands. Several blood spatters were noted to the center face area of the bag (refer to **Figure 8**). There was no direct occupant contact damage noted to the bag.

Figure 8. Deployed front right air bag with blood stain.

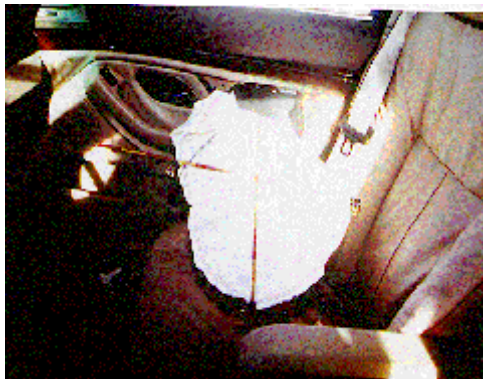
Figure 9. Deployed right side impact air bag.

The ASAP system consisted of side impact air bags that were mounted with the rear third aspect of the front door panels above the level of the armrests (refer to **Figure 9**). A single point electronic sensing system was utilized to detect the lateral crash pulse and deploy the respective side impact air bag. The right side impact air bag deployed as a result of the initial impact with the right side of the vehicle. The air bag was concealed within a dual cover flap configuration. The single outer flap was trapezoidal in shape (refer to **Figure 10**) and consisted of a perforated segment of the padded door panel that was

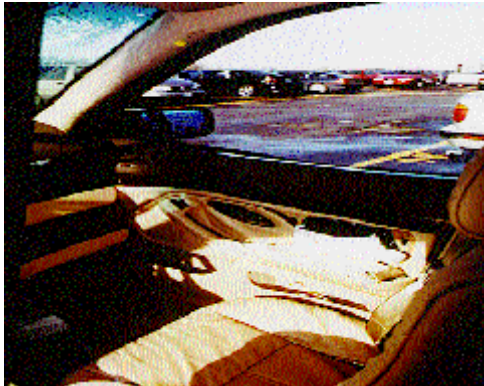
backed by a rigid foam panel. The cover flap appeared to have been hinged at the bottom segment thus opening on an inward and downward trajectory toward the front passenger seat.

Figure 10. Location of the right side impact air bag.

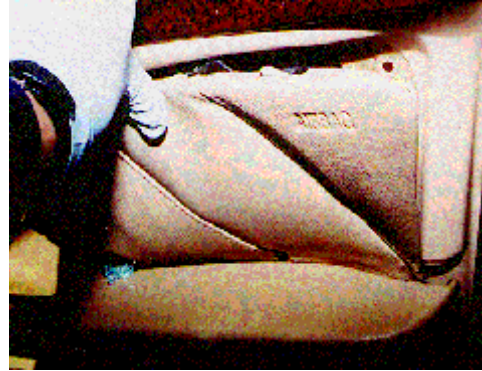
The side impact air bag membrane deployed in both a forward and upward direction with afforded protection to the occupant above the level of the armrest to the beltline area (refer to Figure 11). The bag was tethered by an internal tether panel that was sewn to the face of the bag. There was no direct venting of the bag into the passenger compartment of the vehicle. There was no documented contact evidence on the cover flap of the deployed right side impact air bag.

Figure 11. Side impact air bag cover flap.

The right side impact air bag deployed from a single cover flap that was hinged at the bottom from the rear third area of the door panel. The cover flap contacted the right head and facial areas of the child occupant which resulted in multiple soft tissue injuries (AIS-1). These injuries included a laceration of the right eyelid, an avulsion/contusion/abrasion of the right face, a laceration of the right cheek, a laceration of the right outer ear, and a laceration of the right upper lip.
