REMOTE AIR BAG REPORT

CASE NUMBER - IN97-012

VEHICLE - 1994 FORD ASPIRE

CRASH DATE - June, 1996

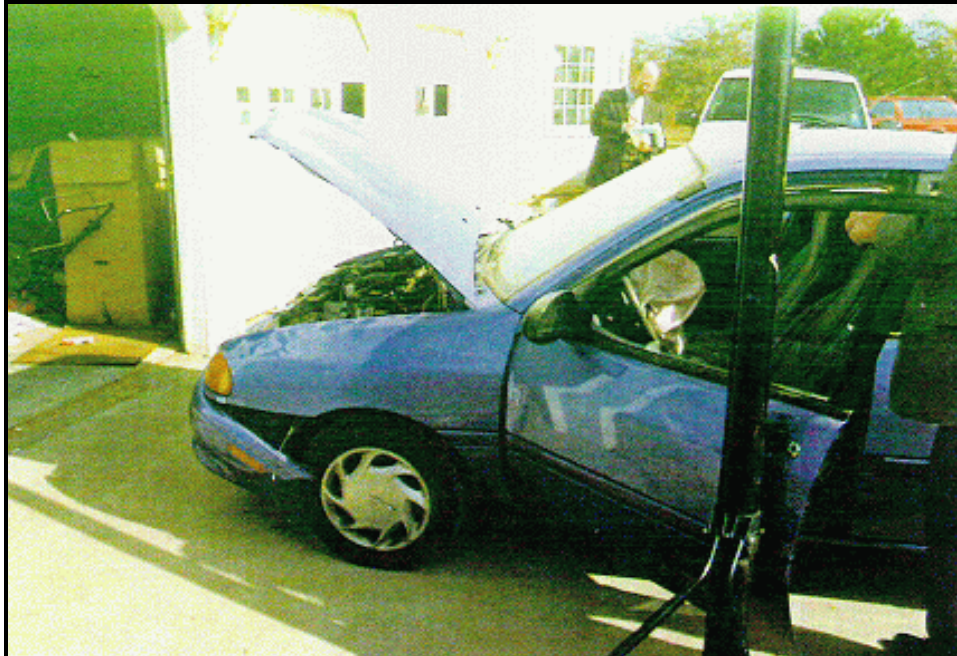
Figure 2: Case vehicle's left side; note: bumper rotated upward (case photo #02)

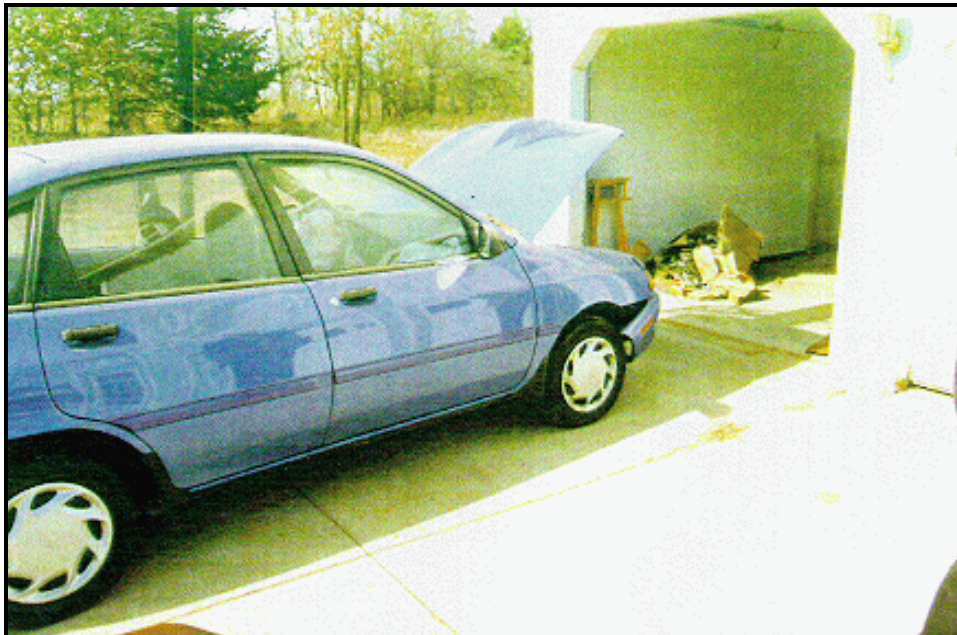
Figure 3: Case vehicle's right side; note: bumper rotated upward (case photo #03)

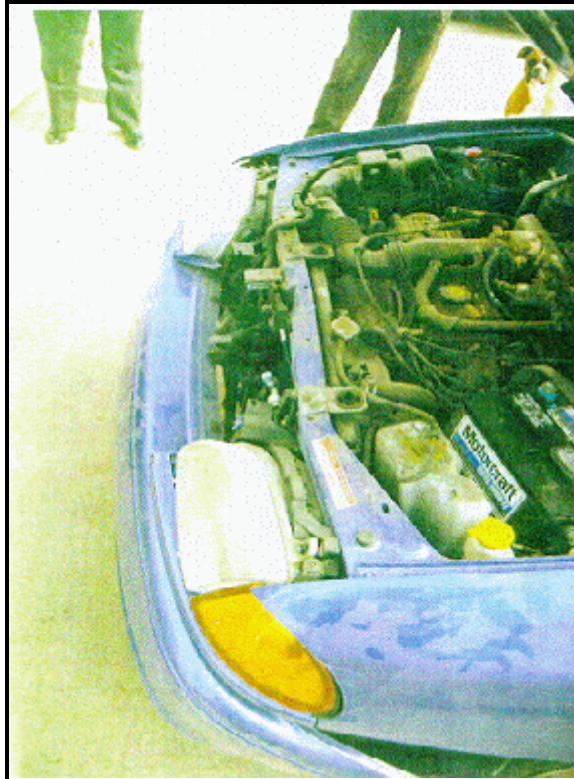
Figure 4: Case vehicle's front and engine compartment, looking down from left; note: left headlight displaced rearward (case photo #04)

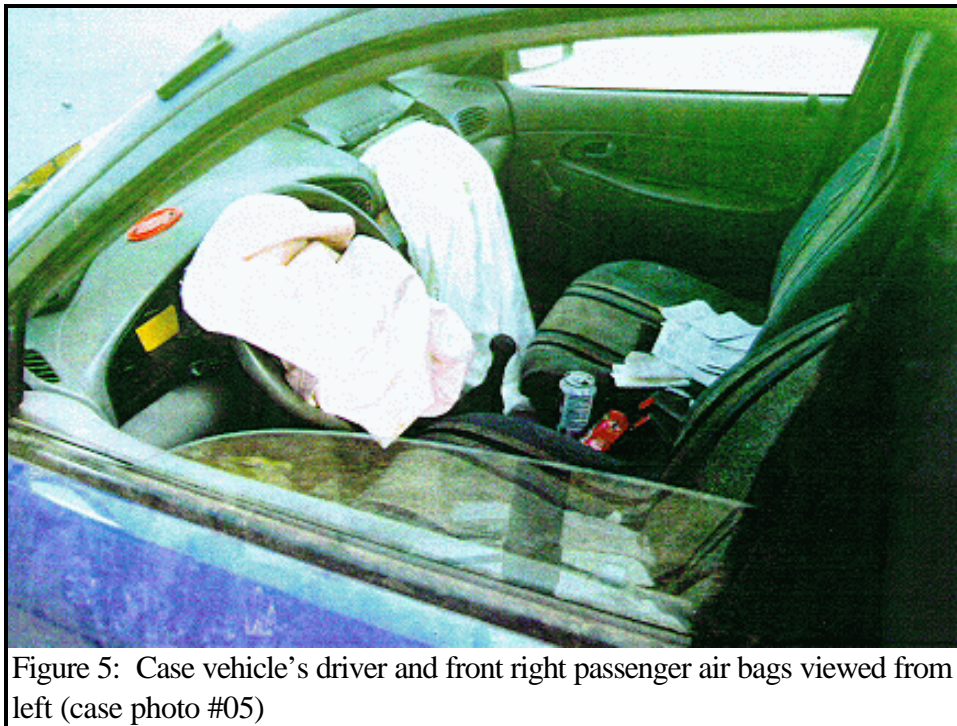
6). This seat adjustment is consistent with the driver’s short stature and indicates that her pre-crash seated position was very close to the steering wheel. The driver’s air bag was located in the steering wheel hub, and the front right passenger air bag was located in the top of the instrument panel. The available photographs do not show any indications of problems with either of the air bags.

Figure 5: Case vehicle's driver and front right passenger air bags viewed from left (case photo #05)

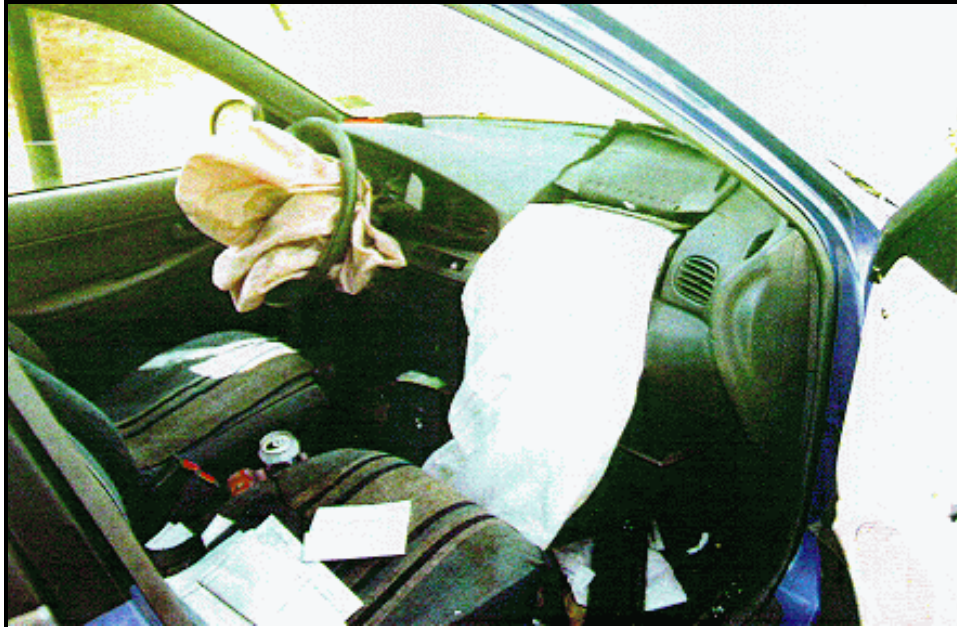
Because the case vehicle was not inspected and because the fatally-injured driver of the case vehicle was the sole occupant, there is no information about pre-crash seat adjustments or posture. The available photographs indicate that the driver's bucket seat was adjusted near its forward-most position (see **Figure**

Figure 6: Case vehicle's front seating area; note: driver's seat adjusted near its forward-most position (case photo #06)

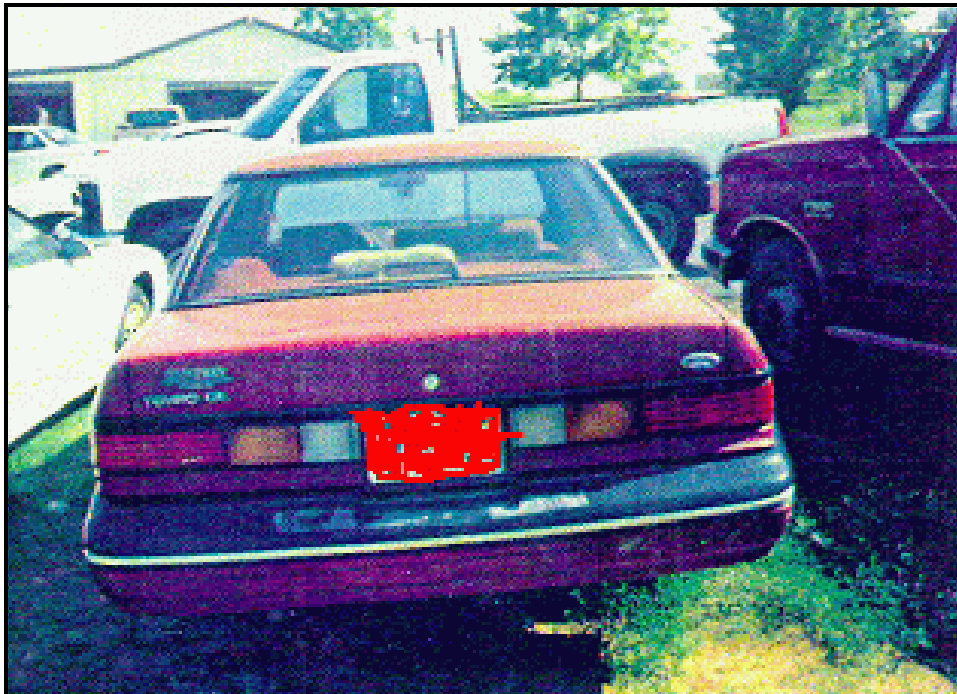
Vehicle #2 was a 1991 Ford Tempo GL, four-door sedan (VIN: 2FAPP36X6MB-----). The entire back bumper was rotated slightly downward (see **Figures 8 and 9**). There was a scrub mark centered on the top surface of the back bumper (see **Figure. 7**) that was a light blue color matching the color of the case vehicle. The other features of the back plane show no damage. The floor of the trunk had an area of minor buckling. The CDC for vehicle #2 was estimated from the available photographs as **06-BCLW-1**. The SMASH reconstruction program, CDC only algorithm, was used on vehicle #2's impact. The Total, Longitudinal, and Lateral Delta Vs are respectively: 16 km.p.h. (10 m.p.h.), +16 km.p.h. (+10 m.p.h.), and 0 km.p.h. (0 m.p.h.).

Figure 7: Vehicle #2's back; note: blue scrub mark at center of bumper (case photo #07)

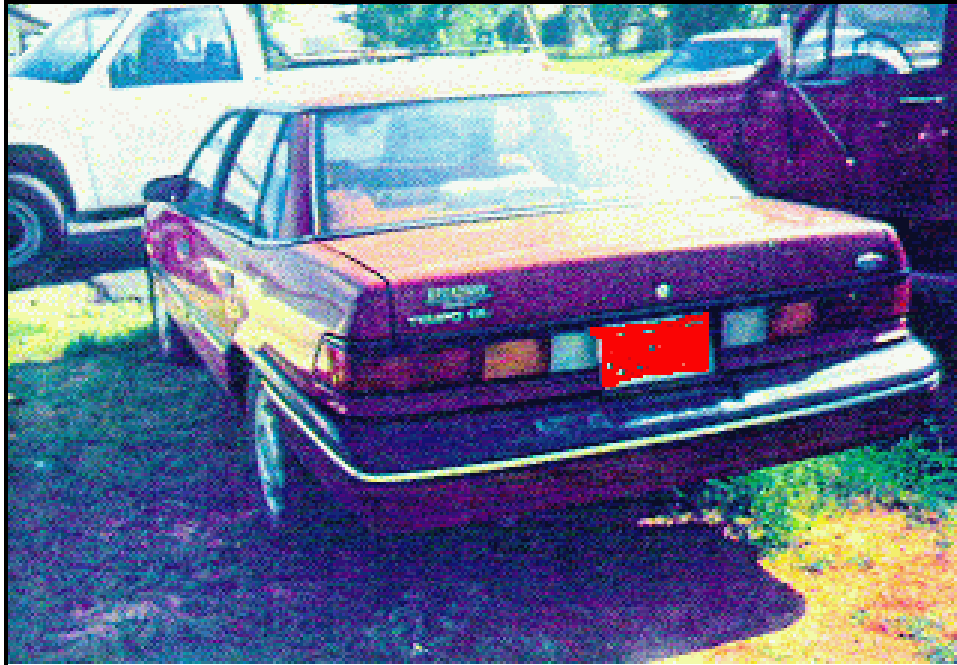
Figure 8: Vehicle #2's back and left side; note: bumper rotated downward (case photo #08)

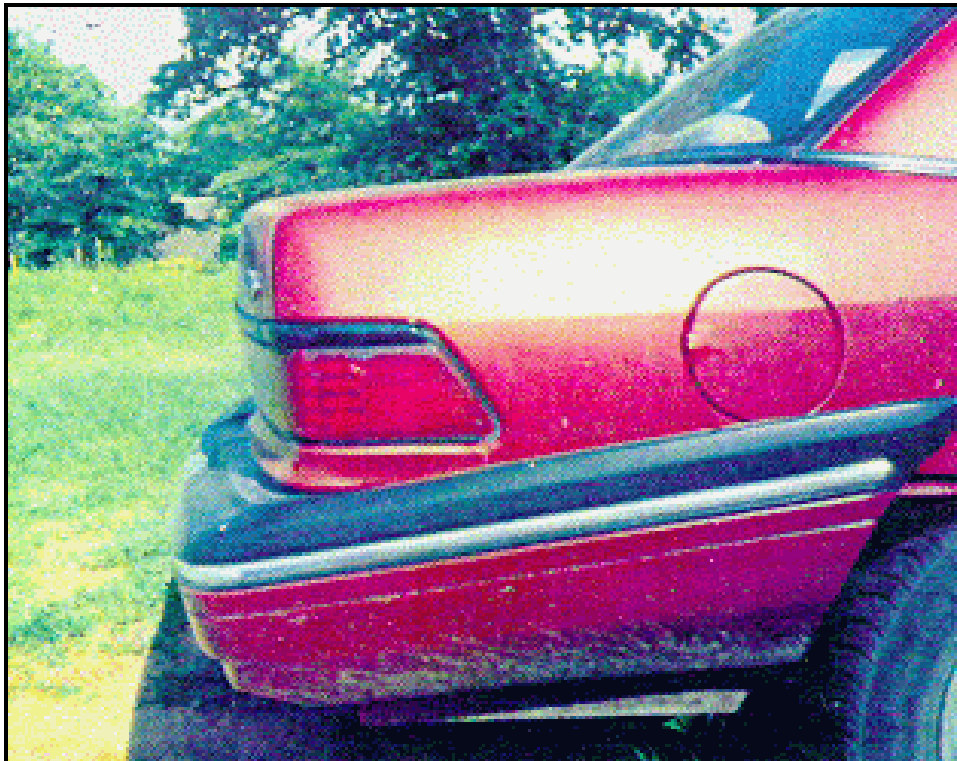
Figure 9: Vehicle #2's right rear corner; note: bumper rotated downward (case photo #09)
