**VERIDIAN ON-SITE AIR BAG RELATED
CLOTHING FIRE INVESTIGATION
VERIDIAN CASE NO. CA97-014
VEHICLE: 1994 TOYOTA CAMRY
LOCATION: VIRGINIA
CRASH DATE: MARCH 1997**

<p>14. <i>Sponsoring Agency Code</i></p>	
<p>15. <i>Supplementary Notes</i> On-site investigation of a front-to-rear crash sequence that resulted in air bag deployment and surface level burning of the driver's clothing.</p>			
<p>16. <i>Abstract</i> This on-site investigation focused on the mechanism that caused a clothing fire following the deployment of the frontal air bag system in a 1994 Toyota Camry. The 56 year old female driver of the Toyota was involved in a minor front-to-rear impact sequence with a 1991 Honda Accord. The impact triggered the deployment of the Toyota's frontal air bag system. As the driver of the Toyota exited her vehicle following the crash, the driver of the Honda and a police officer noted the lower left quadrant of the Toyota's driver's jacket to be smoldering. The driver was assisted in removing the jacket and it was thrown to the ground and stepped on to extinguish the smoldering area. The driver was not injured by the burning jacket, however, she did sustain an abrasion of the left chin fro

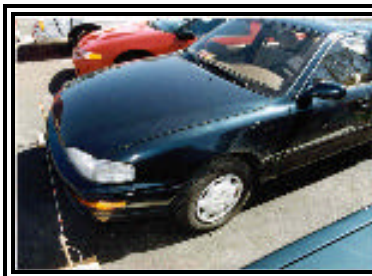
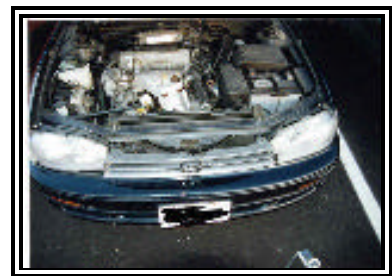
The Toyota Camry sustained minor frontal damage (**Figures 1 and 2**) from its impact sequence with the rear of the Honda Accord. Damage was limited to the front bumper system with displacement of the reinforcement bar. The bumper fascia rebounded to its original profile. Maximum crush was (3.25") located on the reinforcement bar 15.9 cm (6.25")

Figure 1. Front left view of the Camry.

Figure 2. Frontal damage to the Toyota Camry.

right of the vehicle's centerline. The direct contact damage began 29.2 cm (11.5") left of center and extended 99.0 cm (39.0") to the right corner of the bumper fascia. The crush profile at the bumper

reinforcement bar was as follows: C1 = 0 cm, C2 = 0.6 cm (0.25"), C3 = 5.1 cm (2.0"), C4 = 6.4 cm (2.5"), C5 = 2.5 cm (1.0"), C6 = 0 cm. The Collision Deformation Classification (CDC) for this impact was 12-FDLW-1.

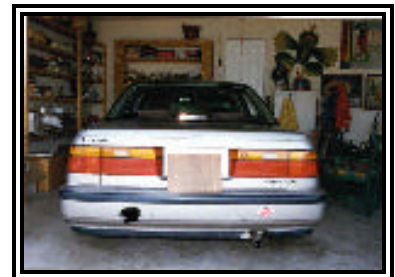
The rear of the Honda Accord sustained minor damage to the bumper fascia (**Figure 3**). The direct contact damage began 41.9 cm (16.5") right of center and extended 18.1 cm (46.5") to the left corner. There was no deformation of the bumper beam or residual crush at the rear of the Honda. The CDC for this damage was 06-BDLW-1.

Figure 3. Rear damage to the Honda Accord.

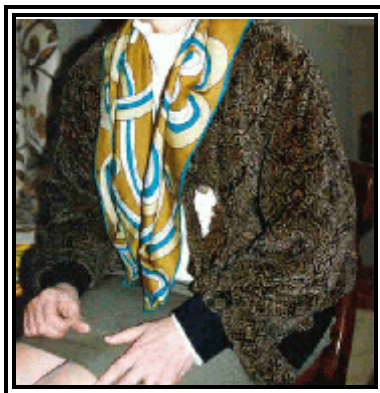
Figure 4. Burn to the driver's jacket

A 5.1 cm x 7.6 cm (2.0" x 3.0") burn hole was noted on the left frontal surface of the jacket in an area located 3.5 cm (1.4") left of the zipper and 26.7 cm (10.5") above the bottom edge of the jacket (**Figure 4**).

It appeared likely, however, that the driver air bag was the cause of the garment fire. This conclusion was based upon the location of the burn on the driver's jacket, the location of the driver air bag vent port with respect to the garment burn location, and the location of several areas of generant residue found to the left of the vehicle's interior. The location of the burn on the driver's clothing indicated the wheel was rotated between 190-210 degrees clockwise which was consistent with the steering maneuver through the right channel curve. In this rotated position, the upper right air bag vent port would have been aligned with the left side of the driver's jacket. It should be noted that the driver air bag did not exhibit any signs of heat singed fabric.

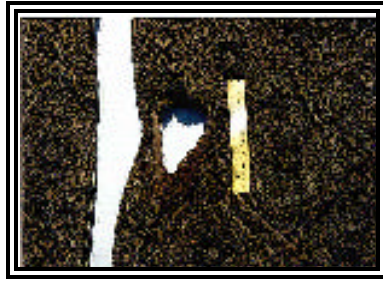
Figure 5 is a close-up view of the burn damage to the jacket. The scarf exhibited numerous burn holes (**Figure 6**) which aligned with the location of the burn hole through the jacket. The underlying white mock turtle neck top sustained a brown singe damage pattern with a raised fiber texture that was attributed to heat generation from the surface level burn of the jacket. The left frontal

Figure 5. Close-up view of the burn to the driver's jacket.

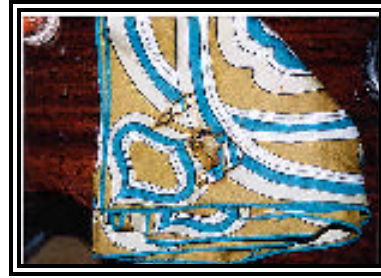
Figure 6. Burn to the driver's scarf.

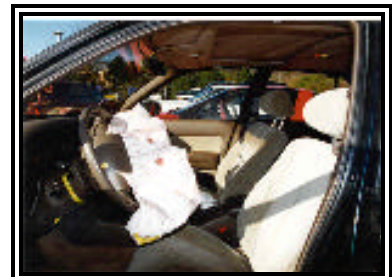
Figure 7. Deployed driver air bag and the vent ports.

in diameter. The back side of the bag was vented by two 2.9 cm (1.1") diameter ports located at the 11 and 1 o'clock sectors (**Figure 7**).

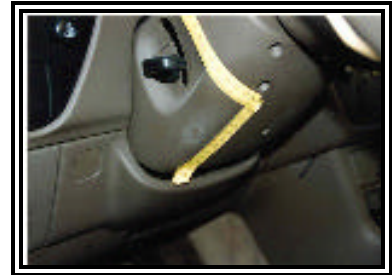
The deploying driver's air bag exhausted residue to the left side of the steering column cover (**Figure 8**), located below the tilt lever mechanism. Additional residue deposits were noted on the turn signal stalk and to the left mid instrument panel below the power mirror switch.

Figure 8. Exhaust residue from the vent ports of the driver air bag.

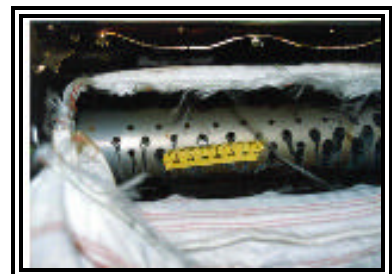
During the air bag deployment event, small metallic fragments separated from the inflator manifold ports (**Figure 9**) by design. Several of these fragments were expelled from the bag through the inboard air bag vent port (**Figure 10**). These fragments may have been embedded in the driver's clothing and initiated the surface level burning when exposed to the windy conditions. Fragments of the air bag bar code identification label attached to the passenger side air bag were noted throughout the right front seating area. Fragments were found on the left upper instrument panel adjacent to the windshield, the

Figure 9. Inflator manifold of the front right air bag.

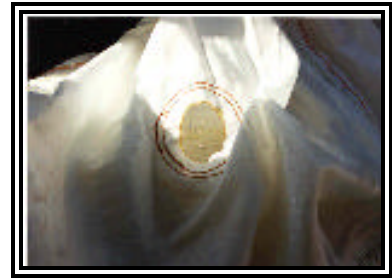
Another source of the surface level burn pattern may have involved debris from the front right passenger air bag. The inside of the passenger air bag contained several circular foil fragments which measured 9.5 mm (0.375") in diameter and correlated in shape and size to the gas ports in the inflator housing unit. Several of these metallic fragments were discovered on the floor in front of the driver seat. A bar coded label that was affixed to the inside surface of the passenger air bag, fragmented during the deployment sequence. Fragments of this label were found exterior to the air bag and within the bag membrane during the on-site SCI inspection of the vehicle.

upper right door panel, the door latch handle, the top and outboard vertical surfaces of the right front seat cushion, and on the floor between the right front door and the right front seat. The label fragments did not exhibit any singed surfaces.

Figure 10. Fragments within the front right passenger air bag.

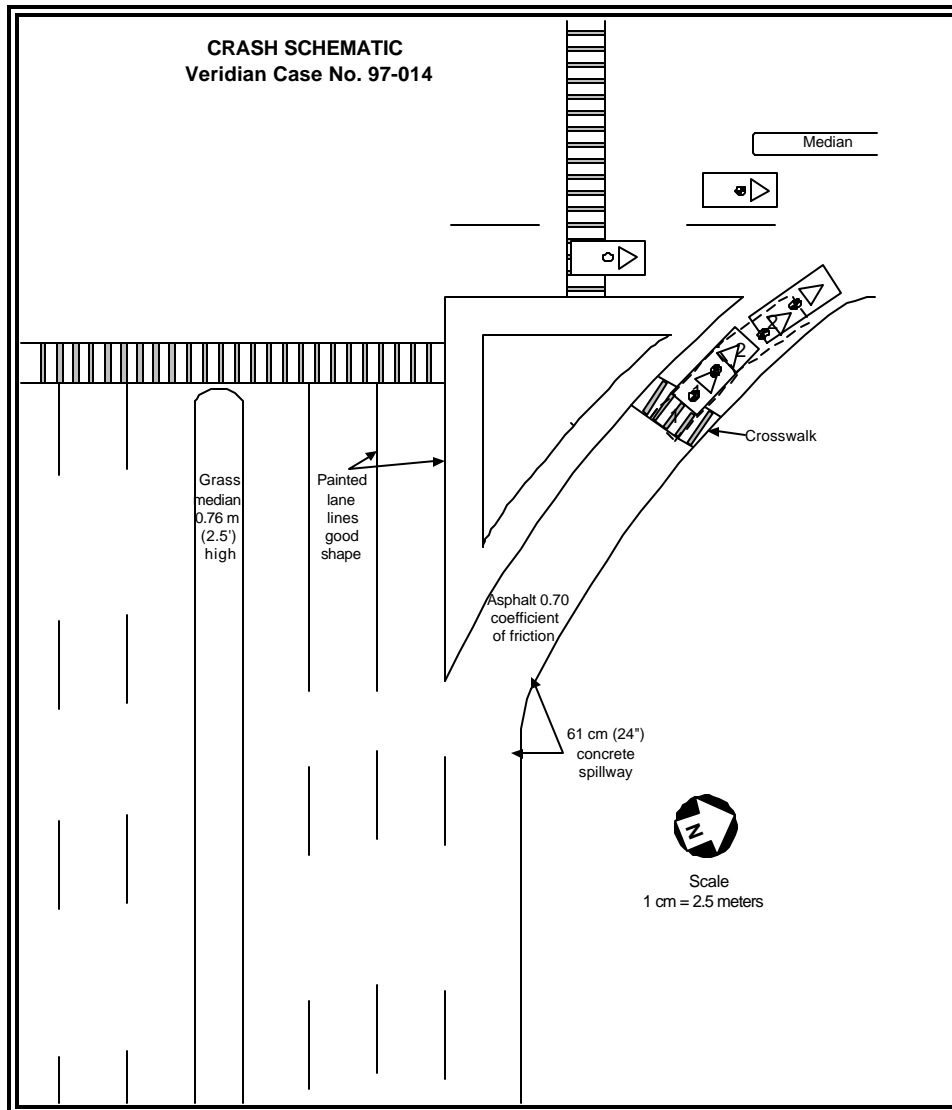
Figure 11. Crash Schematic

The 56 year old female driver of the Toyota Camry was traveling in a westerly direction and was following the Honda Accord. The driver of the Toyota decelerated as she entered the right turn lane and momentarily focused her attention to her right, away from the roadway. As a result of her attention distraction, the driver of the Toyota failed to detect the stopped Honda Accord and did not initiate avoidance action. The Crash Schematic is attached as **Figure 11**, page 8 of this summary report.
