### ON-SITE AIR BAG INVESTIGATION

CASE NUMBER - IN97-014  
LOCATION - LOUISIANA  
VEHICLE - 1996 SUBARU IMPREZA  
CRASH DATE - May, 1997

**CASE SUMMARY**  
**TRC/IU REMOTE/ON-SITE AIR BAG REPORT/INVESTIGATION**  
SCI Team #2, TRC/IU Case Number IN97-014  
Louisiana  
May, 1997

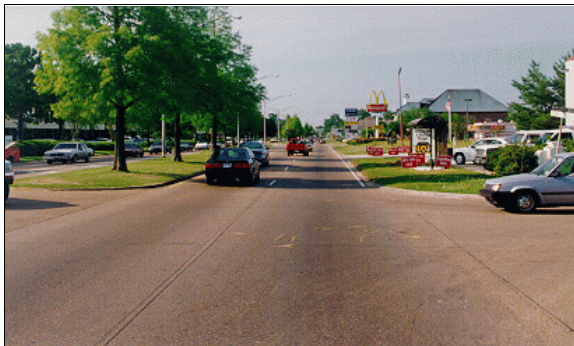
**Figure 1:** Case vehicle's travel path in outside northbound lane; Note: deflection and final rest marks in "Tee" intersection (case photo #02)

**PRE-CRASH:** The case vehicle (Impreza) was traveling north in the outside lane (**Figure 1**) of a five-lane, divided, city trafficway and intended to continue in its northward direction of travel (i.e., both the north and southbound roadways had two through lanes, while the southbound roadway had a left-hand turn lane). Vehicle #2 had been traveling south in the left-turn lane (**Figure 2**) of the southbound roadway and was making a left turn across the northbound roadway (**Figure 3** below), intending to travel east on an intersecting roadway. Vehicle #3 was stopped, heading west, in the westbound lane of the intersecting, two-lane, undivided, city street and was waiting to execute a left turn. In an attempt to avoid the crash, the case vehicle's driver tried to steer to the right and braked (with lock-up), leaving approximately 4.2 meters (14 feet) of a right tire skid, which negated her right steering maneuver. The case vehicle continued essentially straight ahead prior to impact. The driver of vehicle #2 made no pre-crash avoidance maneuvers and thus, vehicle #2 proceeded with its left turn prior to impact. The driver of vehicle #3 made no pre-crash avoidance maneuvers, and vehicle #3 remained at a stop prior to impact. The crash occurred in the southbound roadway of the "Tee" intersection of the two trafficways (**Figure 4** below).

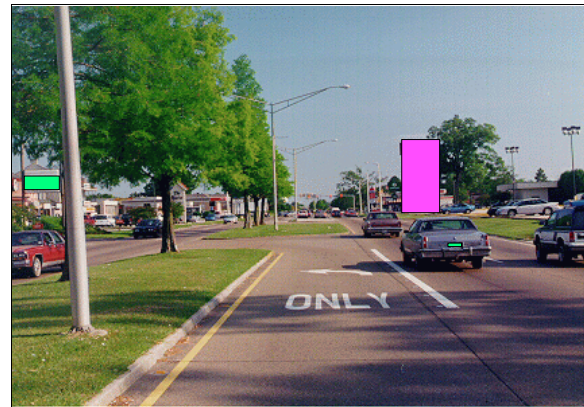
**Figure 2:** Vehicle #2's southward travel path in left-hand turn lane (case photo #06)

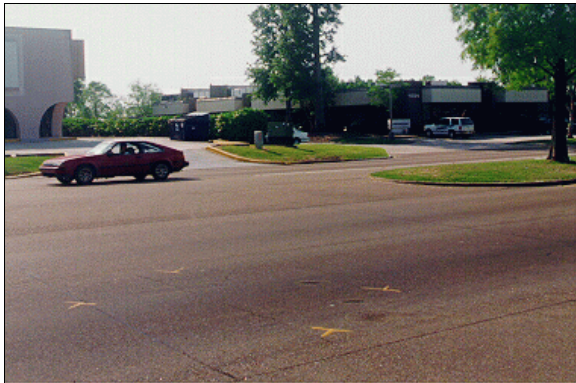
**Figure 3:** West-northwestward view of vehicle #2's travel path from left-hand turn lane into impact; Note: case vehicle's final rest position heading southwest (case photo #09)

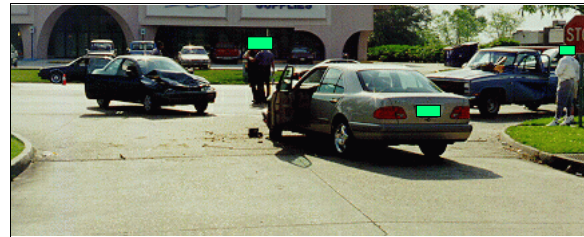
**Figure 4:** On-scene westward view from eastbound lane of all three vehicles at final rest; Note: case vehicle at left, vehicle #3 in center, and vehicle #2 toward right (case photo #12)

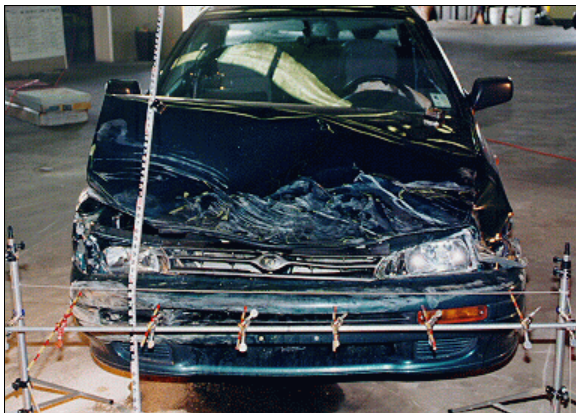
**Figure 5:** Case vehicle's frontal damage showing rightward shift of left front headlight and hood and hood's under riding interaction with right side of vehicle #2 (case photo #16)

The front of the case vehicle (**Figure 5**) impacted the right side of vehicle #2 (**Figure 6** and **Figure 7** below), causing both the driver and front right passenger supplemental restraint systems (air bags) to deploy (**Figure 8** below). The case vehicle, subsequently, rotated clockwise approximately 60 degrees after impact and came to rest in the outside lane, heading primarily east (**Figure 4**). Vehicle #2 was redirected east-northeastward after the impact with the case vehicle and contacted vehicle #3 which was still stopped waiting for traffic to clear. Vehicle #3's front left corner was impacted by the left side of vehicle #2 causing a toolbox and a bicycle in the bed (i.e., pickup) of vehicle #2 to be thrown onto and over the front hood of vehicle #3. Vehicle #2 came to rest on the east leg of the "Tee" intersection most likely heading southeast. The driver of vehicle #2 backed away (i.e., toward the northwest) 1.8-2.4 meters (6-8 feet) in an attempt to flee the scene. Vehicle #2 was found in the outside northbound lane, heading southeast. The front of Vehicle #3 rotated approximately 15 degrees counterclockwise, and vehicle #3 was moved a few feet eastward (i.e., backwards) as a result of the impact. Vehicle #3 came to rest heading west-southwest (**Figure 4**).

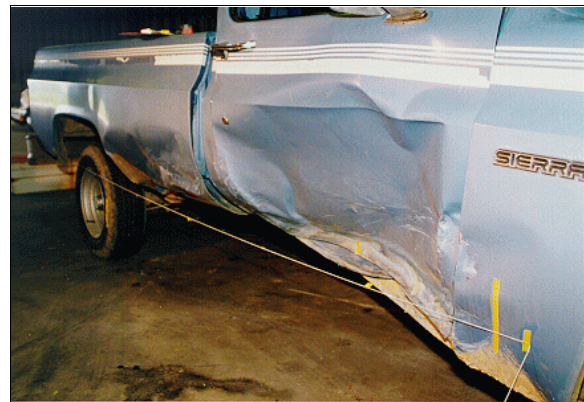
**Figure 6:** Vehicle #2's right side damage viewed from front of right (case photo #60)

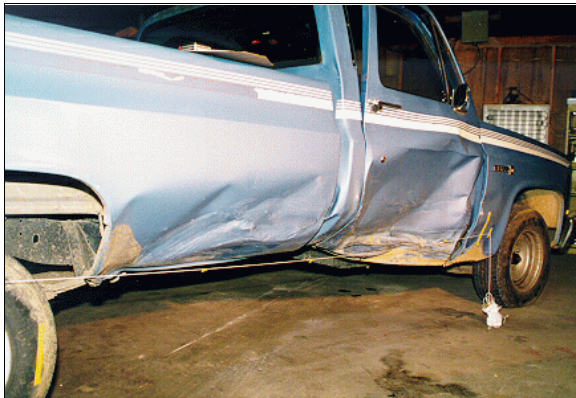
**Figure 7:** Vehicle #2's damaged right side viewed from back of right (case photo #63)

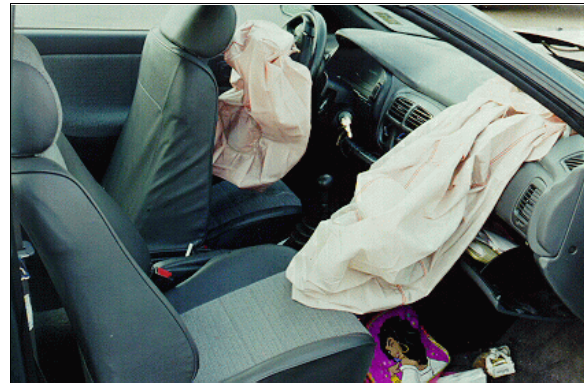
**Figure 8:** Case vehicle's front seating area showing deployed driver and front right passenger air bags (case photo #15)

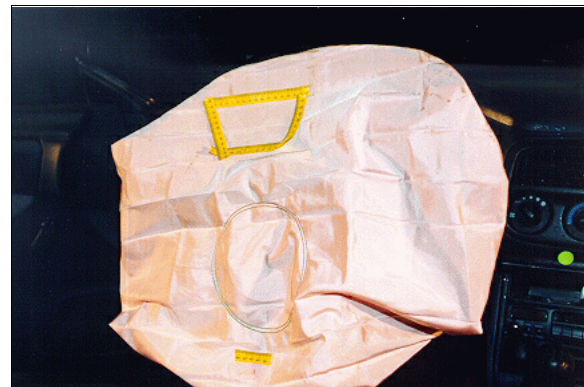
An inspection of the driver's air bag revealed evidence of contact to the upper center portion of the air bag (**Figure 9**). There was no evidence of contact to the driver air bag module's cover flap. The deploying air bag contacted the driver in the face and forearms knocking her back and to the left into her seat back as the case vehicle rotated clockwise to final rest. The driver's face and arm contact with the air bag caused her facial abrasions (lip and chin) and left forearm abrasion.

**Figure 9:** Case vehicle's driver air bag showing contact to upper center front of air bag and blood drops on bottom center (case photo 28)

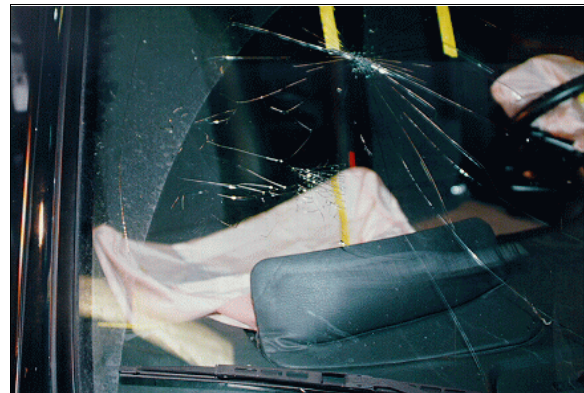
**Figure 10:** Case vehicle's cracked right windshield and deformed front right air bag module's cover flap (case photo #40)

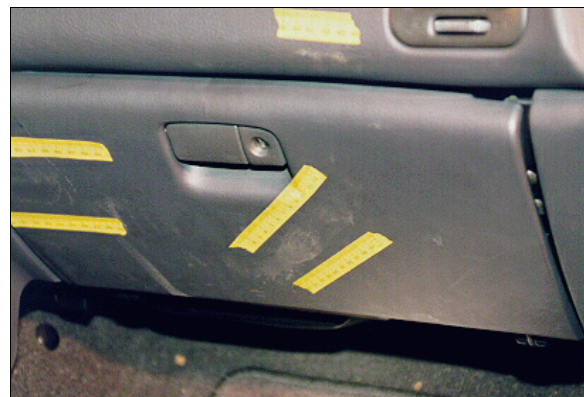
**Figure 11:** Close-up on contacts on case vehicle's glove box from front right passenger's knees (case photo #46)

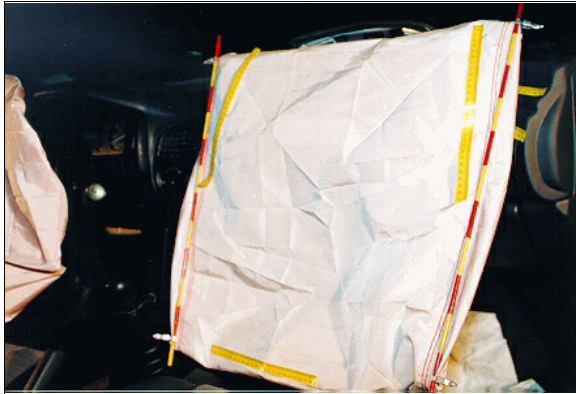
**Figure 12:** Case vehicle's front right passenger air bag (case photo #34)

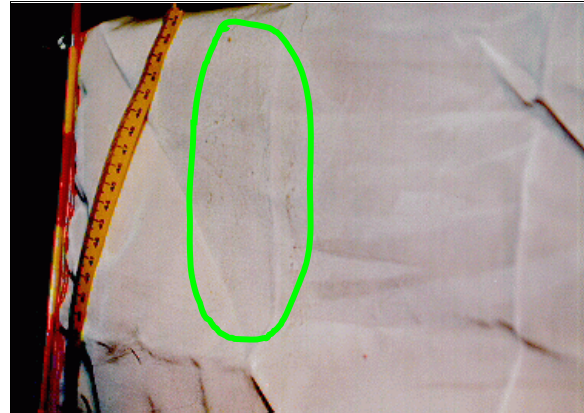
**Figure 13:** Close-up of case vehicle's front right passenger air bag showing skin deposits (case photo #35)

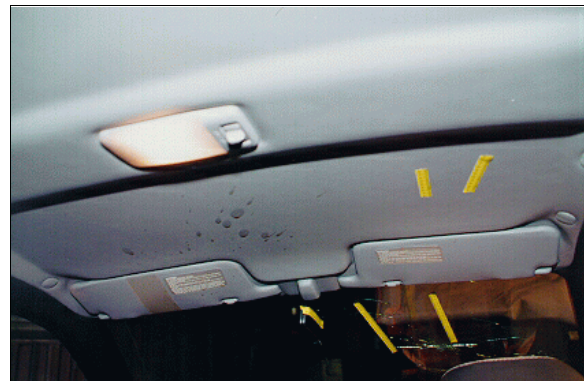
**Figure 14:** Case vehicle's windshield and roof showing front right passenger's head contact to roof, above front right seat, rearward of header and sun visor (case photo #49)

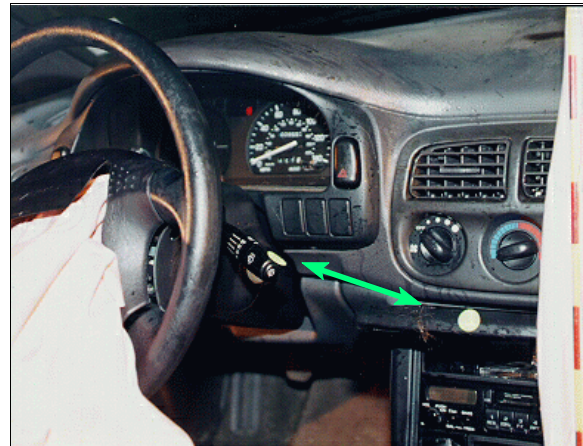
**Figure 15:** Close-up of contacts to case vehicle's center instrument panel and windshield wiper wand; Note: clump of front right passenger's hair in center instrument panel (case photo #43)
