VERIDIAN ON-SITE AIR BAG RELATED BURN INVESTIGATION

VERIDIAN CASE NO. CA 97-018

1994 DODGE DAKOTA SPORT PICKUP TRUCK

LOCATION - STATE OF PENNSYLVANIA

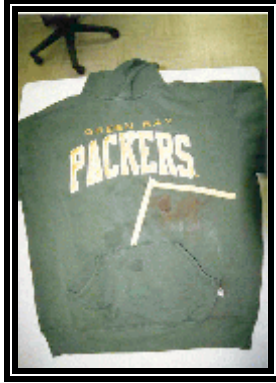
The driver was not using the three point manual lap and torso belt at the time of the crash. During the braking avoidance maneuver, he moved forward and was in close proximity to the air bag module cover at the time of the air bag deployment sequence. The deploying air bag contacted the driver's chest area resulting in circular burn marks in the driver's sweat shirt (**Figures 1 and 2**) and undershirt which correlated with the location and design of the driver air bag vent ports. The driver continued to move forward and loaded through the expanding air bag and compressed the energy absorbing steering column resulting in the complete separation of the steering column shear plate from the shear capsules.

Figure 1 -View of the burn marks on the front of the driver's sweatshirt

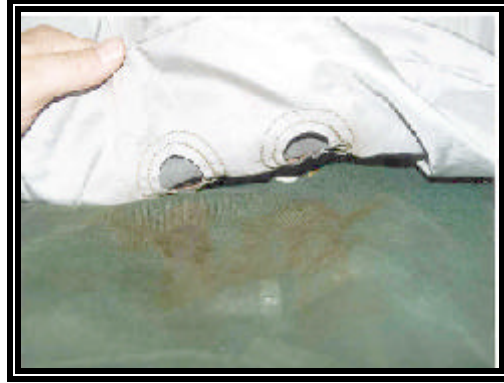
Figure 2 -View of the burn marks on the sweatshirt in correlation with the size and location of the air bag vent ports

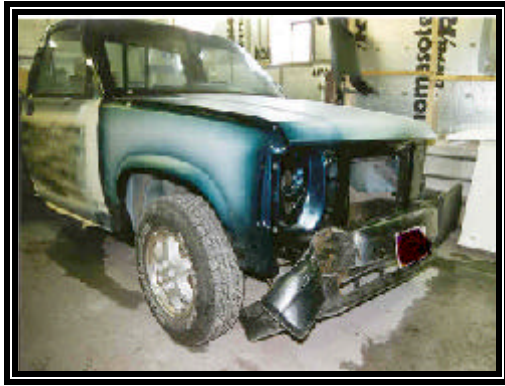
The 1994 Dodge Dakota which had 65,653 km (40,796 miles) on the odometer was undergoing repair at the time of this inspection. The direct damage from the impact with the tree stump was located 43.2 cm (17.0") right of the bumper centerline and measured 25.4 cm (10.0") in length (**Figures 3 and 4**). Damaged components included: the front bumper; grille; hood; right front fender; and right front door panel. The right front door panel was repaired at the time of this inspection.

Figure 3 - Right front corner view of the Dodge Dakota showing the direct impact damage to the right front bumper area

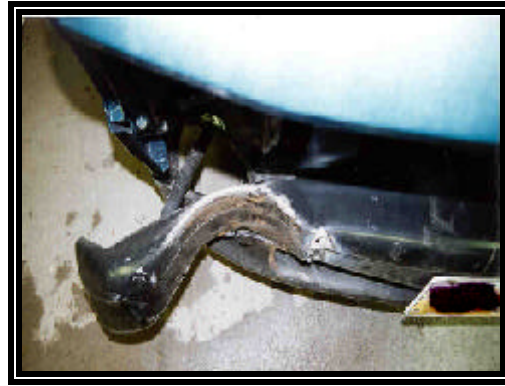
Figure 4 - Overhead view of the impact damage to the front bumper illustrating the extent of crush

The following table lists crush values obtained after setting the front bumper back in position following its removal by the repair shop. These values should be considered as minimum crush values.

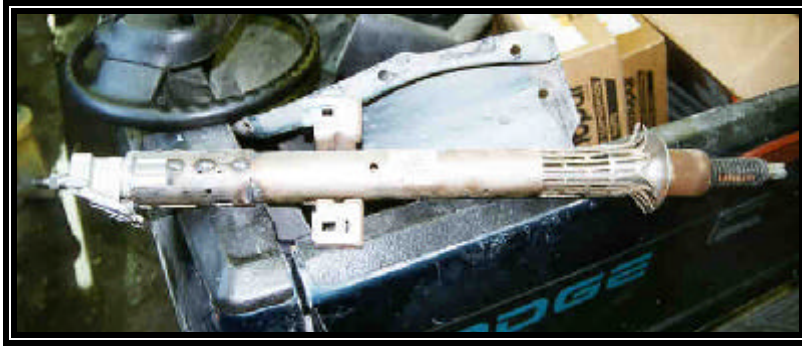
The interior of the Dodge Dakota was under repair at the time of the inspection. The steering column assembly had been removed, but was available for inspection. The steering column was designed with a slotted jacket mandrel which was compressed 2.5 cm (1.0") by driver loading during the crash sequence (**Figure 5**). The shear plate was completely separated from the shear capsules during the crash.

Figure 5 - View of the steering column showing the displacement of the slotted jacket at the mandrel located at the right side of the photograph

The combination of the driver loading the steering column and the air bag loading against the driver's chest resulted in a 2.5 cm (1.0") compression of the steering column with total separation of the shear plate from the shear capsules. The driver indicated that the steering wheel was laying in his lap at final rest.

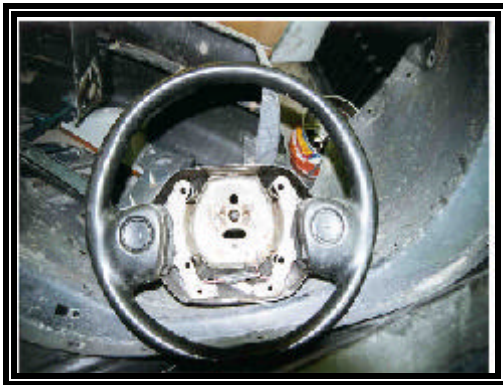
The steering wheel rim was not deformed as shown in **Figures 6 and 7**. The air bag module was removed by the repair facility.

Figure 6- Frontal view of the steering wheel rim

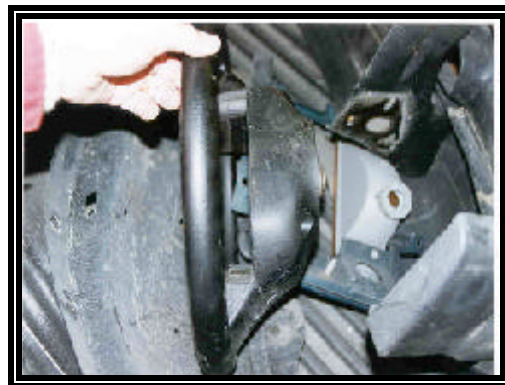
Figure 7 - View along the steering wheel rim

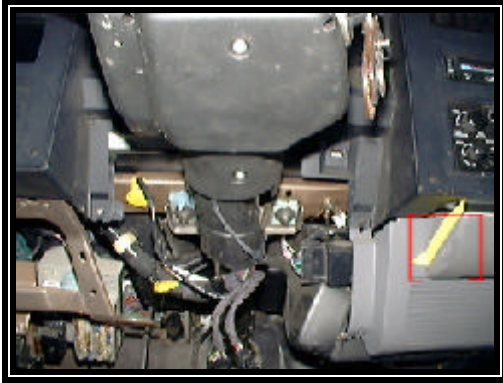
There was a heavy abrasion along the left edge of the ashtray located 10.2 cm (4.0") left of the vehicle centerline which measured 3.8 cm (1.5") in length. This artifact was attributed to contact with the driver's right knee (**Figure 8**). There was a minor scuff on the knee bolster which was located 44.4 cm (17.5") left of the vehicle centerline and left of the steering column. This scuff was attributed to contact by the driver's left knee during the crash sequence with the tree.

Figure 8 - Contact evidence along the left edge of the ashtray door (highlighted by a red box)

The driver's right knee moved forward and contacted the left edge of the ashtray located in the lower center instrument panel. This was noted by an abrasion of the vinyl surface and correlated with the driver's description of pain to his right knee.

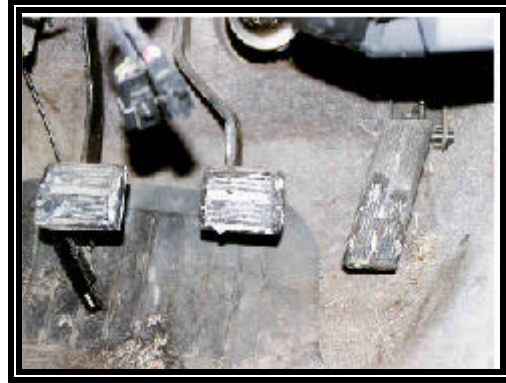
Figure 9 - View of cake like product embedded in vehicle control pedals

There was a food product (cake like substance) noted to the instrument panel and foot pedals. It appeared that this product had been on the seat and struck the instrument panel during the crash sequence. It apparently fell on the floor where the driver upon re-entering apparently stepped on the product and tracked it onto the accelerator, brake, and clutch pedals (**Figure 9**).

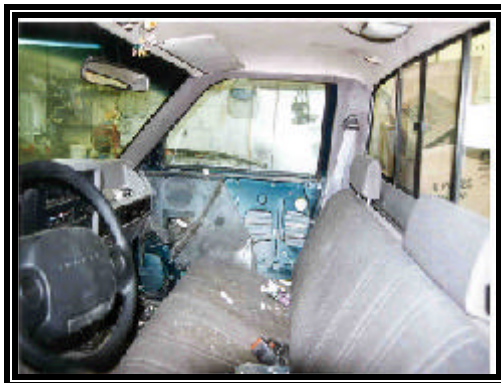
The bench seat was reportedly in the full rear adjusted position (**Figure 10**). The continuous loop three point manual lap and shoulder belts in the outboard set positions did not exhibit any latch plate witness marks (**Figure 11**) which was consistent with non-restraint usage in the crash. The D-rings were fixed.

Figure 10 - lateral view of the front seat area from the left side of the vehicle

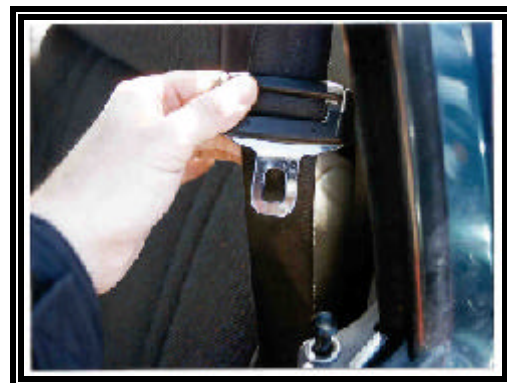
Figure 11 - View of the front left restraint belt latch plate showing the lack of usage related witness marks

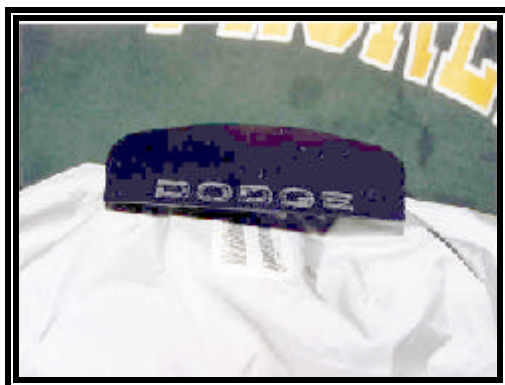
The air bag module cover opened in an "H" configuration with the vertical dimension of the upper flap measuring 6.4 cm (2.5") and the lower flap measuring 7.0 cm (2.75") vertically. The common lateral seam line width measured 16.5 cm (6.5"). The supple vinyl flap thickness measured 6.4 mm (0.25"). There was no driver related contact evidence noted on the surfaces of the flaps (**Figures 12 & 13**).

Figure 12 - View of the upper air bag module cover flap

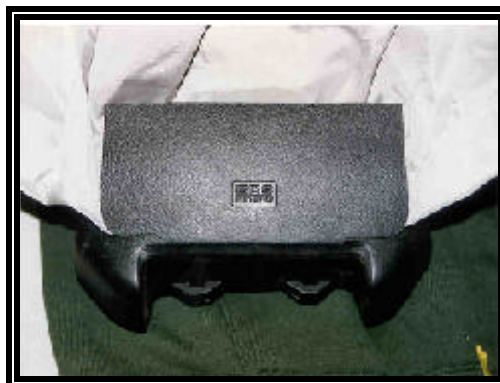
Figure 13 - View of the lower air bag module cover flap

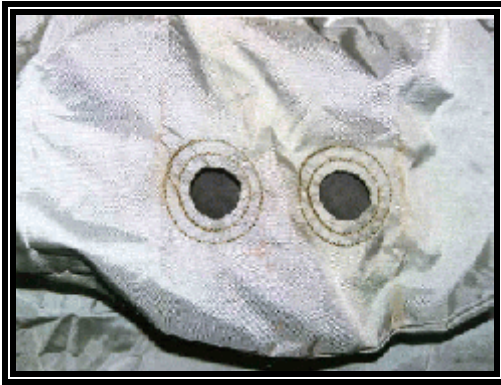
The air bag was a non-tethered design which measured 66.0 cm (26.0") in diameter. There were two 2.5 cm (1.0") diameter vent ports located on the back surface at the twelve o'clock position. The vents ports were separated by a measured distance of 5.0 cm (2.0") and 7.0 cm (2.75") below the perimeter of the air bag. There was brown discoloration around each vent port which was attributed to exhaust gases (**Figure 14**). The air bag identification number was: PUT 11446-02E.

Figure 14 - View of the air bag vent ports illustrating the brown discoloration

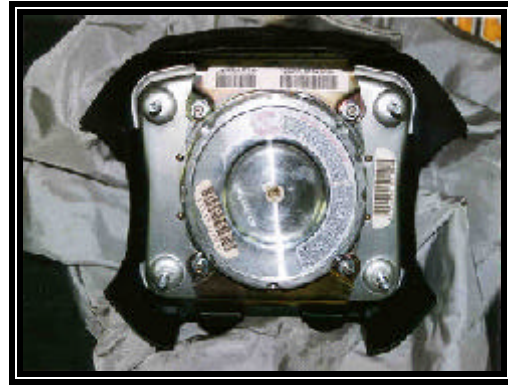
The inflator unit was manufactured by Morton International with an identification label located on the back side of the inflator which read: CBE E8A 3Z CQF (**Figure 15**). There were no obvious defects in the inflator housing.

Figure 15 - View of the rear surface of the inflator unit

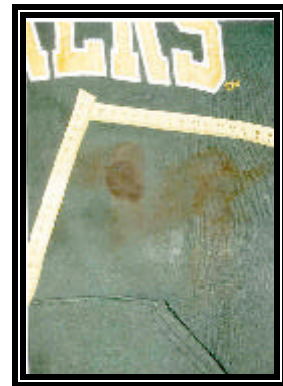
The driver's sweatshirt (50/50 cotton polyester blend) exhibited well defined singe marks located along the left lower chest area which were attributed to contact with the air bag vent ports during the SRS actuation sequence. The prominent circular pattern noted in **Figure 16** (the pattern closest to the vertical calibrated tape) measured 3.2 cm (1.25") in diameter and was located 38.7 cm (15.25") below the shoulder and 7.0 cm (2.75") left of the shirt midline. There was a 9.5 mm (0.375") diameter burn hole in the upper right which was attributed to generant debris exiting the right vent port during the air bag actuation sequence. There were several surrounding circular brown singe marks

Figure 16 - View of the circular burn marks on sweatshirt which were attributed to exhaust gases from vent ports

above and below this pattern which were produced sequentially by the same vent port as the air bag was going through its expansion sequence.

The second set of singe marks (furthest away from the vertical calibrated tape) were located 4.8 cm (1.875") left of the of the first set and correlated with the location of the left vent port. There appeared to be four spherical impressions in this set which began vertically at the same height of as the first set and extended 10.2 cm (4.0") downward.

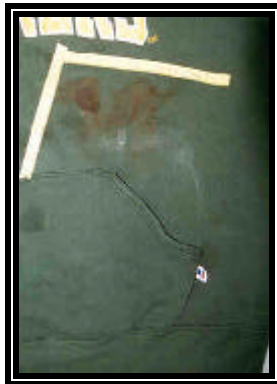
A 16.5 cm (6.5") white powder-type transfer mark was noted below the spherical singe marks on the left side (**Figure 17**). The transfer pattern appeared to be fashioned in an arc which was located 44.4 cm (17.5") below the left shoulder and 12.1 cm (4.75") left of the shirt centerline. This artifact was attributed to contact with the air bag during the expansion sequence.

Figure 17 - View of the white transfer mark on the left front lower surface of the sweatshirt

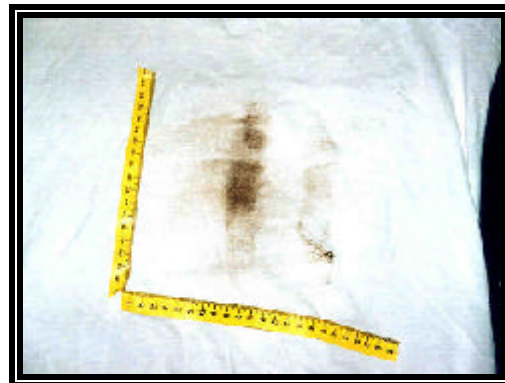
The driver's white 100 percent cotton undershirt exhibited two distinct brown singe mark patterns which were located on the left side of the shirt and correlated with the singe marks noted on the sweatshirt (**Figure 18**). The first pattern which was closest to the centerline of the undershirt began 33.0 cm (13.0") below the left shoulder and extended 12.7 cm (5.0") downward. The second singe pattern was located 34.3 cm (13.5") below the left shoulder and 7.6 cm (3.0") left of the first pattern (center to center). Both singe marks measured 2.9 cm (1.125") in width.

Figure 18 - View of the singe marks on the drive's undershirt which correlated with the location of the singe marks on the sweatshirt
