## ON-SITE AIR BAG FATALITY INVESTIGATION

CASE NUMBER - IN97-019

VEHICLE - 1994 BUICK CENTURY SPECIAL

CRASH DATE - January, 1997

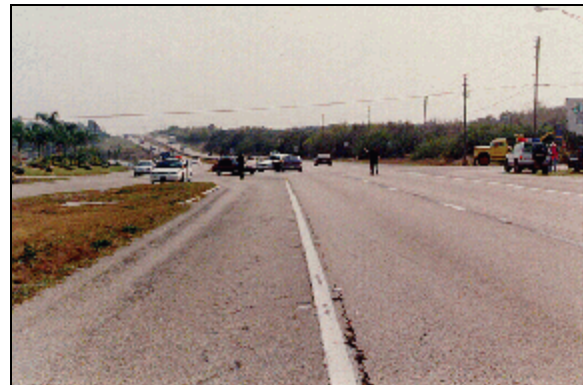
**Figure 1:** On-scene view of case vehicle's southward travel path in inside southbound lane; Note: case vehicle and vehicle #2 at respective final rest positions (case photo #02)

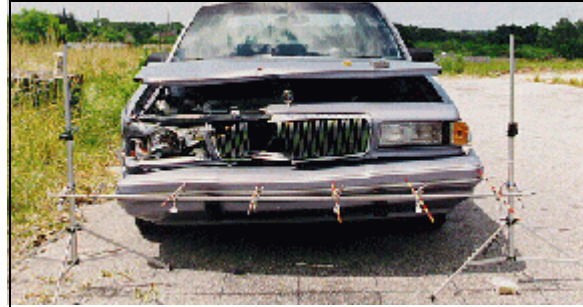
**Figure 2:** Case vehicle's frontal damage; Note: damage above bumper is primarily to right (case photo #07)

The front of the case vehicle impacted the left side of vehicle #2 and involved the entire 162 centimeter (63.8 inch) undeformed end width. Direct contact damage to the case vehicle included the hood's front edge, the front fascia, the grille, the front right headlamp assembly, the front right and front left turn signals and side markers, and the front bumper. The maximum crush, 16 centimeters (6.3 inches), was located at C<sub>6</sub>. Indirect damage was sustained by the right fender. The CDC for the case vehicle was determined to be: **12-FDEW-1 (+10 degrees)**. The WinSMASH reconstruction program, missing vehicle algorithm, was used on the case vehicle's highest severity impact. The Total, Longitudinal, and Lateral Delta Vs are, respectively: 19.0 km.p.h. (11.8 m.p.h.), -18.7 km.p.h. (-11.6 m.p.h.), and -3.3 km.p.h. (-2.1 m.p.h.). Neither the right or left front tire was displaced, and there was no evidence of intrusion to the case vehicle's interior.

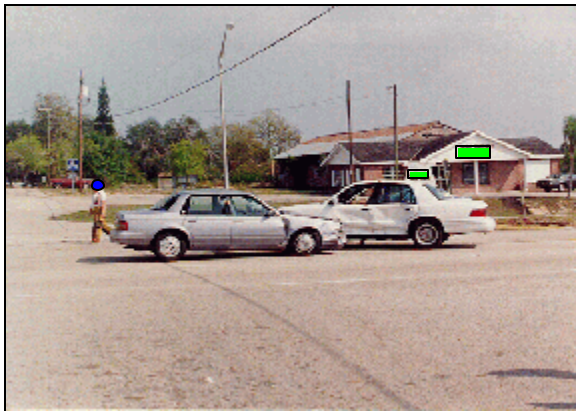
**Figure 3:** On-scene view from vehicle #2's eastward travel path showing case vehicle (at left) and vehicle #2 (at right) at respective final rest positions; Note: vehicle #2 rotated approximately 80 degrees counterclockwise to final rest (case photo #05)

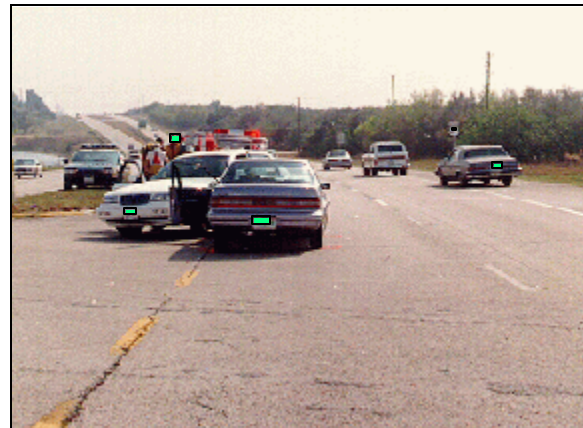
**Figure 4:** On-scene close-up of case vehicle (foreground) and vehicle #2 (background) at final rest near inside southbound lane (case photo #03)

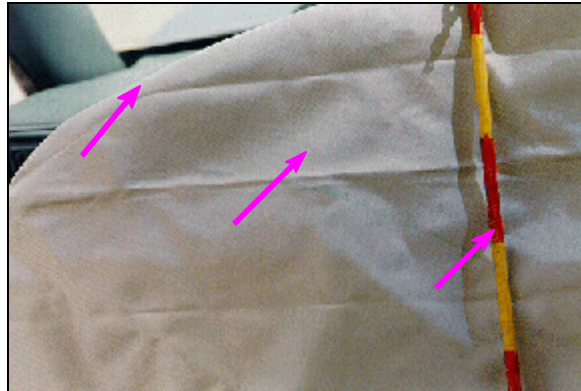
Inspection of the driver's air bag revealed what appeared to be skin, cloth transfers, and some unknown body fluid on the driver's air bag. Specifically, a long, green, cloth transfer (**Figure 5**) was noted in the upper left quadrant beginning on the center vertical axis and 15 centimeters (6 inches) up from the center horizontal axis. This transfer ended 18 centimeters (7.1 inches) to the left of center and 23 centimeters (9.1 inches) up from the horizontal axis. Also noted in the upper left quadrant was a possible skin transfer, approximately 4 centimeters (1.6 inches) left of the vertical center and 8 centimeters (3.1 inches) above the center horizontal axis. Finally, another skin transfer and a brown foreign substance were noted in the lower right quadrant, 1.3 centimeters (0.5 inches) left of center and 10 centimeters (3.9 inches) below the horizontal axis.

**Figure 5:** Case vehicle's driver air bag; Note: green cloth transfer from top of bottom yellow mark towards top left corner (case photo #19)

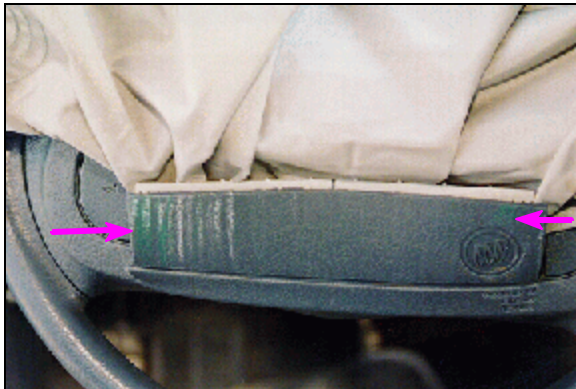
**Figure 6:** Case vehicle driver air bag module's lower cover flap; Note: green cloth transfer to flap (case photo #22)

Furthermore, there were green cloth transfers on the driver air bag module's lower cover flap, with the heaviest transfers to the flap's left side (**Figure 6**), and striations and faint green cloth transfers on the upper cover flap (**Figure 7**). There was skin and hair scuffing on the driver's sun visor (**Figure 8** below), a skin transfer on the left "A"-pillar, and a scuff on the lower left instrument panel of the case vehicle.

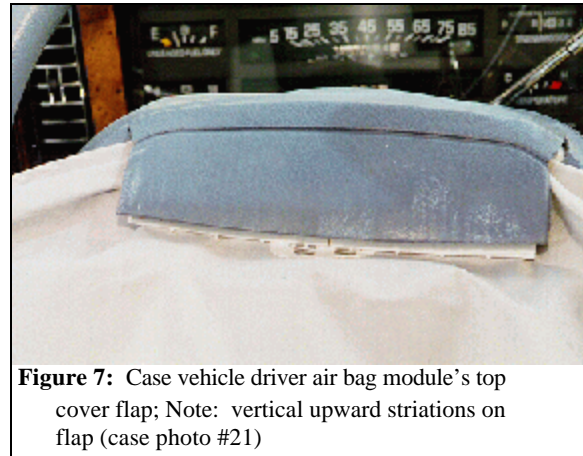
**Figure 7:** Case vehicle driver air bag module's top cover flap; Note: vertical upward striations on flap (case photo #21)

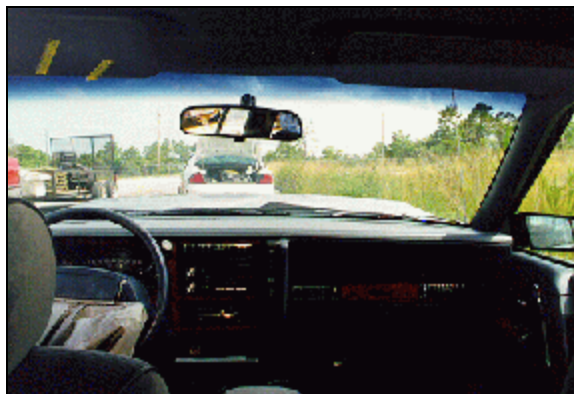
**Figure 8:** Case vehicle's front seating area showing deployed driver air bag, top cover flap, and contact to driver's sun visor (case photo #26)

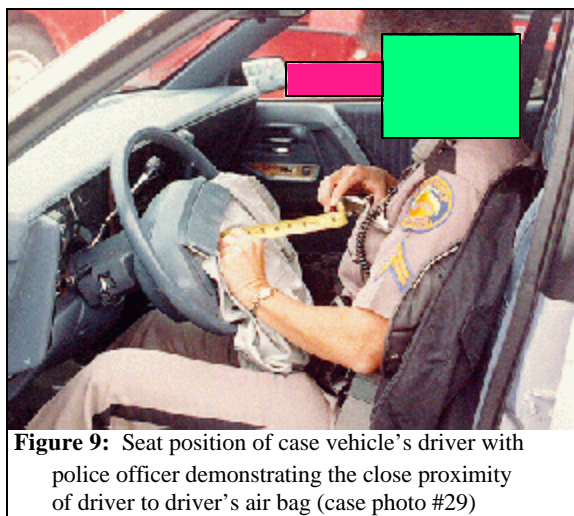
**Figure 9:** Seat position of case vehicle's driver with police officer demonstrating the close proximity of driver to driver's air bag (case photo #29)

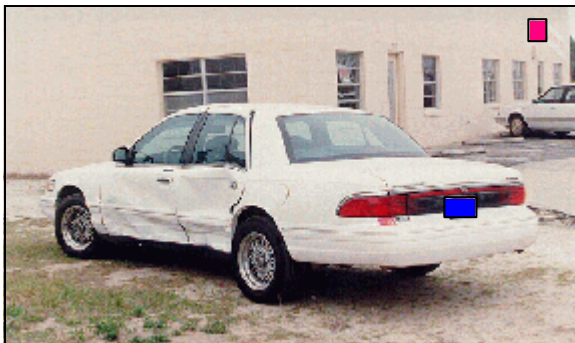
**Figure 10:** Vehicle #2's left side damage; Note: maximum crush near left rear door handle indicates PDOF acted aft of vehicle's center of gravity (case photo #34)

Available police photographs show the direct damage to vehicle #2 at the left front door, the left rear door, the forward edge of the left rear wheel well, and the left rocker panel (**Figures 10 and 11**). There may have been some slight intrusion to the second seat left position in this vehicle. Based on the police photographs, the CDC for vehicle #2 was estimated as: **09-LPEW-2 (+260 degrees)**. The WinSMASH reconstruction program, missing vehicle algorithm, was used on vehicle #2's highest severity impact. The Total, Longitudinal, and Lateral Delta Vs are, respectively: 15.4 km.p.h. (9.6 m.p.h.), 2.7 km.p.h. (1.7 m.p.h.), 15.2 km.p.h. (9.4 m.p.h.).

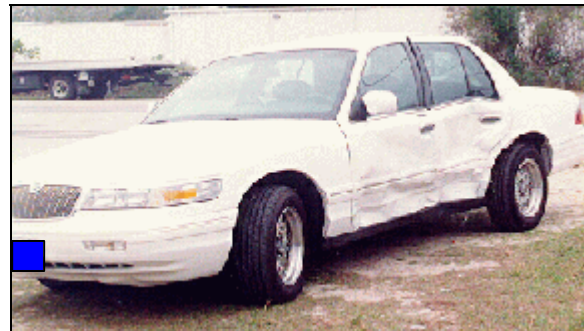
**Figure 11:** Vehicle #2's left side damage viewed from front showing area of maximum crush near left rear door's handle; Note: since PDOF was aft of vehicle #2's center of gravity, vehicle rotated counterclockwise after impact (case photo #31)
