On-Scene / Vehicle versus Fixed Object (Brick Building)
Dynamic Science, Inc. / Case Number: DS9719
1993 Chevrolet Corsica LT 4-Door
Washington
July/1997

1. Report No. DS9719		2. Government Accession No.		3. Recipient Catalog No.	
4. Title and Subtitle In-Depth Accident Investigation				5. Report Date	
				6. Performing Organization Report No.

Dynamic Science, Inc.
Accident Investigation
Case Number: DS9719

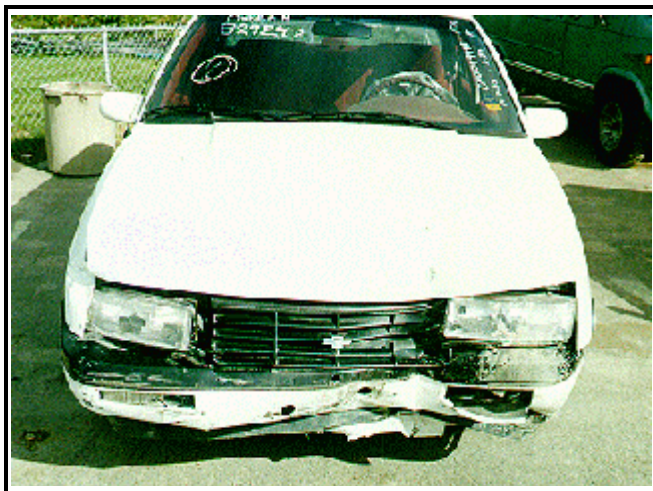
Vehicle 1 sustained minor rear end damage when it struck the standard light/pole; it was minor scratching to the bumper surface. There was minor damage to the front right tire rim. There was moderate damage to the entire front end resulting in the highest Delta-V. A CDC of 12FDEW1 has been coded for the impact, and a total Delta-V of 21.1 km (13.1 mph) was calculated using the barrier portion of WinSmash. Travel speed at impact was calculated using acceleration from stop formula, and an acceleration rate of 4 ft/sec/sec was assumed since there were no obvious tire marks left in the parking lot. The pavement was bare and dry with no obvious signs of oil or other slippery substances.

Figure 1. Front end damage.

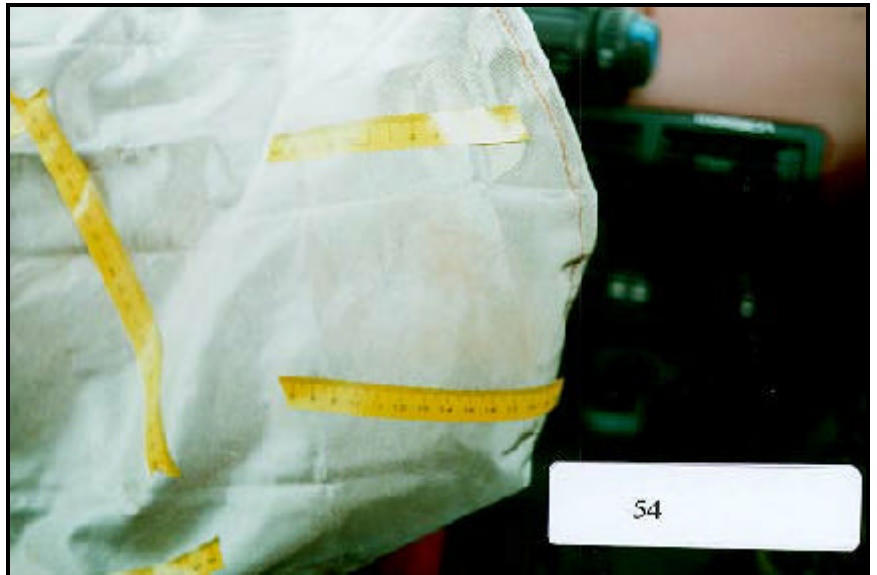
There was makeup transfer on the center of the front part of the air bag. There was also makeup transfer on the right front quadrant that extended to the back part of the air bag (See Figure 2). There were no contacts or damage noted to the module covers.

Figure 2. Makeup transfer on driver's air bag.

On impact with the brick wall/building, the driver was moving forward into the deploying air bag. The right side of the driver's face struck the air bag, as is indicated by the makeup transfer about the air bag. The driver's head was then thrown backwards and to the left. The Ciren investigator indicated that the driver may have struck the B-pillar or the head restraint and that caused the subgaleal hemorrhage/scalp contusion over the left parietal region. Contact tape was found by the SCI investigator at the time of the vehicle inspection that had

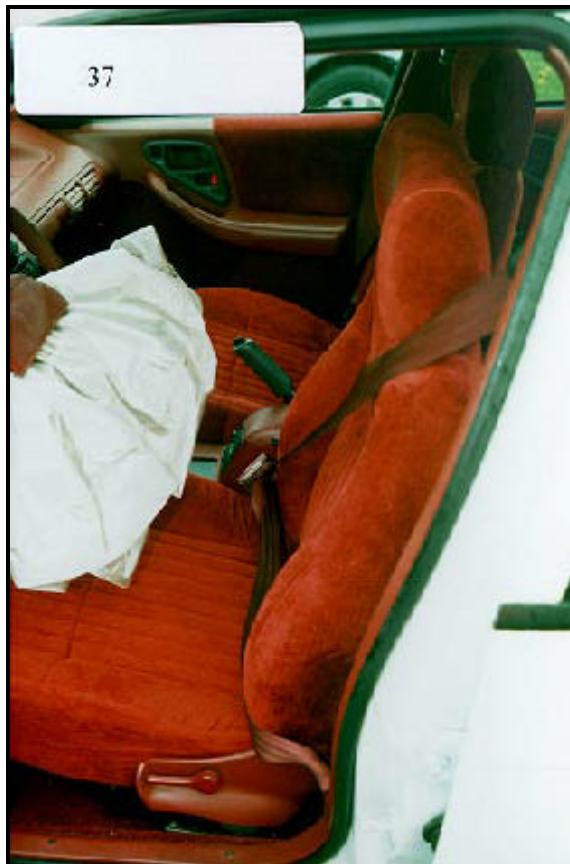
been left by the Ciren investigator. This contact is however being ruled out. The seat was adjusted too far forward to have allowed the head of the driver to contact the B-pillar (See **Figures 3 & 4**). It is possible that the back of the driver's head struck some part of the window frame. The Police report indicated "*...an elderly female lying back, partially out the open driver's side window.*" There were no visible contact points around the window frame area.

Figure 3. Driver's seat adjustment.

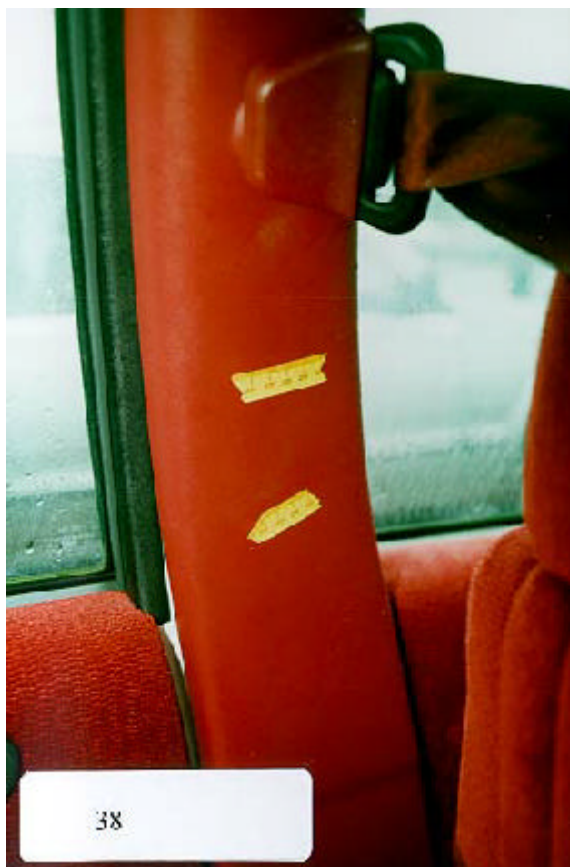
Figure 4. Ciren contact tape.
