On-scene Investigation / Vehicle to Vehicle
Dynamic Science, Inc. / Case Number: DS97-020
1995 Volvo 850 GLT 4-door Station Wagon
California
September 1997

Dynamic Science, Inc.
Accident Investigation
Case Number: DS97-020

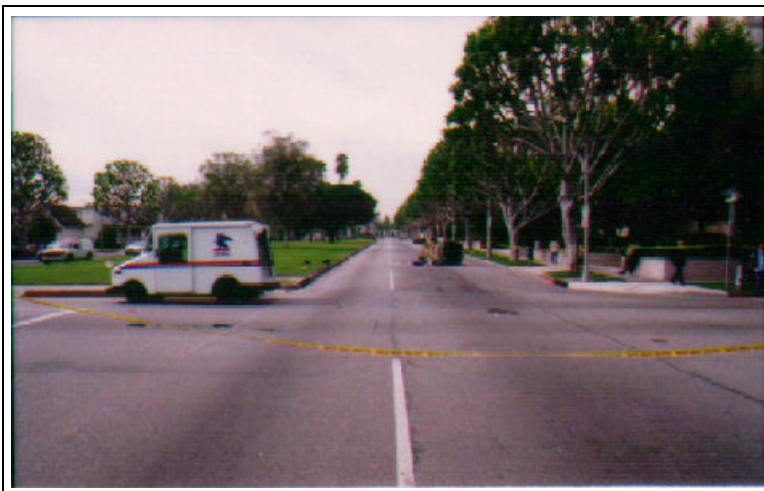
Figure 1. Direction of travel for Vehicle 1, and final rest for both vehicles.

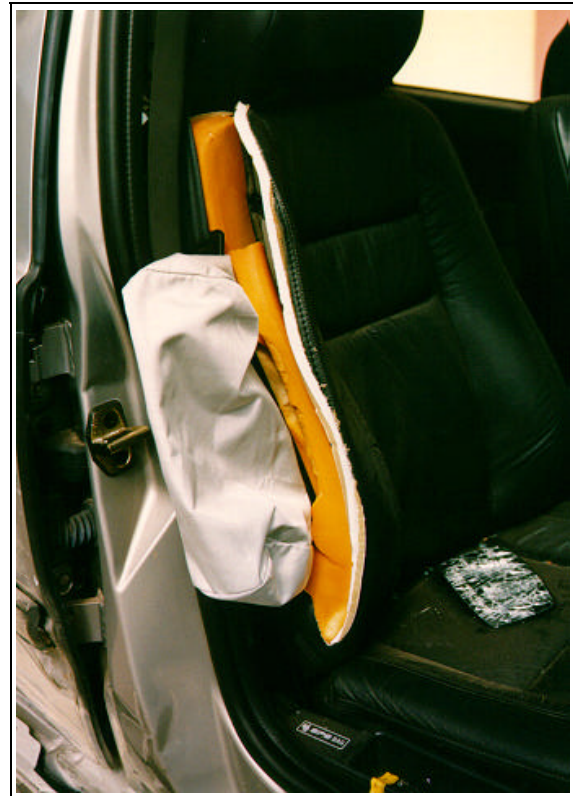
At impact, the longitudinal forces exceeded the deployment threshold of the driver's and front right passenger's air bags in Vehicle 1, and both frontal airbags deployed. In addition, the front right seat's SIPSBAG deployed (see Figure 2). The front right seat's SIPSBAG did not play a role in the injuries sustained by the driver. The driver's seat SIPSBAG did not deploy.

Figure 2. Right front seat SIPSBAG.

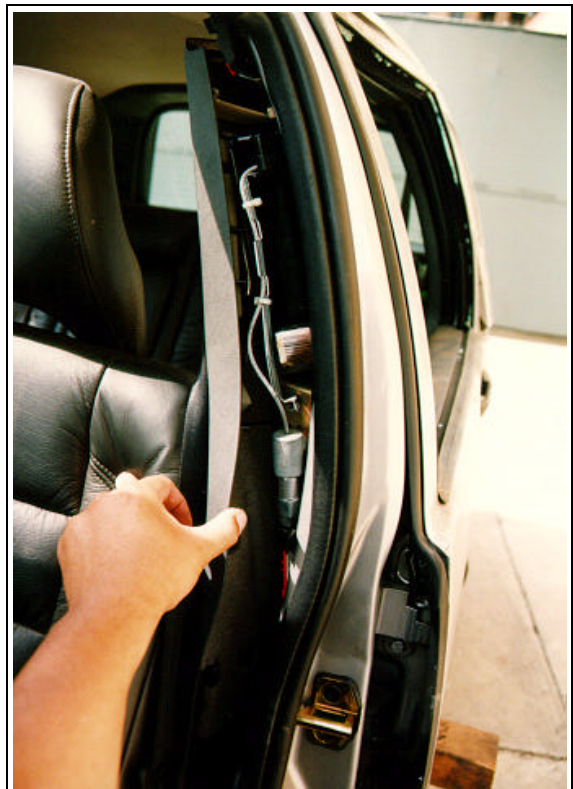
Figure 3. Driver's seat belt pretensioners.

belt systems were triggered and the belts were locked in the retracted position (see Figure 3). The driver of Vehicle 1 was fully ejected out of the driver's side window and onto the roadway just before the vehicle came to final rest, and Vehicle 1 probably rolled over her. Fire paramedics were dispatched to the scene at 1046 hours, and arrived at 1050 hours. They treated the driver of Vehicle 1 at the scene and noted that she was combative and disoriented. Fire paramedics transported her to a trauma center at 1103 hours. They arrived at the trauma center at 1108 hours.

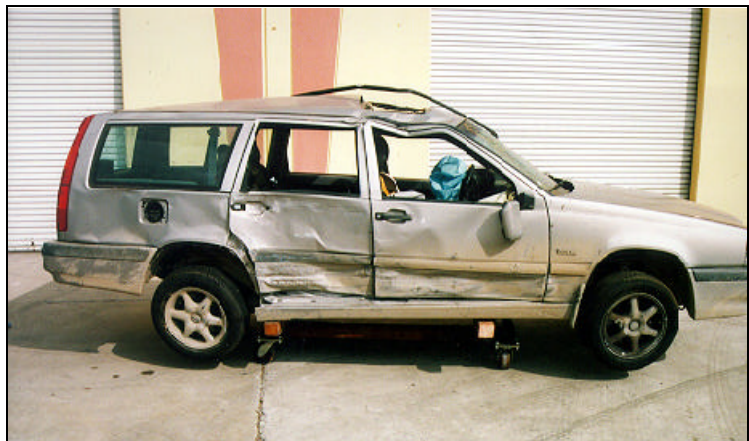
Vehicle 1 sustained moderate to major damage about the entire vehicle. The impact between Vehicle 1 and Vehicle 2 was the highest delta v; Vehicle 1 was assigned a CDC of 01RDEW2 with a positive 25 degrees PDOF, and had a maximum crush of 10 cm (3.9 in) at C3. The damage portion of WinSmash was utilized to compute a delta v. WinSmash computed a total delta v of 13.2 km/h (8.2 mph), a longitudinal delta v of -11.9 km/h (- 7.4 mph), and a latitudinal delta v of - 5.6 km/h (- 3.5 mph). The results fit the collision model but appear low. Vehicle 1 was towed from the scene due to the damage.

Figure 5. Right side damage to Vehicle 1.

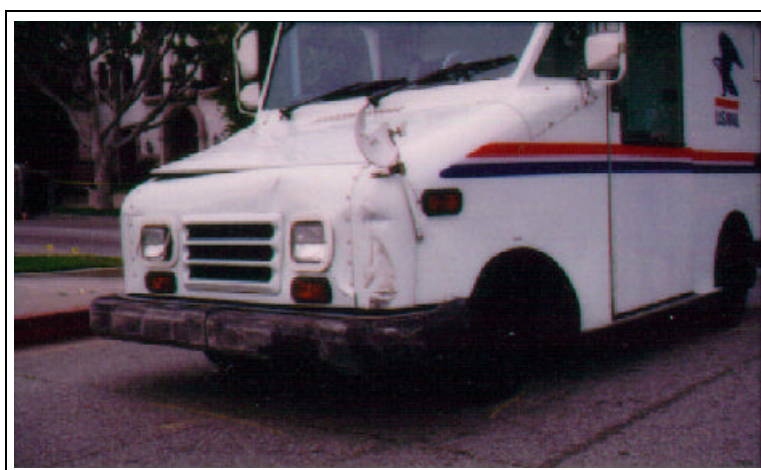
The PAR indicates that the driver of Vehicle 2 was wearing the available lap and shoulder belts. He did not report any injuries. Vehicle 2 sustained moderate contact damage to the front bumper, hood, grille area, and the front left fender. The impact between Vehicle 1 and Vehicle 2 was the highest delta v and a CDC for Vehicle 2 was estimated as 10FDEW1 with a negative 50 degrees

Figure 7. Exterior damage to Vehicle 2.

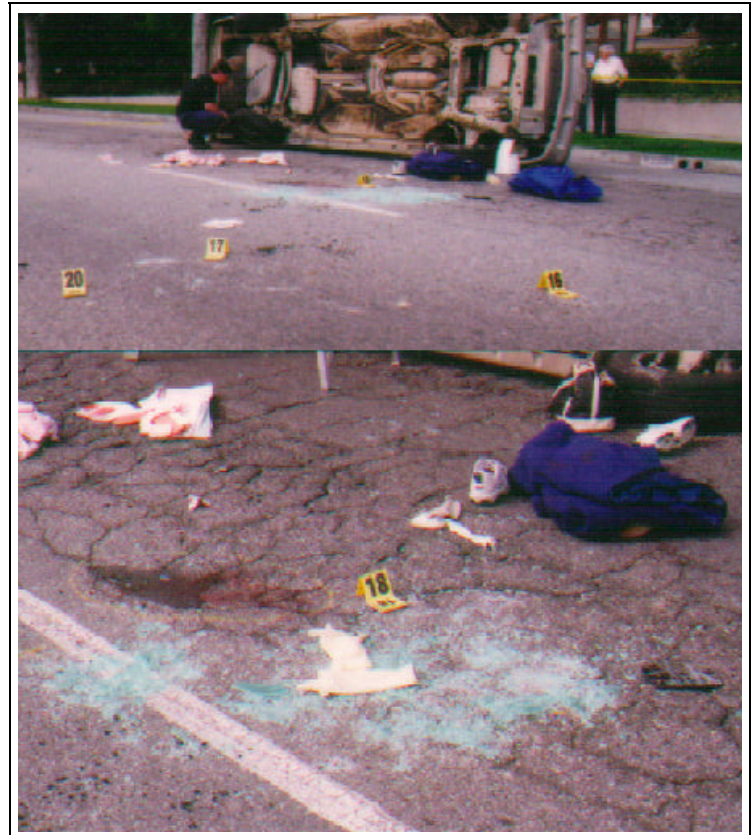
Figure 8. Final rest area of Vehicle 1 and its driver ejected from front left door glazing.
