CALSPAN REMOTE SIDE AIR BAG DEPLOYMENT INVESTIGATION

CALSPAN CASE NO. CA 97-020

**SUBJECT VEHICLE - 1996 MERCEDES E320W
VEHICLE #2 - 1988 ISUZU TROOPER 4X4**

CRASH DATE - MAY, 1996

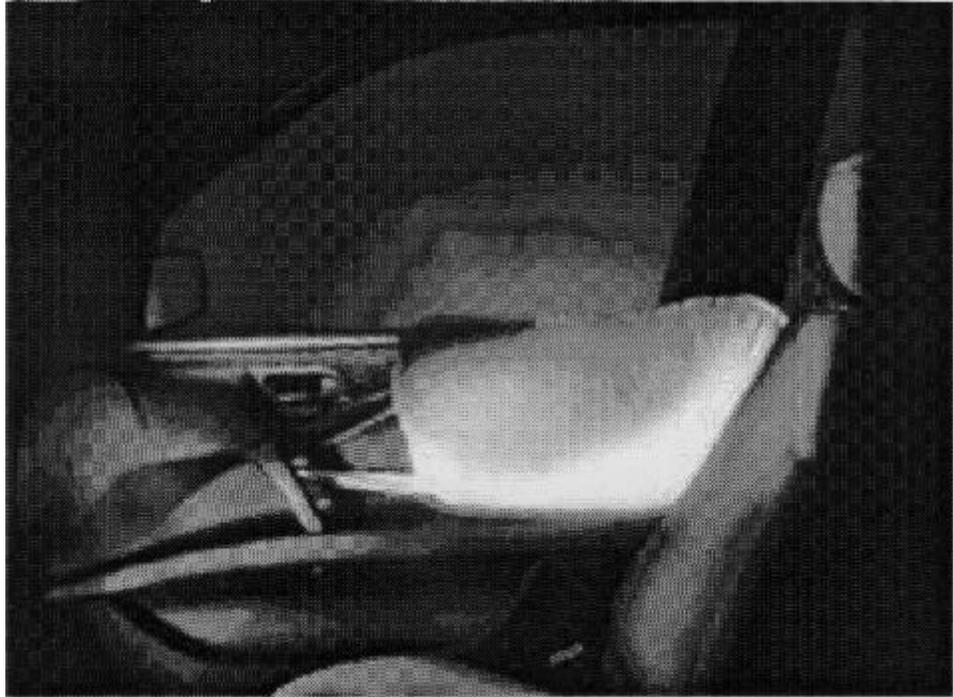
The left and right side impact air bags of the Mercedes E320W were installed in the rear sector of their respective doors and were designed to work independently of one another. Statements from safety engineering personnel at Mercedes-Benz revealed that the side impact air bag inflated above the armrest to provide a rounded cushion approximately 43 cm (17 in) long, 28 cm (11 in) high, and 8 cm (3 in) thick (refer to figure 1). One satellite sensor was located under each front seat and relay information to a main control unit, or brain box, which decides in ten milliseconds whether to deploy the air bag. Deployment requires a force equivalent to a 1360 kg (3000 lbs) weight impacting at approximately 25 to 27 km/h (16 to 17 mph).

Figure 1. Exemplar photograph of a Mercedes-Benz's deployed door-mounted side impact air bag
