On-scene Investigation / Vehicle to Vehicle
Dynamic Science, Inc. / Case Number: DS97021
1996 Mercury Sable
Oregon
October/1997

1. Report No. DS97021		2. Government Accession No.		3. Recipient Catalog No.	
4. Title and Subtitle In-Depth Accident Investigation				5. Report Date May 1998

Description:	This case was initiated in response to a report of a child-involved air bag fatality and an atypical air bag deployment in a 1996 Mercury Sable.
Investigation Type:	On-scene
Crash Location:	Oregon
Crash Date:	October 1997
Notification Date:	October 9, 1997
Field Work Completed:	October 14, 1997

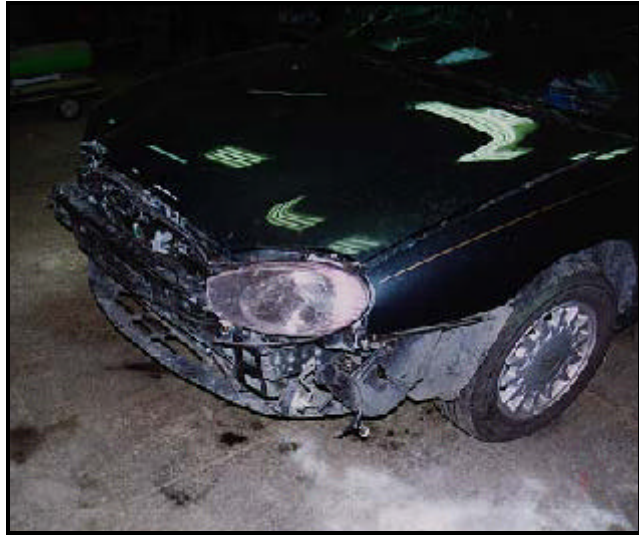
Figure 3. Exterior, Vehicle 1

Description:	1996 Mercury Sable GS four-door	
VIN:	1MELM50UXTGXXXXXX	
Odometer:	64,417 km (38,164 miles)	
Engine:	3.0L EFI V6	
Reported Defects:	None	
Cargo:	None	
Damage Description:	The bumper fascia was knocked off, the left discriminating sensor was broken free of its mountings, the right discriminating sensor was pushed into the radiator, and the right front door was jammed shut (it could be opened, but not without further damaging the vehicle).	
CDC:	10FDEW1	
Delta V:	Total	17.8 km/h (11.1 mph)
	Longitudinal	-10.2 km/h (-6.4 mph)
	Latitudinal	14.6 km/h (9.1 mph)
	Energy	38,141 joules (28,157 ft-lbs.)

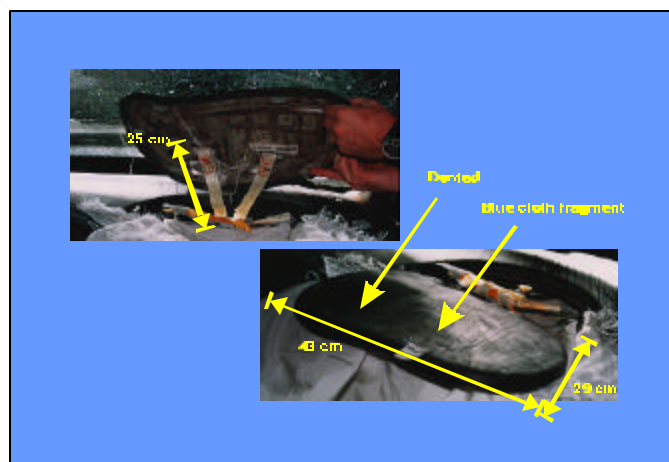
Figure 5. Module cover

Vehicle 1 was equipped with a driver's side air bag and a top-mount passenger side air bag. There are three sensors on the vehicle, two discriminating sensors on the radiator mounting bracket and one in the instrument panel. All are of the ball-in-tube design. The top-mount, passenger air bag module cover is vaguely oval in shape and is secured to the vehicle by two fabric tethers. The air bag was rectangular and measured 59 cm (23 in.) laterally by 63 cm (25 in.) vertically. It had a maximum excursion of 77 cm (30 in.) as measured from the top of the module cover. The right front seat was of the electrical adjustment variety; it was positioned 21 cm (8 in.) rearward of the face of the instrument panel.

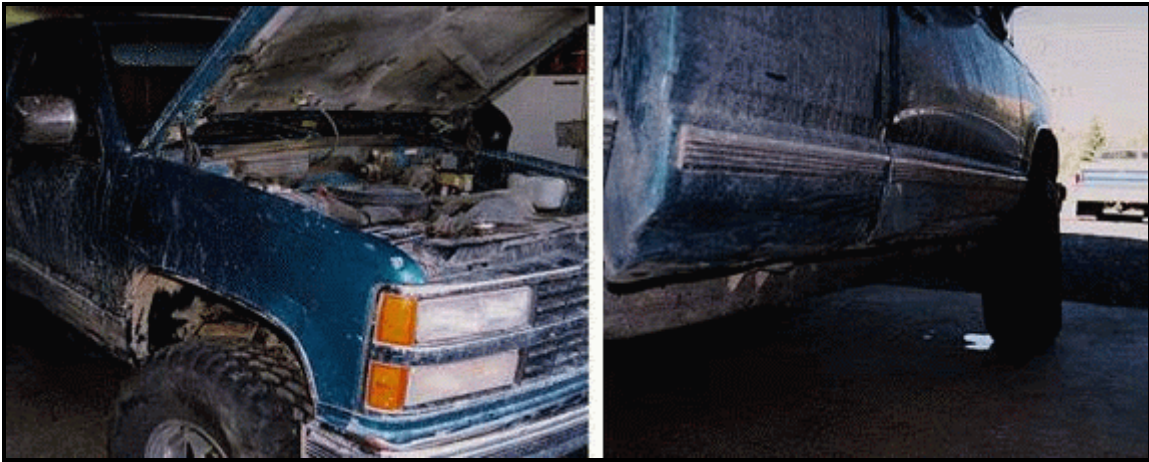
Figure 6. Exterior, Vehicle 2, Impact #1

Description:	1993 Chevrolet C150 pickup	
VIN:	2GCEK19K6P1XXXXXX	
Odometer:	91,557 km (56,893 miles)	
Engine:	5.7l V8	
Reported Defects:	Steering	
Cargo:	Unknown	
Damage Description:	Impact #1: Glancing, sideswipe type damage along lower sill on right side. Right tire knocked off.	
	Impact #2: Moderate crush to the rear part of the left side of the cab.	
CDC:	Impact 1: 12FZLW2 Impact 2: 11LZAW2	
Delta V:	Total	13.4 km/h (8.3 mph)
	Longitudinal	-13.2 km/h (-8.2 mph)
	Latitudinal	-2.3 km/h (-1.4 mph)
	Energy	31,963 joules (23,592 ft-lbs)

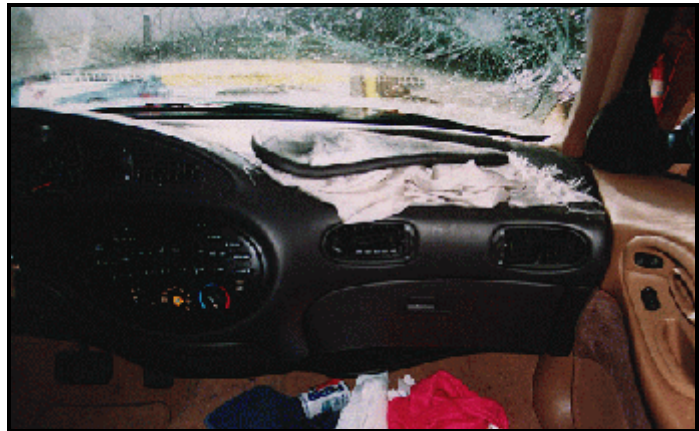
Figure 11. Interior, module cover in down position

The right front occupant of Vehicle 1 was seated forward on the seat with his legs over the edge of the seat. He was wearing a school backpack. His mother had just picked up the child from school and they were apparently discussing the day's events. As Vehicle 1 approached the intersection, it appears likely that the driver of Vehicle 1 tapped her brakes just prior to impact. This caused the child to move forward, bringing his head closer to the air bag module cover. His right arm was probably extended outward to catch himself which put him in a somewhat left facing position. It appears likely that the child was wearing some type of blue denim jacket or shirt but the actual clothing could not be located. There is blue fabric fragment evidence which was found embedded in the top of the module cover and in the windshield. There are blue fabric transfers along the front of the air bag, mostly on the right side, extending 20 cm (7.8 in.) along the face of the air bag and 37 cm (14.5 in.) along the top. At impact, the air bag on the passenger side deployed. The module cover likely struck the right arm and forced it into the windshield. This held the child in place. As the air bag expanded it contacted the underside of the chin and anterior neck area of the child causing the abrasions, and hyperextending the neck, which resulted in a complete C-1 separation. There is substantial skin transfer evidence of this contact, mostly on the left side of the face of the air bag beginning near the bottom and continuing on for 27 cm (10.6 in.). The child also sustained an abrasion to the right ear which appears to be a wraparound injury from the air bag and a laceration to the right elbow which was likely related to interaction between the air bag module cover and the windshield. According to the mother, the child came to rest near her.

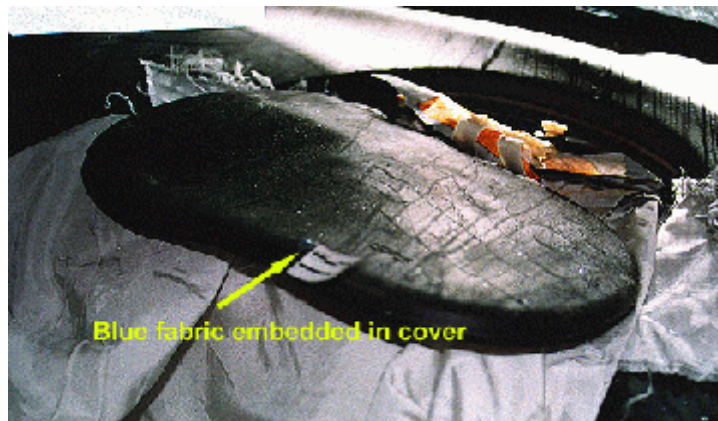
Figure 9. Module cover, embedded blue fabric

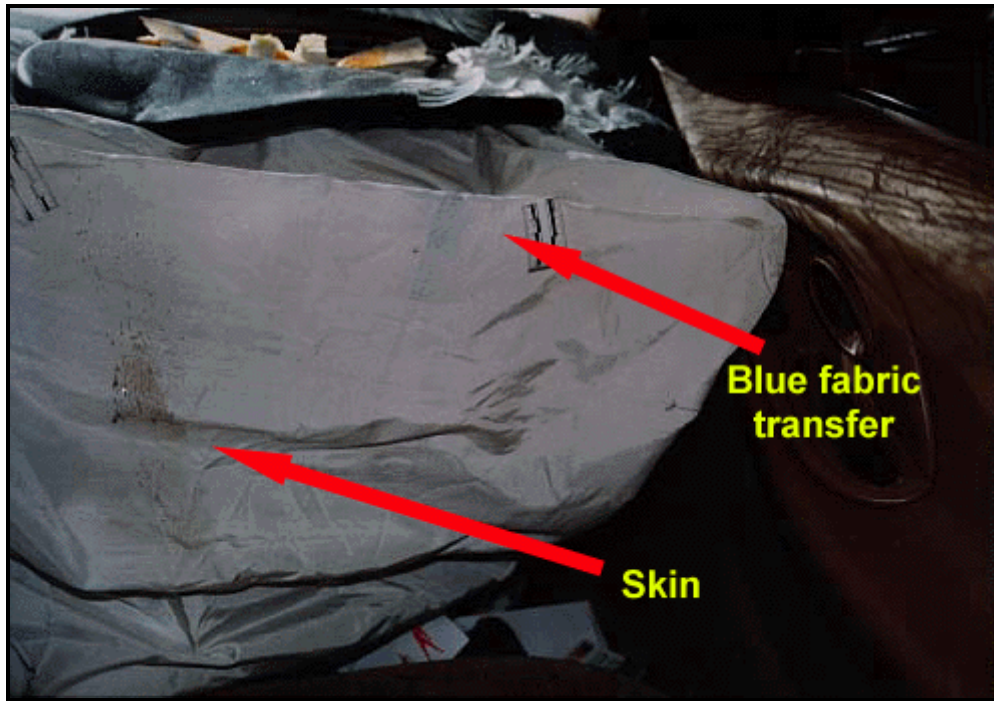
Figure 12. Skin and fabric transfers to passenger air bag
