ON-SITE AIR BAG INVESTIGATION

CASE NUMBER - IN97-021
LOCATION - OKLAHOMA
VEHICLE - 1995 DODGE NEON
CRASH DATE - July, 1997

1. Report No. IN97-021		2. Government Accession No.		3. Recipient's Catalog No.	
4. Title and Subtitle On-Site Air Bag Fatality Investigation Vehicle - 1995 Dodge Neon Location - Oklahoma			5. Report Date: 10/30/1999; 7/24/2000; 8/27/2001

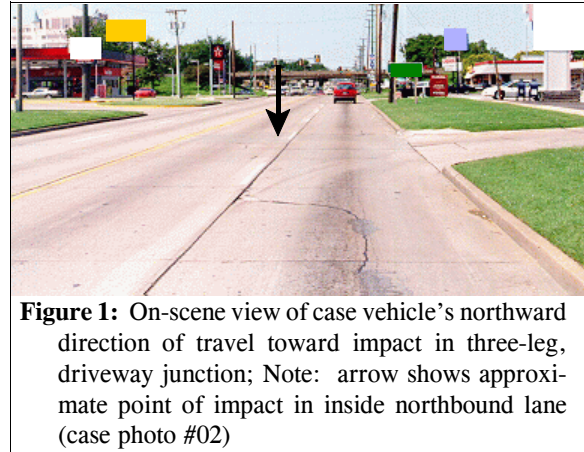
Figure 1: On-scene view of case vehicle's northward direction of travel toward impact in three-leg, driveway junction; Note: arrow shows approximate point of impact in inside northbound lane (case photo #02)

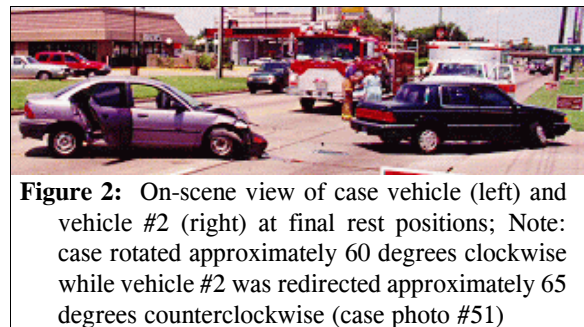
Figure 2: On-scene view of case vehicle (left) and vehicle #2 (right) at final rest positions; Note: case rotated approximately 60 degrees clockwise while vehicle #2 was redirected approximately 65 degrees counterclockwise (case photo #51)

rotated approximately 60 degrees clockwise and came to rest straddling the inside northbound lane heading east-northeast (Figure 6). Vehicle #2 was redirected approximately 65 degrees counterclockwise and came to rest heading east-northeast with its front end in the exit lane of the driveway access (Figure 7), against the front bumper of a pickup truck (undamaged) that was stopped in the parking lot exit lane waiting to make a turn. According to the available information, there was no damage to the pick-up and it subsequently departed the scene prior to the arrival of police. The Police Crash Report did not list this pickup, and its year, make, and model are unknown.

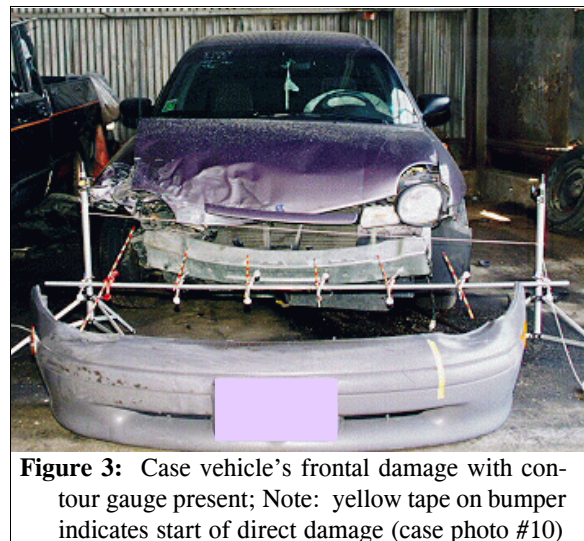
Figure 3: Case vehicle's frontal damage with contour gauge present; Note: yellow tape on bumper indicates start of direct damage (case photo #10)

The initial contact involved the case vehicle’s front bumper fascia (**Figures 3 through 6** above) against the right fender and wheel areas of vehicle #2 (**Figure 7** above). The direct contact damage consisted of a lateral abrasive pattern that began 47 centimeters (18.5 inches) left of center and extended 117 centimeters (46.1 inches) to the front right bumper corner. The bumper fascia was consequently torn off during the case vehicle’s clockwise rotation to final rest. The residual deformation to the bumper reinforcement bar, was relatively minor. The deformation to C₁ [1 centimeter (0.4 inches)] was minor while deformation at C₆ [33 centimeters (13.0 inches)] was fairly moderate. The damage pattern suggests a angular impact consistent with vehicle #2 turning left across the case vehicle’s travel path. The case vehicle’s two fenders, hood, and bumper reinforcement bar were shifted slightly to the right (**Figure 5** above). None of the case vehicle’s tires were deflated or physically restricted. There was no evidence of intrusion to the case vehicle’s interior.

Based on the vehicle inspection, the CDC for the case vehicle was determined to be: **12-FDEW-1 (350)** [maximum crush was 33 centimeters (13.0 inches)]. The WinSMASH reconstruction program, missing vehicle algorithm, was used on the case vehicle’s highest severity impact. The Total, Longitudinal, and Lateral Delta V’s are, respectively: 28.9 km.p.h. (18.0 m.p.h.), -28.5 km.p.h. (-17.7 m.p.h.), and +5.0 km.p.h. (+3.1 m.p.h). The case vehicle was towed due to damage from the scene.

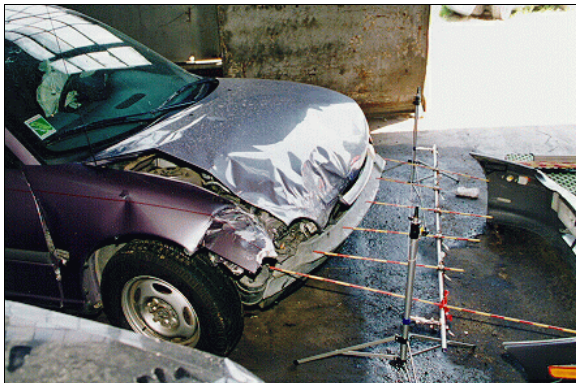
Figure 4: Case vehicle's frontal deformation viewed along reference line from right with contour gauge present; Note: bumper fascia torn away (case photo #18)

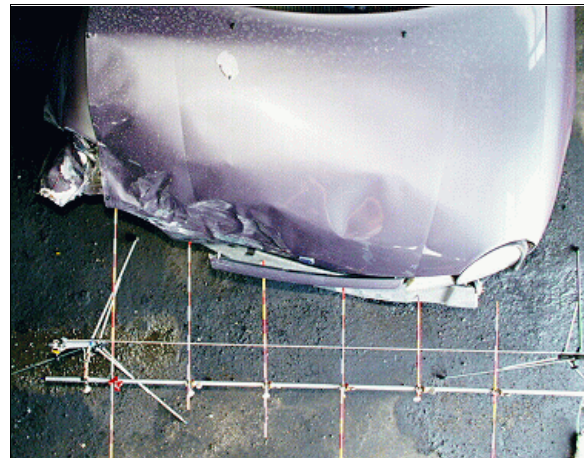
Figure 5: Overhead view of case vehicle's frontal damage/crush measurements (case photo #22)

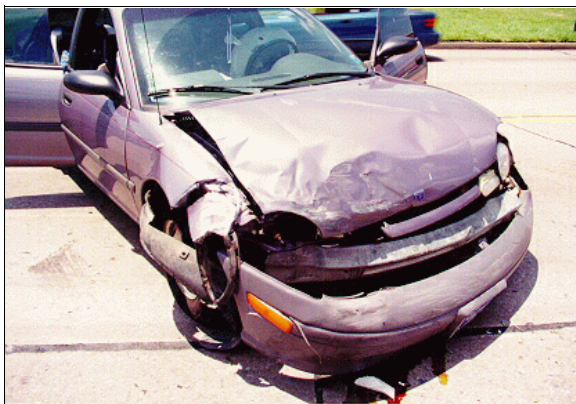
Figure 6: On-scene view of case vehicle at final rest straddling inside northbound lane; Note: frontal damage, particularly to front right (case photo #53)

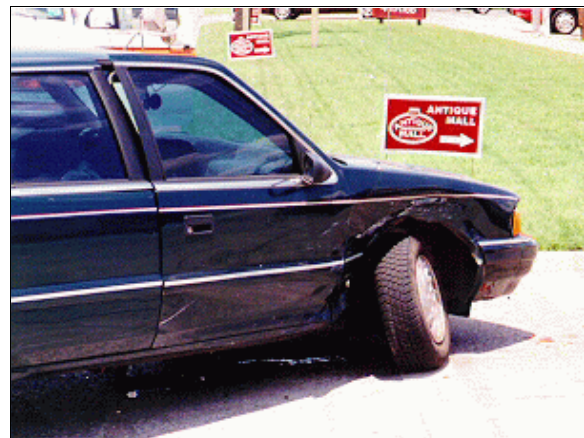
Figure 7: On-scene view of vehicle #2 at final rest; Note: direct damage to right fender and right front wheel assembly (case photo #56)

Based on the on-scene photographs, the direct damage extended from just behind the right front bumper corner to the middle of the right front door. The right front tire is bent inwards towards the top with damage to the associated wheel assembly components. The front right turn signal glass is broken out, most likely from this vehicle's minor front impact with the unknown pick-up truck in the driveway exit.

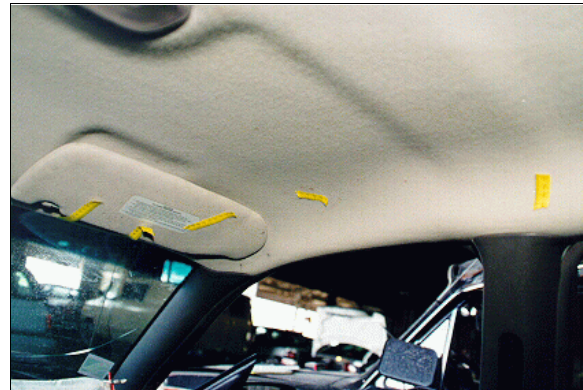
Figure 8: Case vehicle’s front right sun visor and roof showing air bag residue on sun visor and blood splatters on roof from front right passenger (case photo #41)

(SRS) that consisted of frontal air bags for both the driver and front right passenger positions. An examination of the interior revealed evidence of contact (i.e., smeared white powder used to package the air bag) on the front right windshield caused by the air bag during deployment, and air bag exhaust particles were found on the sun visor and roof area above the front right seating position. Also found on the roof above the passenger seating area were two blood splatters from the front right passenger (**Figure 8**). The knee bolsters showed no evidence of contact.

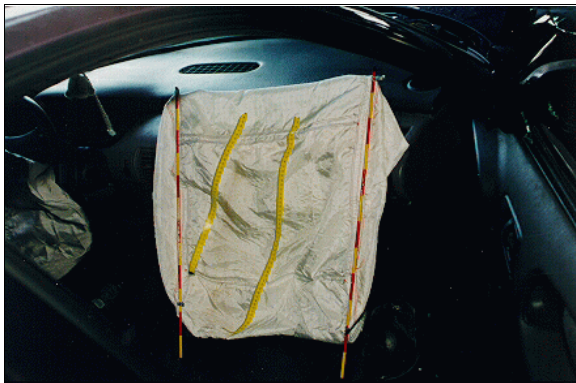
Figure 9: Case vehicle's front right air bag with yellow tape outlining skin transfer to air bag from front right passenger's face (case photo #33)

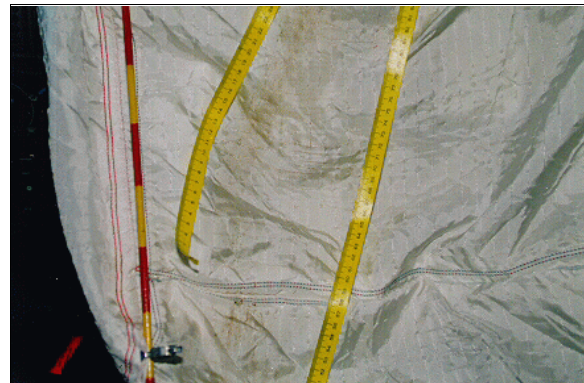
Figure 10: Close-up of skin transfer with blood smear to front of case vehicle's front right air bag (case photo #36)

An inspection of the front right air bag module's cover flap revealed what appeared to be two dark spots (unknown substance, possibly blood splatter) on the cover flap. An inspection of the front right passenger air bag revealed what appeared to be a large dark skin transfer to the front left portion of the air bag (**Figures 9 and 10**). The skin evidence on the front of the air bag ranged from approximately 5 centimeters (2.0 inches) wide at the top to 15 centimeters (5.9 inches) at the middle and 8 centimeters (3.1 inches) at the bottom. The skin evidence started

approximately 3 centimeters (1.2 inches) above the top horizontal edge of the air bag and 15 centimeters (5.9 inches) in from the left edge of the air bag. The skin contact continued down the whole front of the air bag for a distance of 58 centimeters (22.8 inches) and extended 2 centimeters (0.8 inches) into the bottom portion. There was no contact evidence to the top portion of the air bag which would indicate (based on previous SCI air bag cases), that the front right passenger was grossly out-of-position at the time of deployment. There was no evidence of direct contact to the windshield, sun visor, or header; however, the roof area on the front right side showed blood splatters. According to the investigating officer, the attending physician told him that the front right passenger's injuries were from her head being hung over the torso belt at maximum engagement and were not air bag-related.

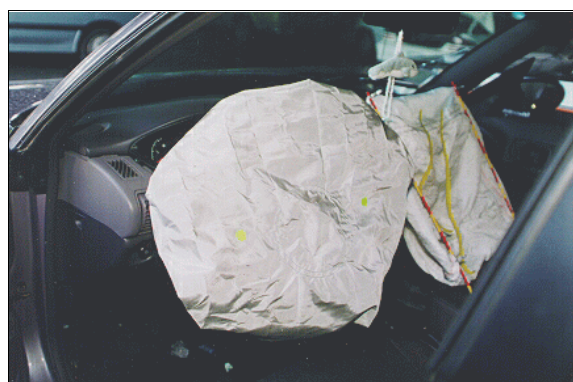
Figure 11: Case vehicle's front seating area showing deployed air bags with contact evidence (i.e., skin transfers) highlighted (case photo #26)

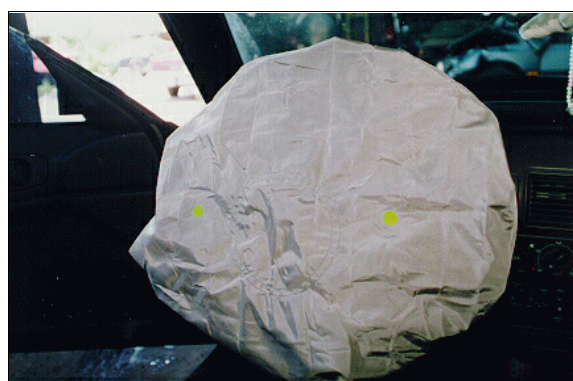
Figure 12: Case vehicle's deployed driver air bag showing contact evidence (i.e., skin transfers); Note: steering wheel inverted 180 degrees (case photo #27)

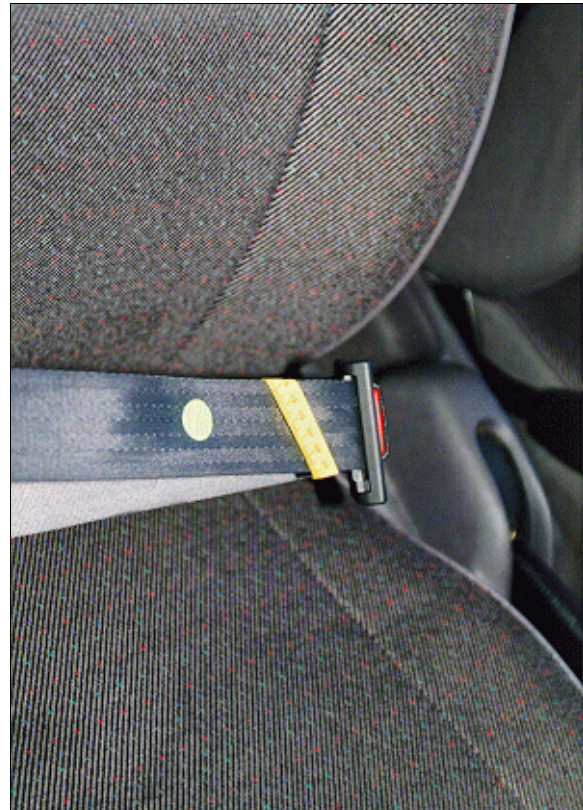
Figure 13: Close-up of case vehicle's front right seat belt webbing showing evidence (i.e., blood drop and angled scrub) of usage (case photo #47)

In addition, the front right safety belt's upper anchorage adjustment was in the full down position. There is no evidence of belt pattern bruising and/or abrasions to the front right passenger's body; however, she sustained a small splenic contusion, which could have resulted from the lap portion of her safety belt if the belt spooled out (no locking clip) during impact. In addition, the inspection of the front right passenger's safety belt webbing, "D"-ring, and latch plate showed no conclusive evidence of loading; although, there were dark fluid blood drops on the webbing as well as an angled crease near where this occupant would have had the belt latched and heavier than normal wear marks on the latch plate (**Figure 13**).

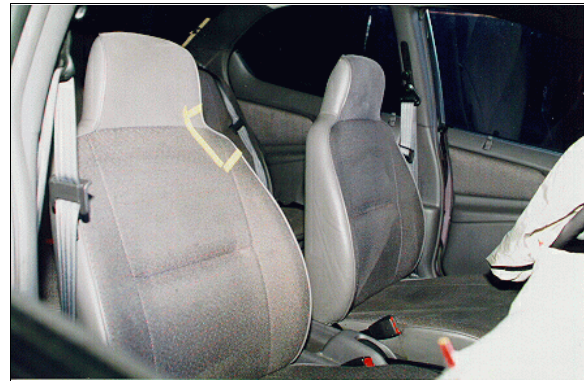
Figure 14: Case vehicle's front bucket seats showing seat back positions; Note: contact to front right seat back (i.e., grease or blood smear) from front right passenger (case photo #45)

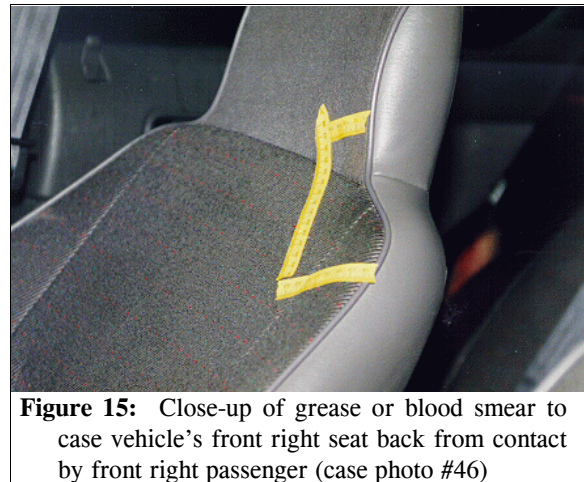
Figure 15: Close-up of grease or blood smear to case vehicle's front right seat back from contact by front right passenger (case photo #46)
