**CALSPAN ON-SITE AIR BAG DEPLOYMENT/CHILD PASSENGER
FATALITY INVESTIGATION
CALSPAN CASE NO. CA97-25
VEHICLE: 1995 FORD ASPIRE
LOCATION: PENNSYLVANIA
CRASH DATE: JUNE, 1997**

Contract No. DTNH22-94-D-07058

U.S. Department of Transportation
National Highway Traffic Safety Administration
Washington, D.C. 20590

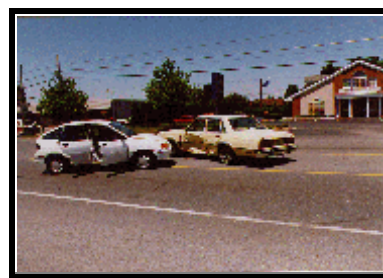
Figure 1. Final rest position of the involved vehicles.

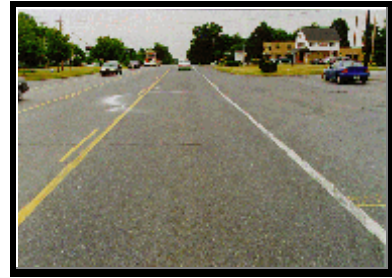
Figure 2. Overall view of the crash site and trajectory of the Ford Aspire.

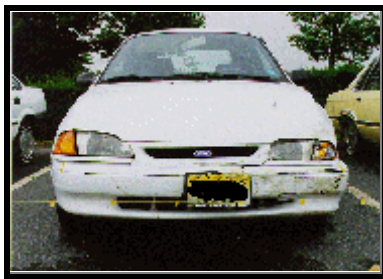
The Ford Aspire sustained moderate frontal damage as a result of its impact sequence with the side of the Ford Fairmont. Maximum crush was 13.7 cm (5.4") located at the front left corner of the bumper. The direct contact damage began 51.4 cm (20.25") right of center and extended 120.9 cm (47.6") to the front left corner (Figure 3). The combined induced and direct contact damage involved the full frontal width of the vehicle and was measured at 134.6 cm (53.0"). The crush profile was documented at the level of the bumper fascia and was as follows (Figure 4): C1 = 13.7 cm (5.4"), C2 = 11.7 cm (4.6"), C3 = 9.5 cm (3.75"), C4 = 7.4 cm (2.9"), C5 = 2.3 cm (0.9"), C6 = 1.9 cm (0.75").

Figure 3. Direct contact damage to the Ford Aspire.

Damaged components included the front bumper fascia and reinforcement system, hood, and the right front fender. The Collision Deformation Classification (CDC) for this impact event was 01-FDEW-1.

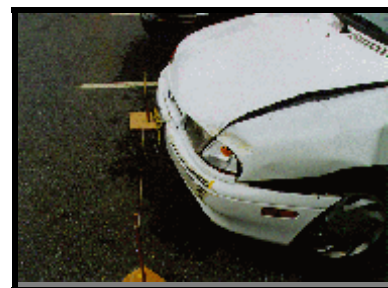
Figure 4. Profile view of the frontal crush.

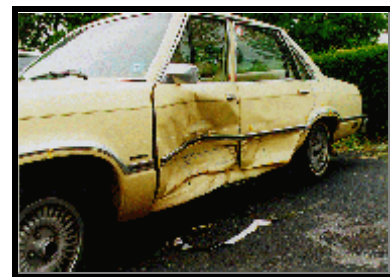
Exterior damage to the Ford Fairmont was located on the left side of the vehicle at the doors between the A- and C-pillars (**Figure 5**). The direct contact damage began 81.3 cm (32.0") rearward of the left front axle and extended 143.5 cm (56.5") to the left C-pillar. The damage deformed both front doors resulting in a combined induced and direct damage length of 199.4 cm (78.5"). Maximum crush was 31.1 cm (12.25") located at the mid aspect of the lower left front door panel at the C4 location. The crush profile at the level was as follows: C1 = 0 cm, C2 = 8.3 cm (3.25"), C3 = 21.6 cm (8.5"), C4 = 31.1 cm (12.25"), C5 = 19.7 cm (7.75"), C6 = 0 cm.

Figure 5. Ford Fairmont's damage pattern.

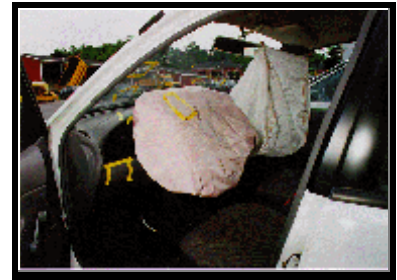
The Ford Aspire was equipped with a Supplemental Restraint System (SRS) that consisted frontal air bags for the driver and right passenger positions (**Figure 6**). The driver air bag deployed from an H-configuration module assembly that was housed within the four spoke steering wheel assembly. The upper module cover flap was 14.6 cm (5.75") in width at the horizontal tear seam and 7.0 cm (2.75") in height while the lower flap had respective dimensions of 14.6 cm (5.75") and 8.3 cm (3.25"). The deployed air bag was constructed of two panels sewn with an internal peripheral seam and was a pinkish fabric that was 64.8 cm (25.5") in diameter. The identification numbers 075437C were stamped onto the panel exposed to the driver while the forward panel was stamped with 096439C. The bag was tethered internally by four tether straps sewn to the face of the bag with a 18.0 cm (7.1") diameter reinforcement. The bag was vented by two 3.8 cm (1.5") diameter ports located at the 10 and 2 o'clock positions. The vent ports were centered 18.4 cm (7.25") forward of the peripheral seam, or 8.9 cm (3.5") outboard of the inflator.

Figure 6. Overall view of the Aspire's deployed frontal air bag system.

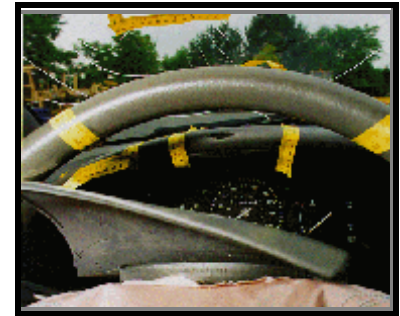
Figure 7. Air bag exhaust gas burn to the upper instrument panel.

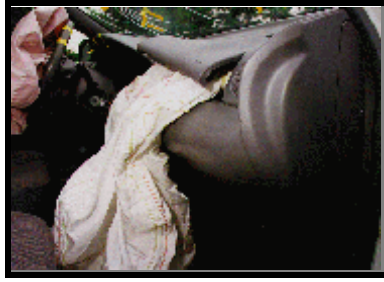
The front passenger air bag was mounted in the right instrument panel in a mid mount (**Figure 8**) configuration. The single cover flap was 32.0 cm (12.6") in length and 19.1 cm (7.5") in height. The top hinge point was located at the upper instrument panel while the horizontal tear seam was at the mid panel. The cover flap opened in an upward direction and fractured the windshield (**Figure 9**) 17.1-41.9 cm (6.75-16.5") right of center and 15.2-17.8 cm (6.0-7.0") above the instrument panel.

Figure 8. Deployment of the passenger air bag from its mid mount position.

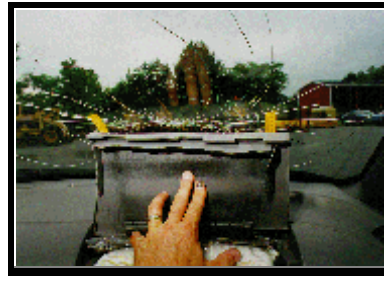
The front passenger air bag module cover flap impacted and cracked the laminated windshield 17.1-41.9 cm (6.75-16.5") right of center. Exhaust gases venting from the lateral port of the passenger air bag were deposited on the right upper A-pillar. At the base of the windshield, a whitish scuff mark (possible tissue transfer) was noted 29.2-33.7 cm (11.5-13.25") right of center and 1.3-5.7 cm (0.5-2.25") above the upper instrument panel. This transfer possibly resulted from a left hand contact by the child passenger.

Figure 9. Front right passenger air bag cover flap contact to the windshield.

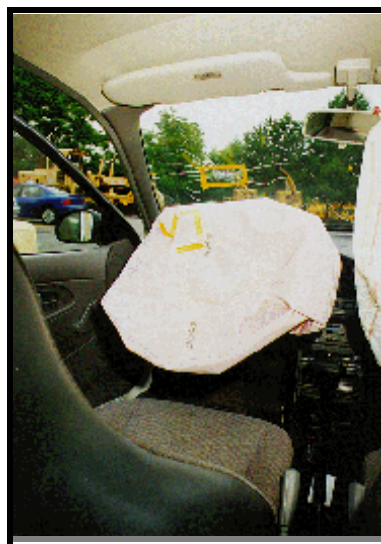
At impact, the driver initiated a forward trajectory in response to the 1 o'clock impact force (**Figure 10**). His right knee loaded the base of the steering column which produced a scuff mark to the plastic component. No injury was reported from this contact point. His left hand separated from the steering wheel rim and wiped across the upper instrument panel. His right hand subsequently impacted and cracked the windshield 31.8-41.7 cm (12.5-16.4") left of center. The driver complained of upper extremity pain which probably resulted from this contact.

Figure 10. Trajectory and contact points of the driver.

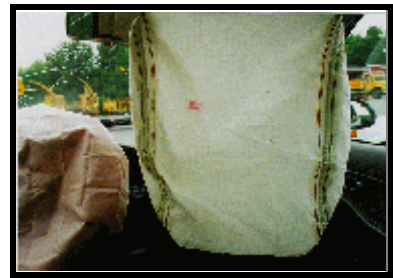
Several areas of occupant contact were noted to the face of the front right passenger air bag. A lip stick transfer from both lips was located on the left midpoint of the bag which extended 17.6-12.1 cm (3.0-4.75") right of the left side of the bag and 17.1-19.7 cm (6.75-7.75") below the top apex of the bag. This transfer subsequently smeared to the lower left corner of the bag extending 31.8 cm (12.5") below the referenced apex and 7.0-10.8 cm (2.75-4.25") right of the left seam. There was no damage, burns, or tears to the membrane of the bag.

Figure 11. Lipstick transfer to the left side of the passenger air bag.

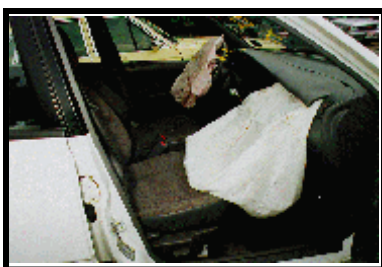
deployed (**Figure 12**), the air bag membrane contacted the child in the right upper facial area producing abrasions of the forehead, right eye and the right cheek. These soft tissue injuries were noted in the medical examiner's report. Hospital records identified a laceration with abrasion of the right eyelid. The location of this abrasion pattern indicates the child passenger's head was turned to the left as the air bag deployed. His left face was free of abrasion, thus supporting the head position. Additionally, the child passenger did not sustain soft tissue injury of the neck and/or cervical injuries. The lack of these injuries was attributed to his low position within the vehicle which probably supported the child being seated on the lap versus standing on the seat cushion.

Figure 12. Deployment of the front right passenger air bag.

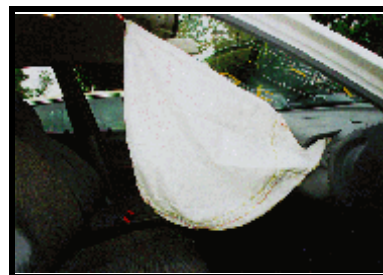
The expansion of the air bag membrane (**Figure 13**) displaced the child passenger rearward into the front right passenger. His direct contact with the passenger resulted in the depressed skull fracture of the left occipital bone and ecchymosis of the right posterior shoulder. In addition to these injuries, the child passenger sustained severe cerebral edema with extensive brain swelling and a large fronto-parietal subdural hematoma. These injuries could have resulted from the air bag induced acceleration of the head, or from the contact with the adult passenger, or both mechanisms.

Figure 13. Profile view of the front right passenger air bag.

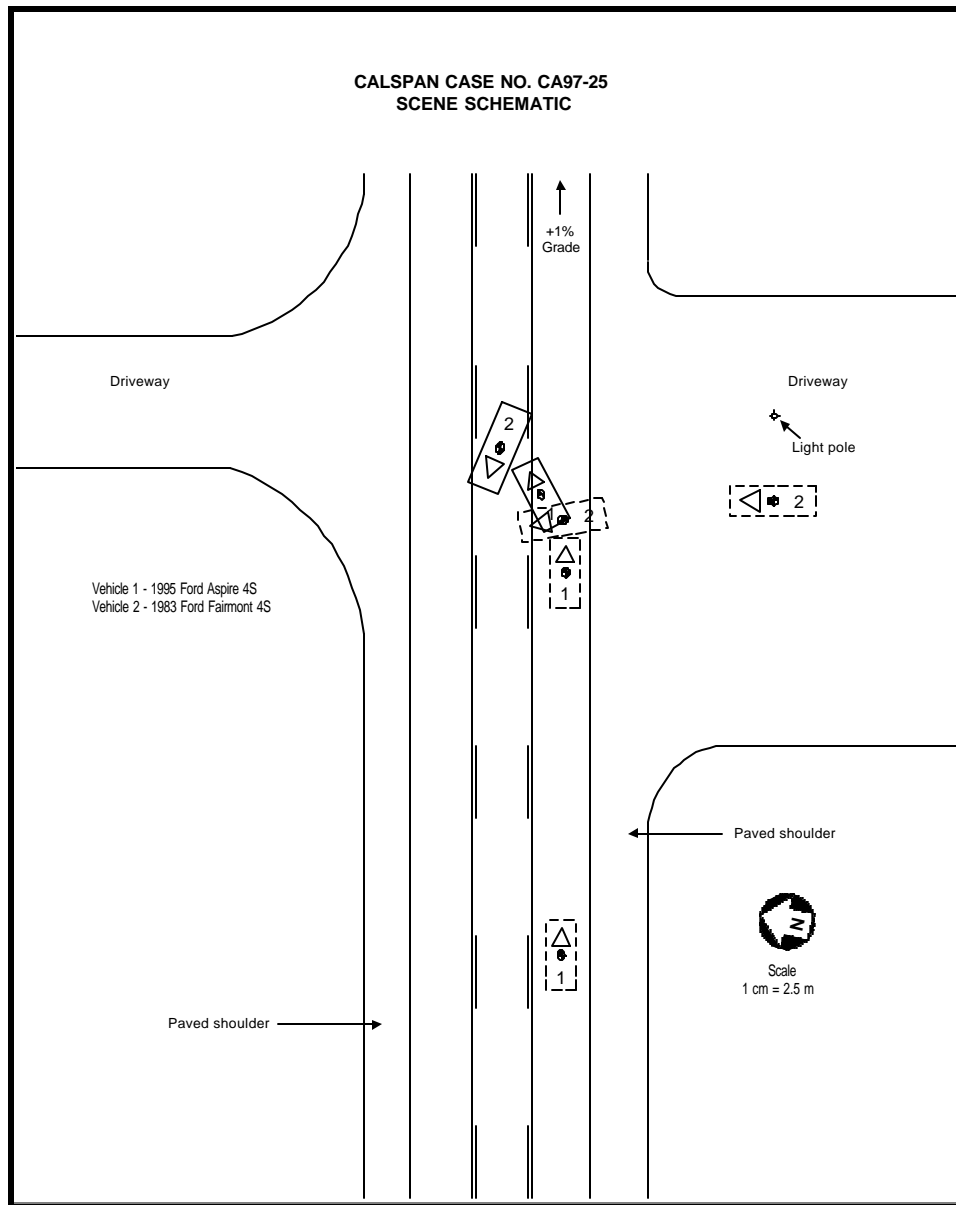
Figure 14. Crash schematic

The crash occurred on a two lane urban street with a dual direction left turn lane designated by painted markings. The asphalt travel lanes were 10.4 m (34.0') in width, inclusive of the left turn lane. Both travel lanes were bordered by wide paved shoulders with commercial driveways intersecting the shoulders. The roadway was straight with a positive grade of 1 percent to the east (**Figure 2**). At the time of the crash, the viewing conditions were daylight, the weather was clear, and the environmental surfaces were dry. The crash occurred in a mid block area with a posted speed limit of 72 km/h (45 mph). The Crash Schematic is attached as **Figure 14**, Page 13.
