## ON-SITE AIR BAG INVESTIGATION

CASE NUMBER - IN97-027  
LOCATION - WISCONSIN  
VEHICLE - 1996 PLYMOUTH GRAND VOYAGER  
CRASH DATE - November, 1996

1. <i>Report No.</i> IN97-027	2. <i>Government Accession No.</i>	3. <i>Recipient's Catalog No.</i>	
4. <i>Title and Subtitle</i> On-Site Air Bag Fatality Investigation Vehicle - 1996 Plymouth Grand Voyager Location - Wisconsin		5. <i>Report Date:</i> June 3, 1999; July 31, 2001

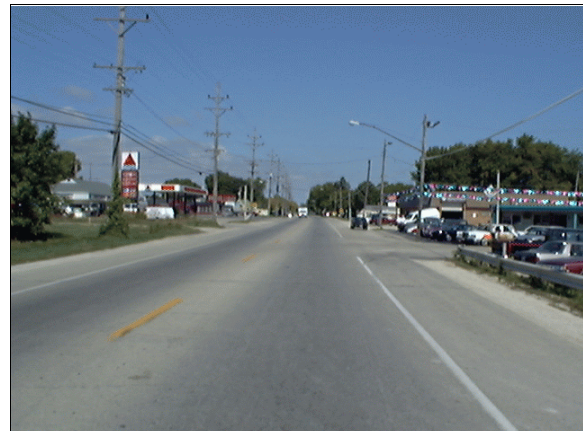
The case vehicle was traveling north in the northbound lane of a two-lane, undivided, state roadway (**Figure 1**) and intended to continue in its northward direction of travel. The Chevrolet was traveling south in the northbound lane of the same two-lane, undivided, state roadway and intended to continue traveling south (see **CRASH DIAGRAM**). In the area of the crash there is a "W"-beam guardrail along the east shoulder parallel to the trafficway. The roadway was constructed of bituminous material and was straight and level near the area of impact. At the time of the crash it was precipitating, and the roadway was wet. The north and southbound lanes are divide by yellow dashed lines with a solid white fog line along each outside edge. The northbound roadway was 4.2 meters (13.9 feet) wide with a 2 meter (6.6 feet) gravel shoulder on each side of the roadway. The estimated coefficient of friction for the roadway is 0.70% when dry. The legal speed limit is 56 km.p.h. (35 m.p.h.). The area is primarily commercial with some undeveloped rural areas along the roadway.

**Figure 1:** Case vehicle's northbound path of travel just prior to impact (case photo #03)

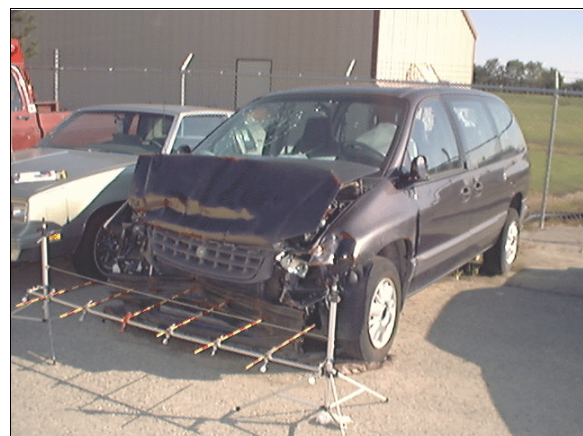
The case vehicle’s initial contact with the Chevrolet involved the entire front end (**Figure 2**). The direct contact damage extended across the entire front end, from bumper corner to bumper corner, a distance of 148 centimeters (58.3 inches). The direct damage width and the field L were the same. The initial bumper fascia contact with the Chevrolet resulted in residual crush to the bumper reinforcement beam. The front bumper fascia, bumper reinforcement beam, grille, and radiator were crushed rearward. The hood was folded back towards the windshield. The windshield had stress fractures across the whole surface with a spider web from the passenger’s head impact on the passenger side. Both front tires were physically restricted from the front end damage with the right front tire being flat. The

**Figure 2:** Case vehicle’s frontal deformation viewed from front left with contour gauge present (case photo #10)

residual crush to the front bumper and bumper reinforcement bar was 20 centimeters (7.9 inches), 27 centimeters (10.6 inches), 37 centimeters (14.6 inches), 43 centimeters (16.9 inches), 25 centimeters (9.8 inches) and 14 centimeters (5.5 inches) respectively C<sub>1</sub> through C<sub>6</sub>. The wheelbase was altered by only 1 centimeter (0.4 inches) on the drivers side. Both fenders sustained induced damage from the frontal impact.

The case vehicle was towed from the scene due to damage. Based on the vehicle inspection, the CDC was determined to be: **12-FDEW-3 (+10)** for the case vehicle [maximum crush was 43 centimeters (16.9 inches)]. The WinSMASH reconstruction program, missing vehicle algorithm, was used on the highest severity impact to the case vehicle. The Total, Longitudinal, and Lateral Delta V's are, respectively: 39.8 km.p.h. (24.7 m.p.h.), -39.2 km.p.h. (-24.4 m.p.h.), and -6.9 km.p.h. (-4.3 m.p.h.). The case vehicle's barrier equivalent speed is: 37.0 km.p.h. (23.0 m.p.h.).

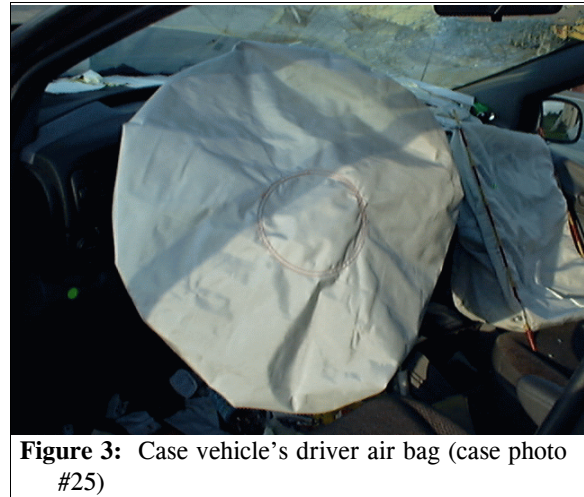
**Figure 3:** Case vehicle's driver air bag (case photo #25)

(24.8 inches) in diameter and was tethered by two 6 centimeter wide (2.4 inch) tethers sewn interiorly to the center of the face of the air bag. The driver's air bag had no vent ports. There was no visible evidence of direct contact to the driver's air bag from either occupants involvement (**Figure 3**). There were two vertical black transfers along the outside of the air bag, caused by the cover flaps during the deployment sequence.

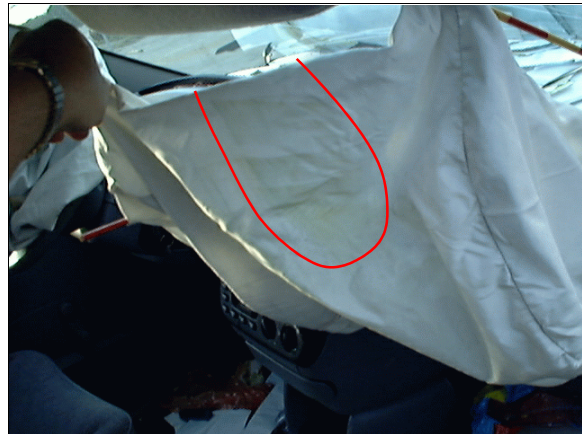
The front right passenger air bag was untethered and had no vent ports. The air bags front face was 46 centimeters (18.1 inches) wide and 56 centimeters (22 inches) tall. Examination of the passenger air bag revealed a heavy skin transfer to the front left portion of the air bag and a large amount of horizontal yellow and green cloth transfers to the front and bottom portions towards the center and right side of the air bag (**Figure 4**). The yellow and green transfers came from the passenger's Green Bay Packers jacket that she was wearing at the time of the crash. The skin evidence on the front of the air bag (**Figure 5**) was approximately 6 centimeters (2.4 inches) wide and 14 centimeters long (5.5 inches). The skin evidence started 17 centimeters (6.7 inches) down from the top horizontal edge of the air bag and 17 centimeters (6.7 inches) in from the left edge of the air bag. The yellow and green horizontal cloth transfers were 12 centimeters (4.7 inches) wide and started 25 centimeters (9.8 inches) down from the top horizontal edge of the air bag. They continued down onto the bottom portion of the air bag for an additional 21 centimeters (8.3 inches).

**Figure 4:** Bottom portion of case vehicle's front right passenger air bag showing green and gold cloth transfers from Green Bay Packers coat passenger was wearing at time of crash (case photo #38)

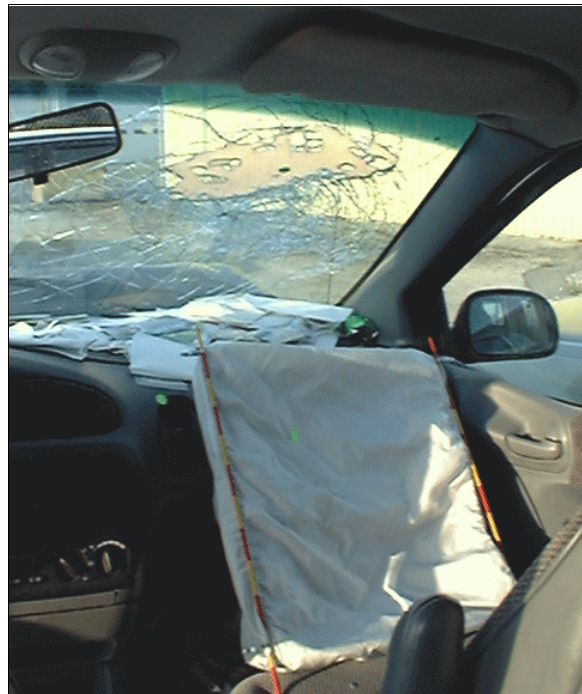
**Figure 5:** Vertical view of case vehicle's front right passenger seating area; Note: contacts (dots) to dash air vent (broken/scuffed) and front of air bag (skin and cloth transfer) (case photo #35A)

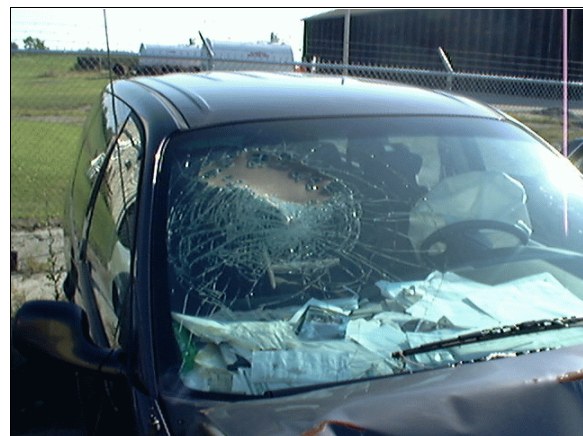
**Figure 6:** Close-up of case vehicle's windshield contact; Note: the membrane of the deploying air bag was between the passenger's head and the windshield (case photo #19)

passenger's head would have contacted the windshield, but the fabric of the air bag mitigated the impact by serving as a buffer between her head and the windshield (**Figure 6** above and **Figure 7**). The passenger did not sustain any lacerations to her head, but the top portion of the air bag had numerous small cuts from the cracked windshield. The passenger subsequently rebounded upwards, contacting the windshield header/sun visor area before she rebounded backwards. As the case vehicle rotated approximately 10 degrees counterclockwise the passenger rebounded back and to the left falling between the two front bucket seats. At final rest the passenger was unconscious and her upper torso was laying on the floor between the two front bucket seats with her feet in the floorboard area of the front right passenger seating area (i.e., still in the passenger foot well).

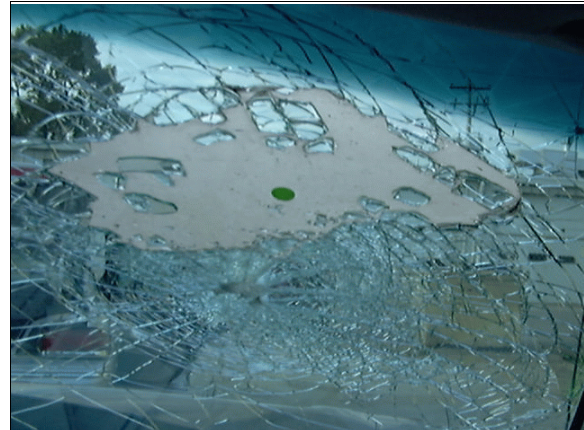
**Figure 7:** Interior view of contact to case vehicle's windshield from front right passenger (case photo #47)

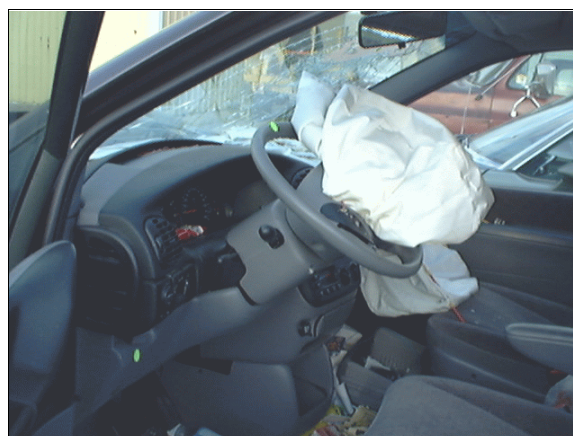
The case vehicle's primary impact with the Chevrolet deployed both the driver the front right passenger's air bags. Since there were no avoidance maneuvers, the driver's upper torso would have remained against his seat back just prior to impact. At impact the case vehicle's driver moved into the deploying air bag, impacting it with his chest and head. The driver's left knee struck the left lower dash, braking off the parking brake handle, and his right knee impacting the right lower dash (cloth transfer) forcing his thigh back into his hip causing his right hip fracture/dislocation. The frontal impact and the deploying air bag lifted the driver upwards where he contacted the sun visor with his forehead cutting it prior to falling back down in his seat. An inspection of the driver's air bag, which was located in the steering wheel hub, showed no visible evidence of contact. An inspection of the driver air bag module's cover flap revealed no evidence of contact. The driver's interaction with the deploying air bag combined with the vehicle's moderate frontal impact most likely caused the steering column's energy absorbing shear capsules to separate to some degree, but the exact amount was not documented. The top half of the steering wheel rim (**Figure 8**) was deformed by 4 centimeters (1.6 inches).

**Figure 8:** Deformation to upper half of case vehicle's steering wheel rim and contact to knee bolster by driver's left knee (case photo #28)

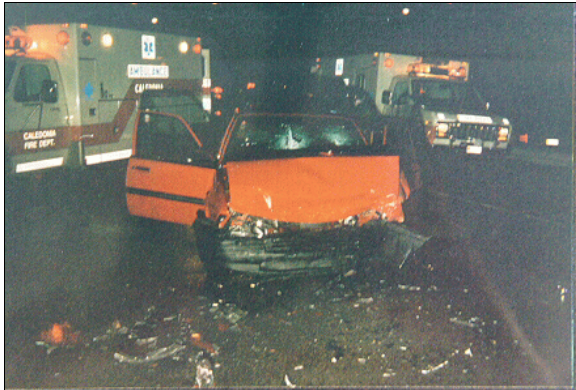
The direct damage to the Chevrolet extended from bumper corner to bumper corner. The hood was folded back with both side fenders crushed rearwards as well (**Figures 9 and 10**). The windshield had two, holed, spider web contacts, one in the driver's area and the other in the passenger's area. Presumably, there was intrusion to the Chevrolet's toe pan, floor board, and dash. The steering wheel appeared collapsed from loading by the driver's chest.

**Figure 9:** On-scene view of Chevrolet at final rest with both front seat occupants removed; Note: moderate front end damage and head contacts to windshield (case photo #54)

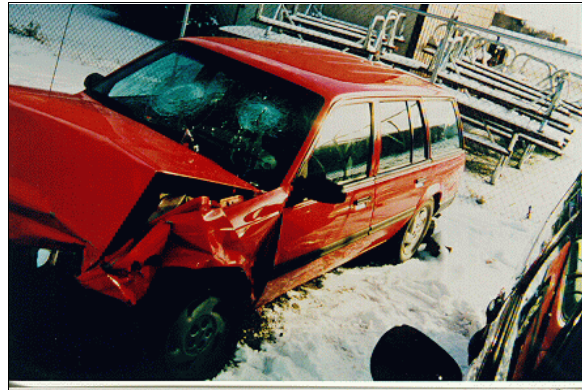
**Figure 10:** Chevrolet's frontal damage and induced damage viewed from front left while in impound lot (case photo #58)

The Chevrolet was towed from the scene due to damage. Based on the available photographs, the CDC was determined to be: **12-FDEW-2 (-10)** for the Chevrolet [maximum crush was estimated as 48 centimeters (18.9 inches)]. The WinSMASH reconstruction program, missing vehicle algorithm, was used on the highest severity impact to the Chevrolet. The Total, Longitudinal, and Lateral Delta V's are, respectively: 55.0 km.p.h. (34.2 m.p.h.), -54.2 km.p.h. (-33.7 m.p.h.), and +9.6 km.p.h. (+6.0 m.p.h.). The Chevrolet's barrier equivalent speed is: 57.5 km.p.h. (35.7 m.p.h.).
